CTU in Prague  
Faculty of Civil Engineering  
Department of Building Structures

# Restoration of load-bearing structures

Holy Trinity Church in the Zahořany near Litoměřice

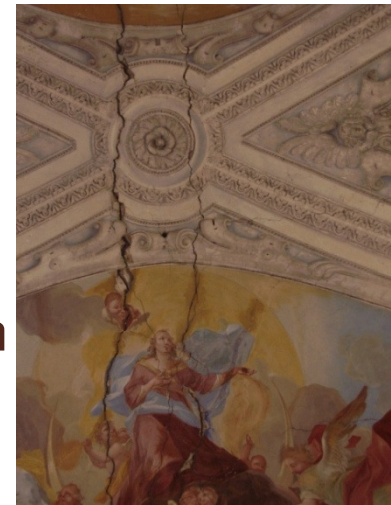
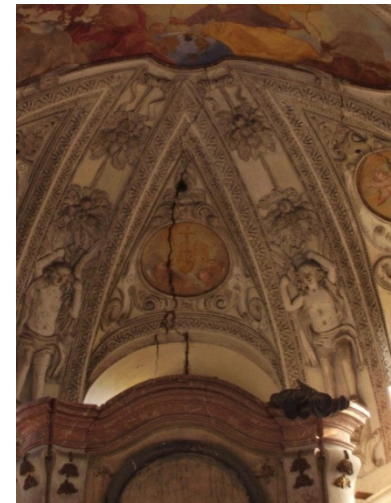
- ▶ Formation of defects
  - ▶ new roof in 1816 - increase loading
- ▶ Defects in floor structure
  - ▶ main tension cracks along the length of the church
  - ▶ crack width from 20 to 30 mm
  - ▶ locally cracks width up to 50 mm
- ▶ For reasons of large defects was the church in 1980 closed

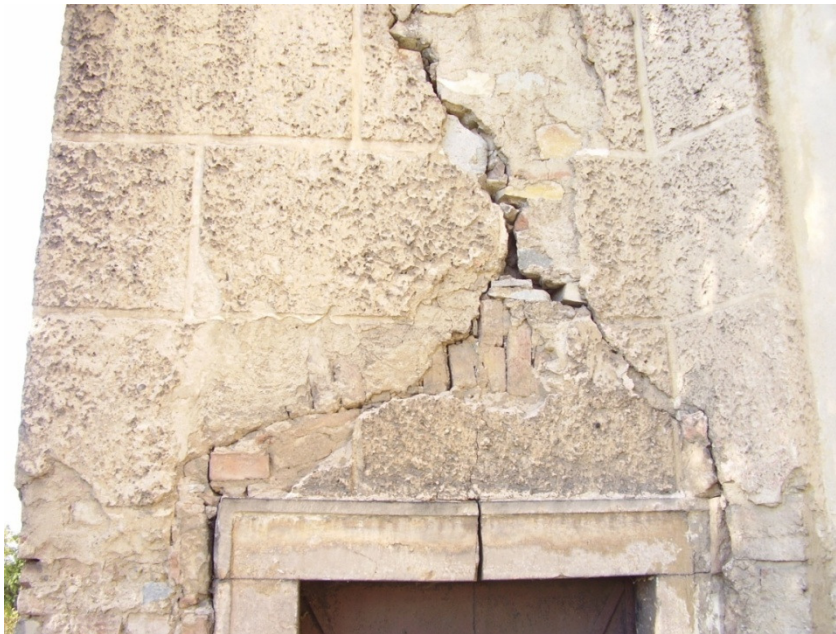
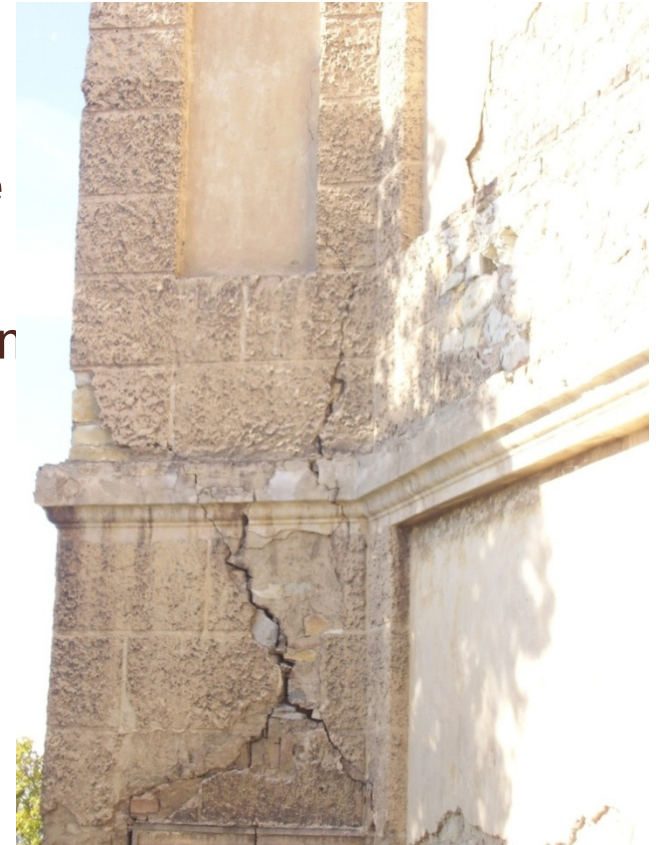
- ▶ Walls defects
  - ▶ longitudinal tension crack in the wall
  - ▶ significant boom of cracks on the east side
  - ▶ cracks extend into the door lintels
  - ▶ crack width 10 - 30 mm, locally up to 40 mm

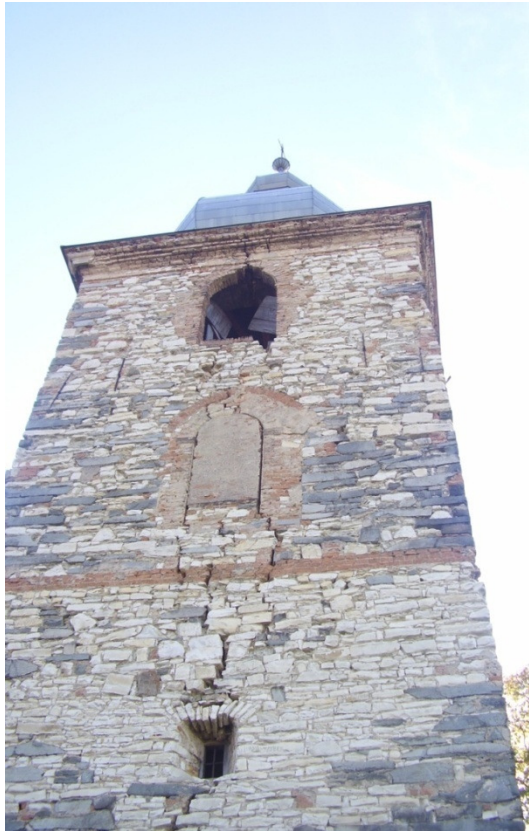
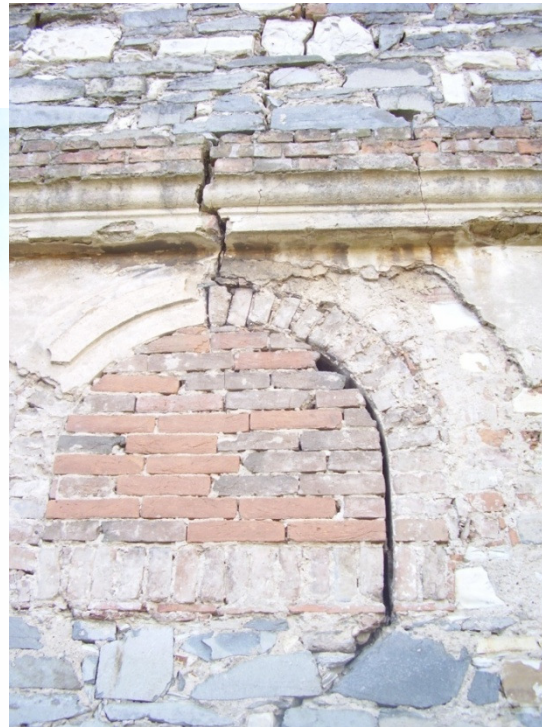
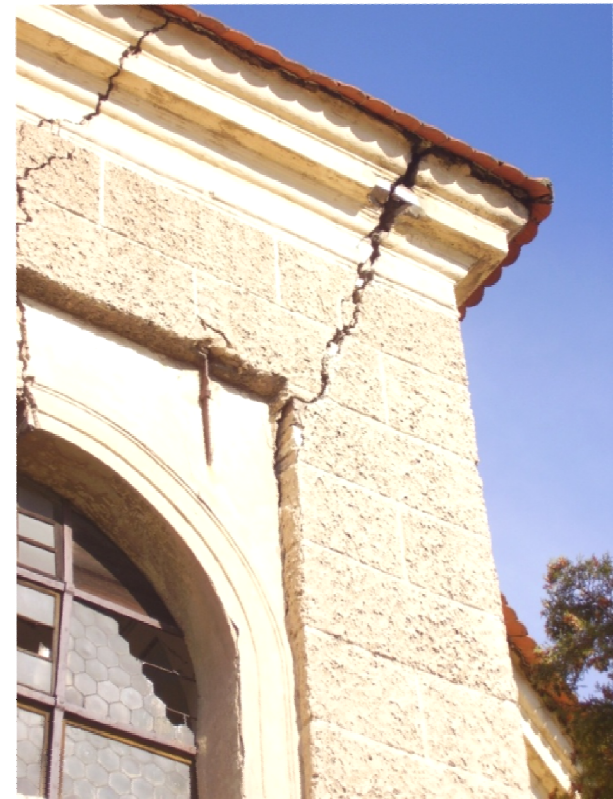
- ▶ Cracks in load-bearing wall

- ▶ Gradual development of tension cracks due to insufficient capture horizontal forces from the truss
