Restoration of masonry

Hotel Central – Hybernská street, Praha 1

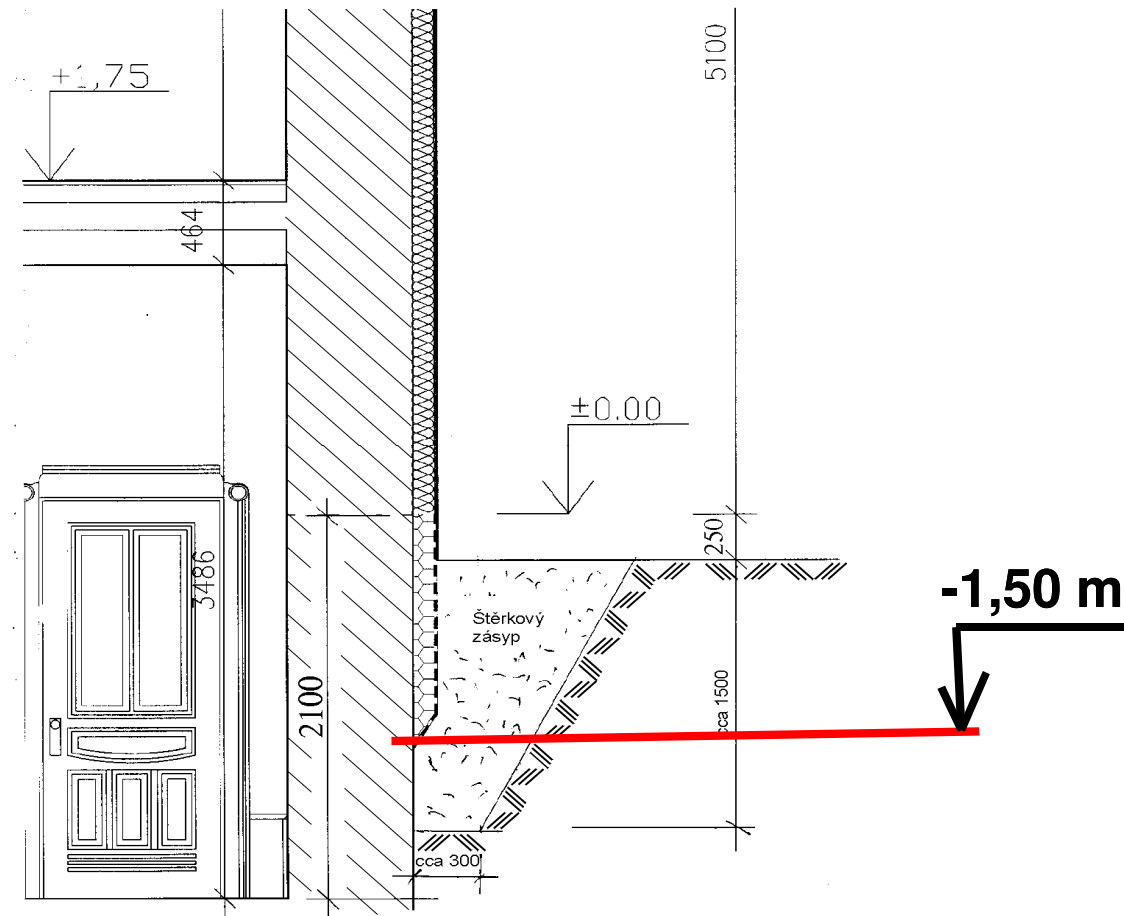
- Realization of vertical waterproofing system

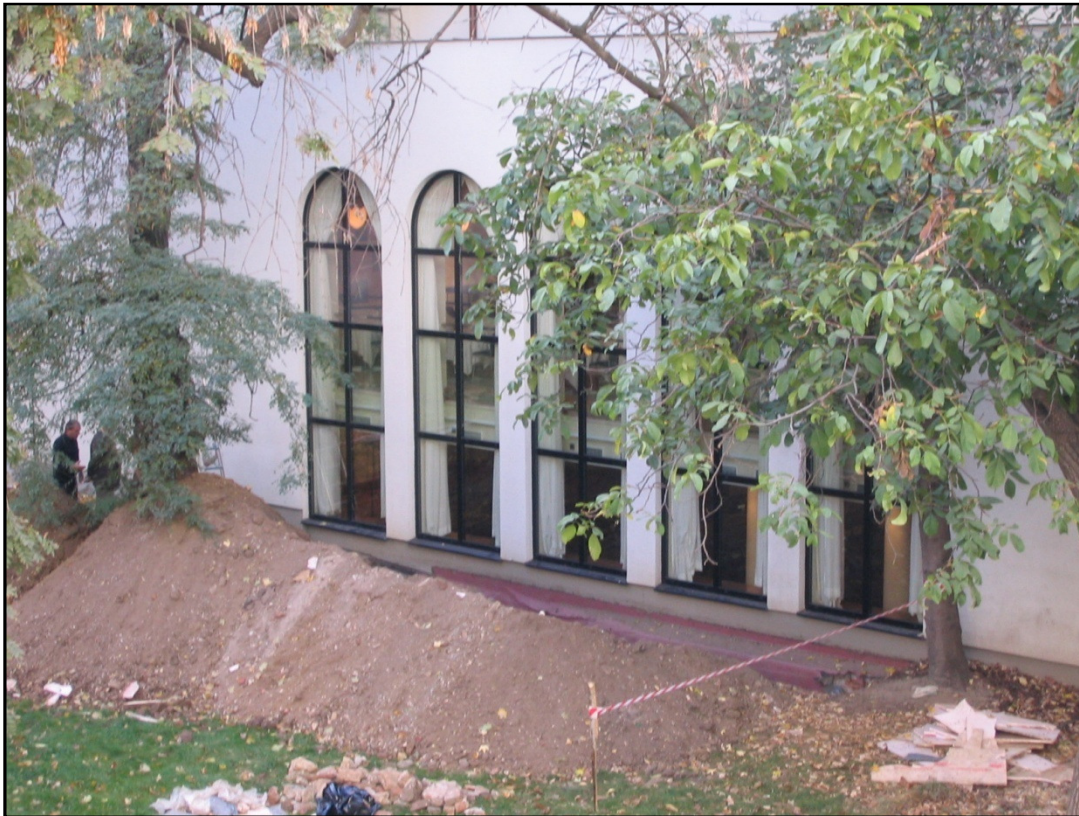
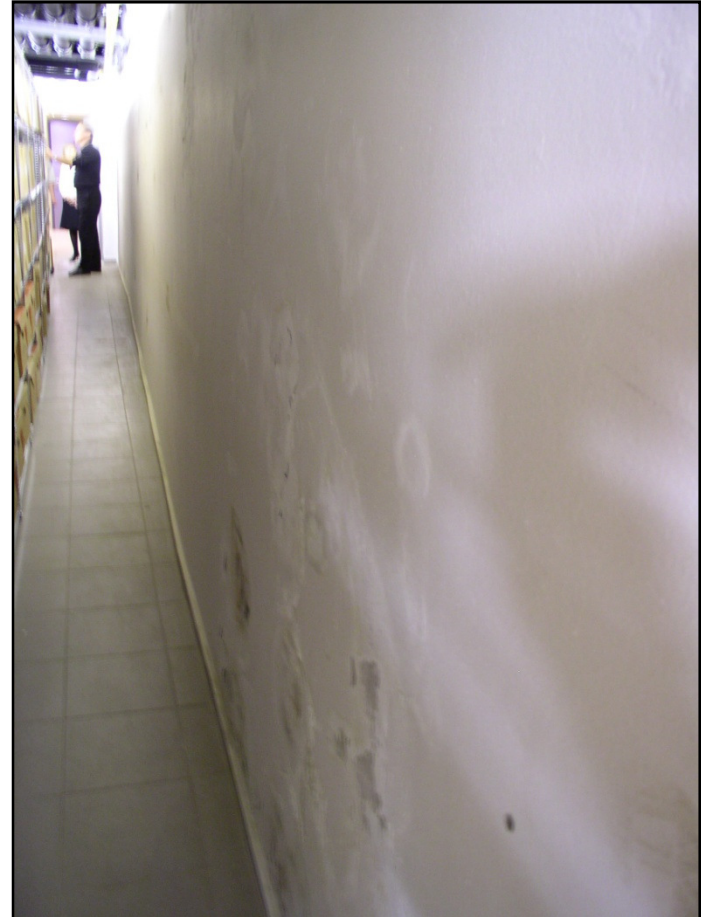
► Defects

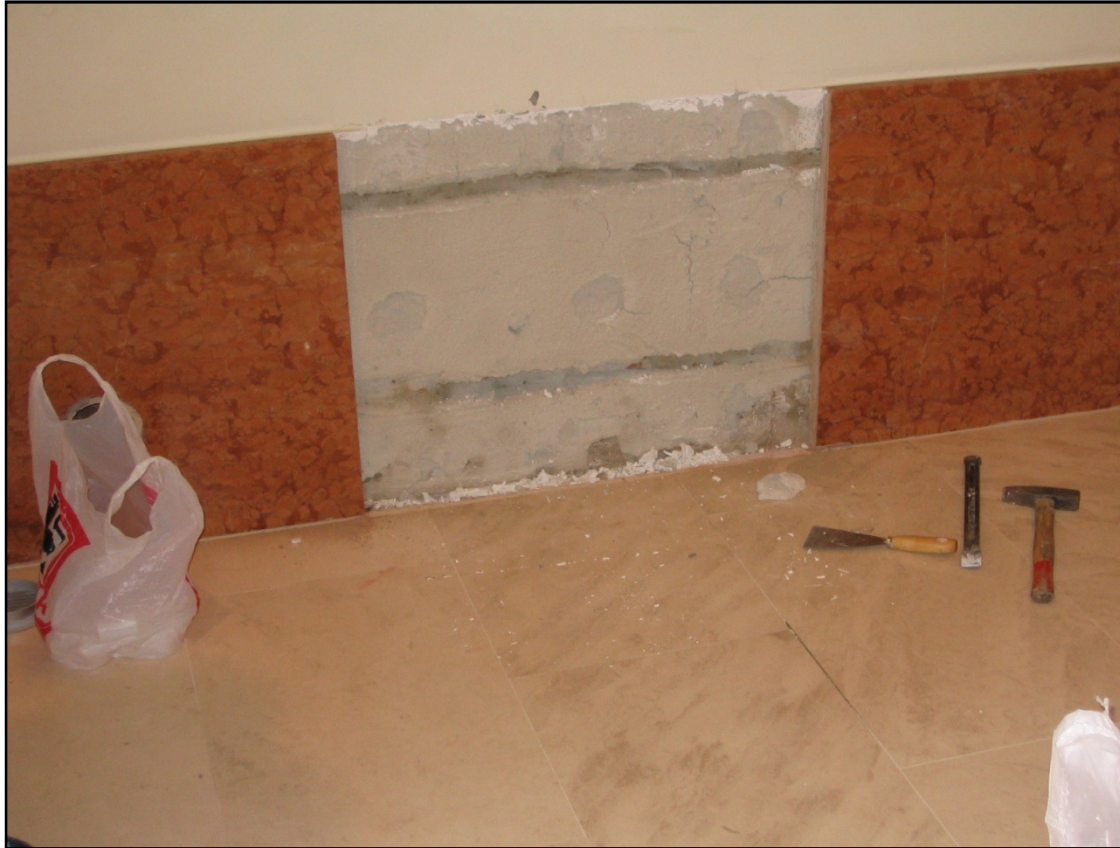
- ▶ Socel facing by marble-slabs

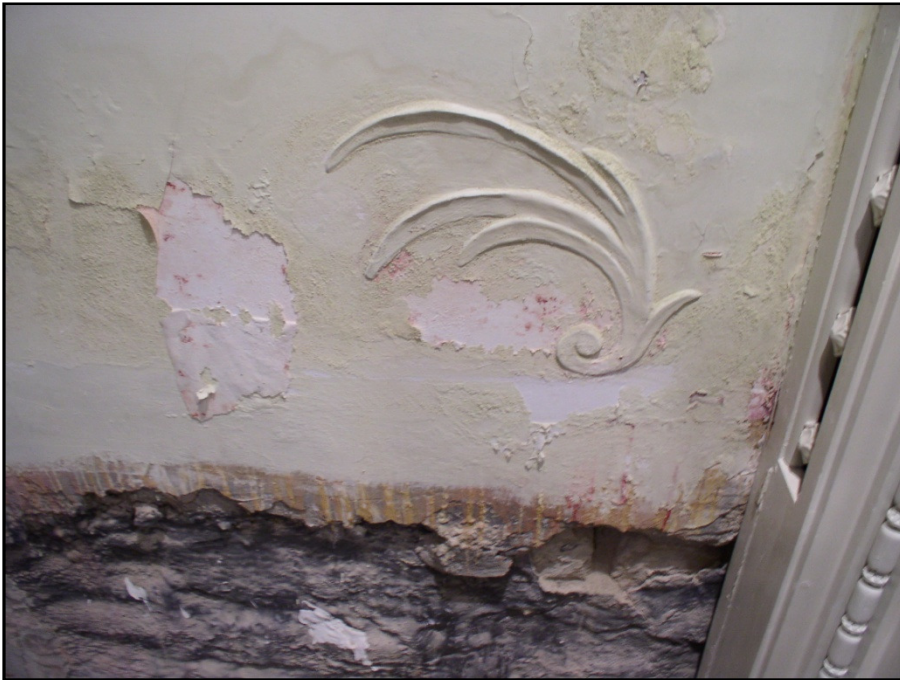
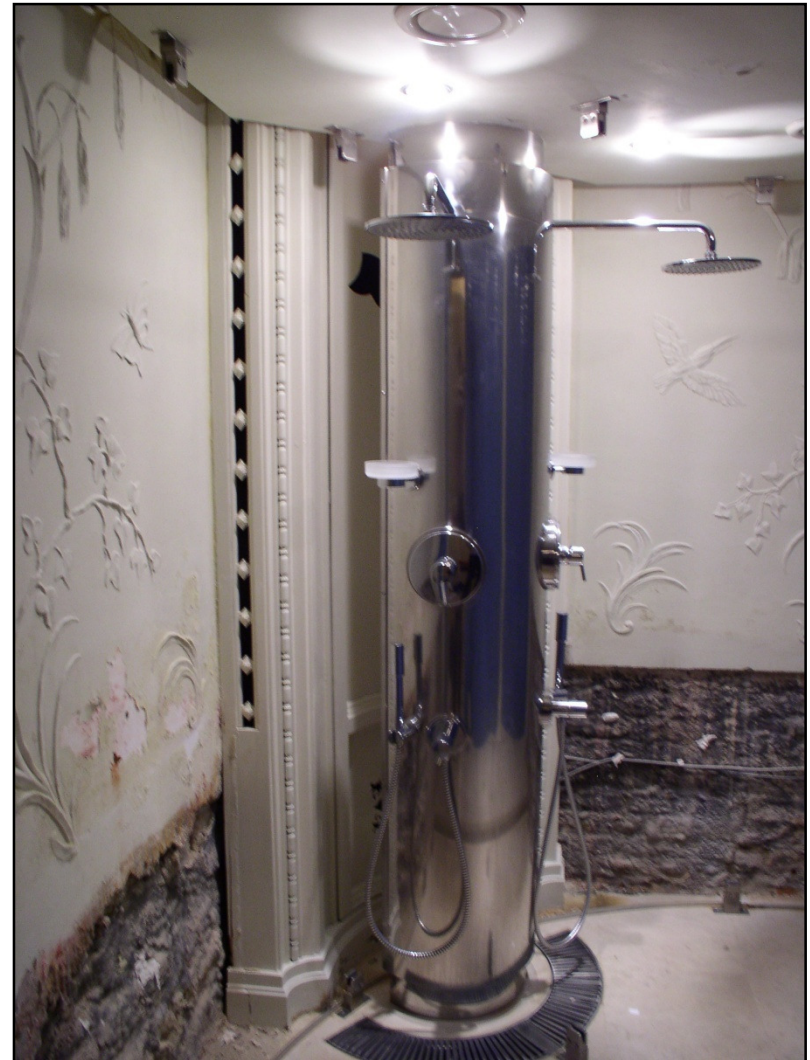
► Defects

- ▶ New implemented waterproofing system does not reach the floor level of first basement (water is accumulated in gravel layer)
- ▶ Complete absence of vertical waterproofing in the 2nd basement
- ▶ Dysfunctional depth core bore holes (princip of Knapen channels)

- ▶ realized solutions
 - ▶ vertical insulation
 - ▶ grouting
 - ▶ drainage
- ▶ effects of second reconstruction
 - ▶ difficult to identify an additional defects
 - ▶ technically and economically demanding solutions
 - ▶ difficult implementation
 - ▶ not always 100% guarantee of effective measures

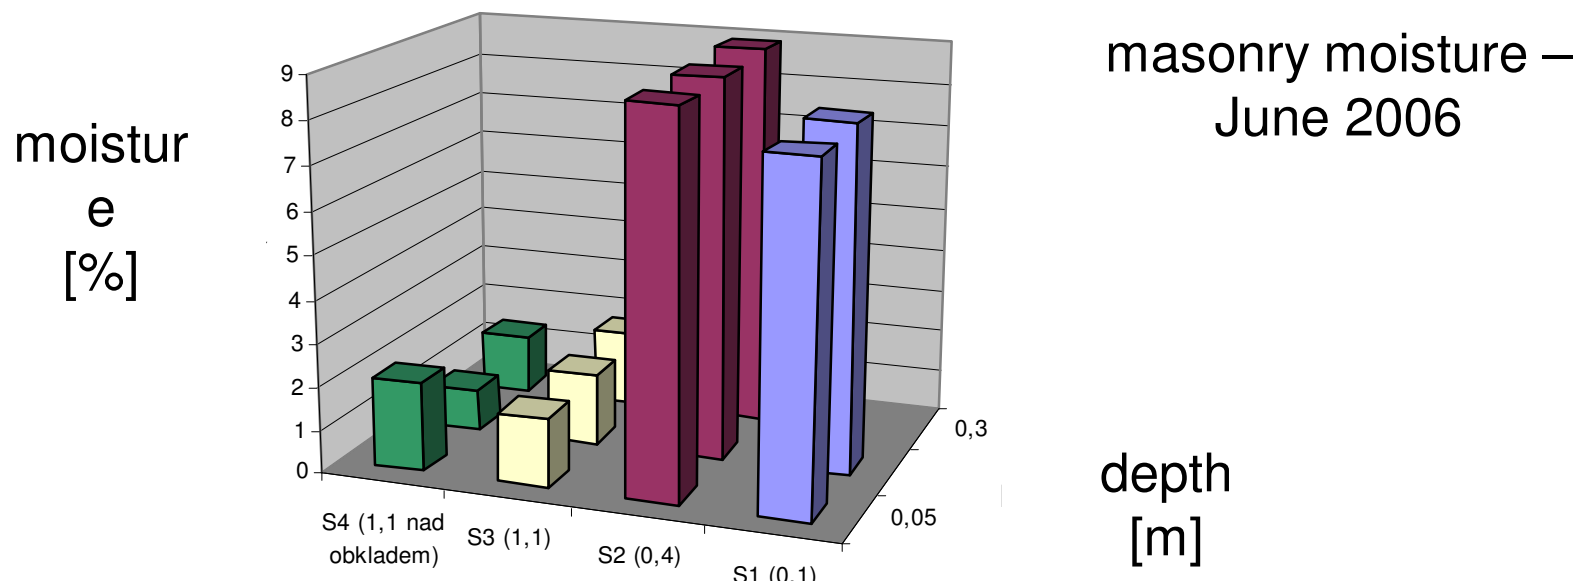
- ▶ Masonry survey - determination of:
 - ▶ masonry moisture
 - ▶ chemical status of masonry
 - ▶ parameters of the internal environment
 - ▶ biological infestation of the historic wooden facing
