CTU in Prague
Faculty of Civil Engineering
Department of Building Structures

Restoration of vaults

Nerudova 15, Prague

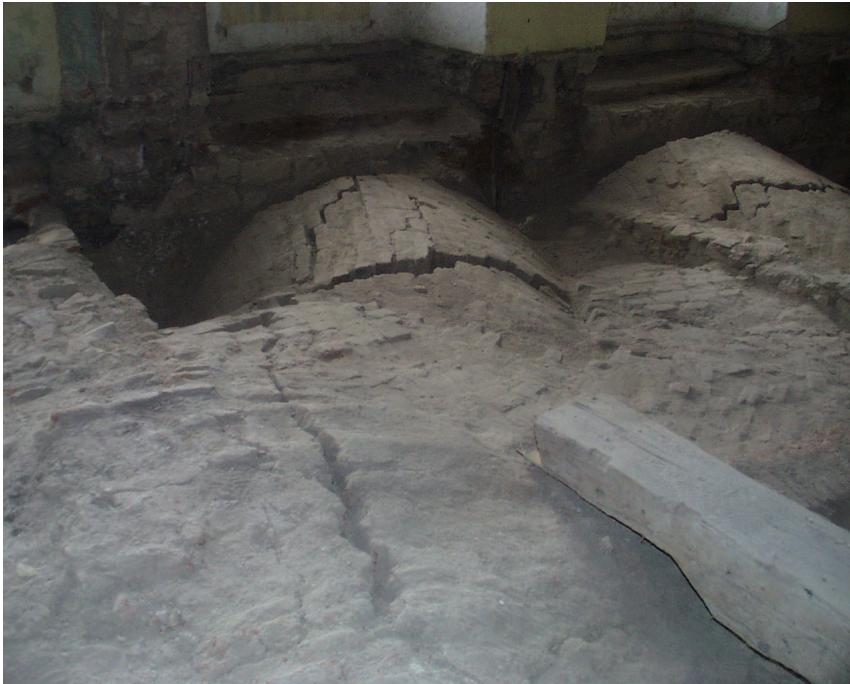
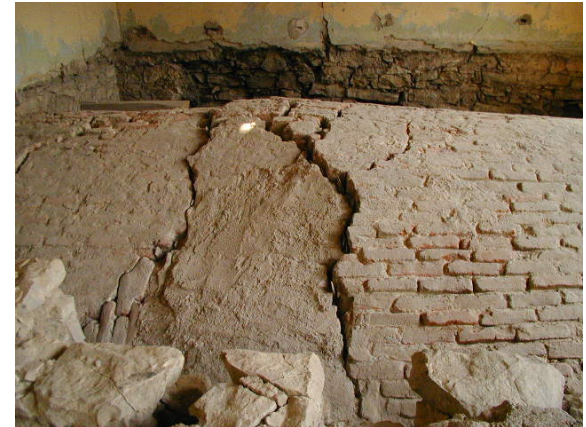
- ▶ active cracks in the arches
- ▶ cracks in the facade
- ▶ infestation of truss elements by wood decaying fungi

- ▶ unstable foundation subsoil (site Jánský vršek)
- ▶ insufficient structure reinforcement in the past

- ▶ temporary stabilization of the floor
- ▶ injection of load-bearing masonry with cement grout and making of tear-off tests
- ▶ reinforcement of the building with prestressing steel draw rods
- ▶ reinforcement of vaults on the reverse side
- ▶ reconstruction of wooden truss elements
- ▶ injection of bearing soil
