CTU in Prague
Faculty of Civil Engineering
Department of Building Structures

Restoration of load-bearing structures

Chateau in Bystřice pod Hostýnem

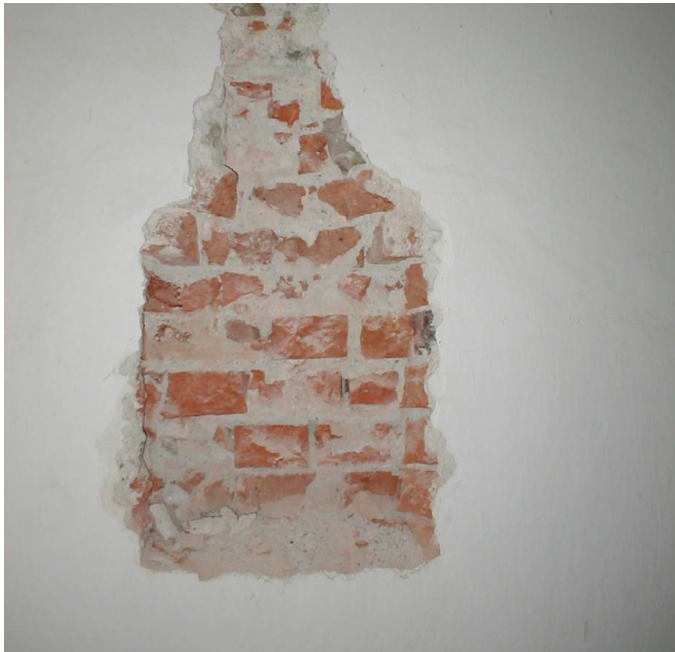
probing into the masonry in 2nd floor

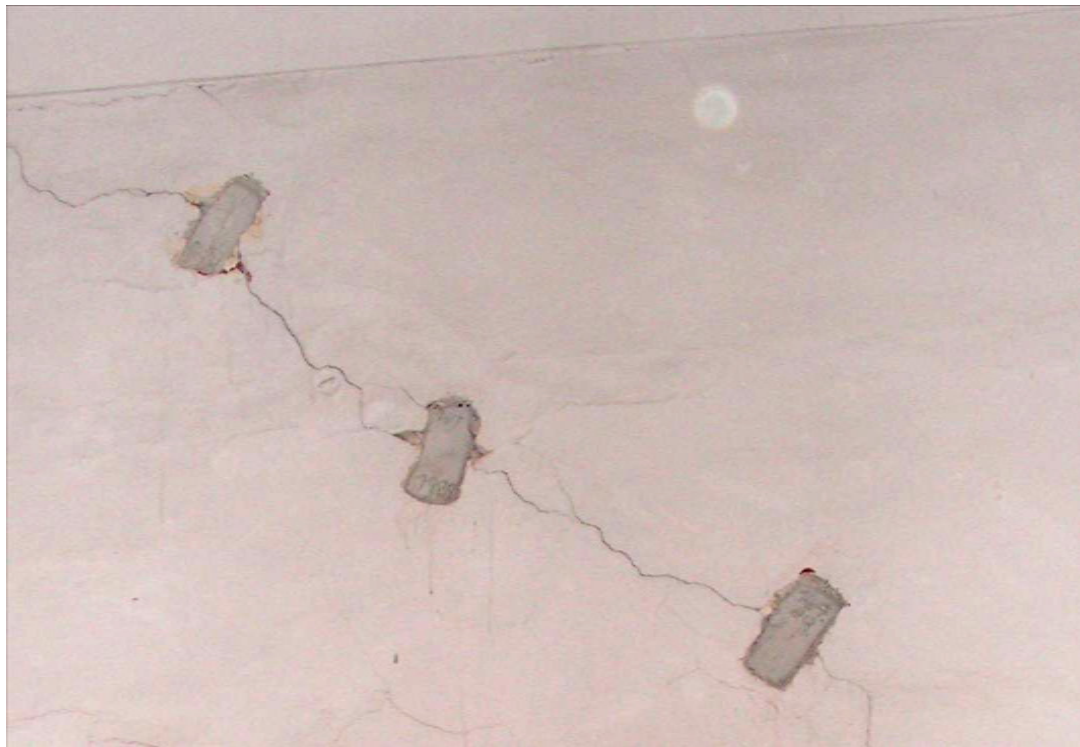
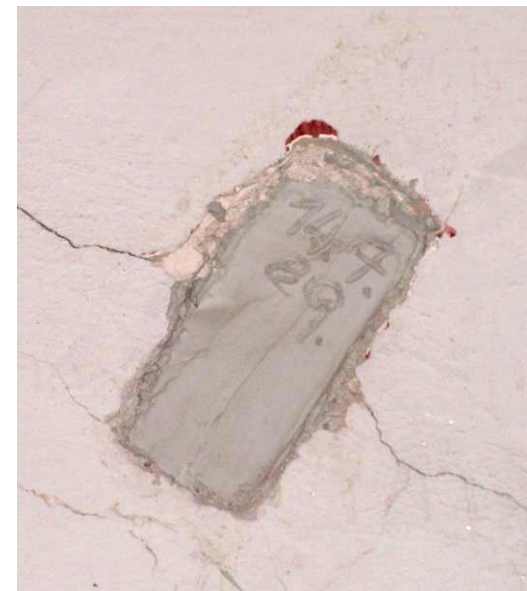
- ▶ Defects of vertical structures in 2nd floor
 - ▶ plaster labels

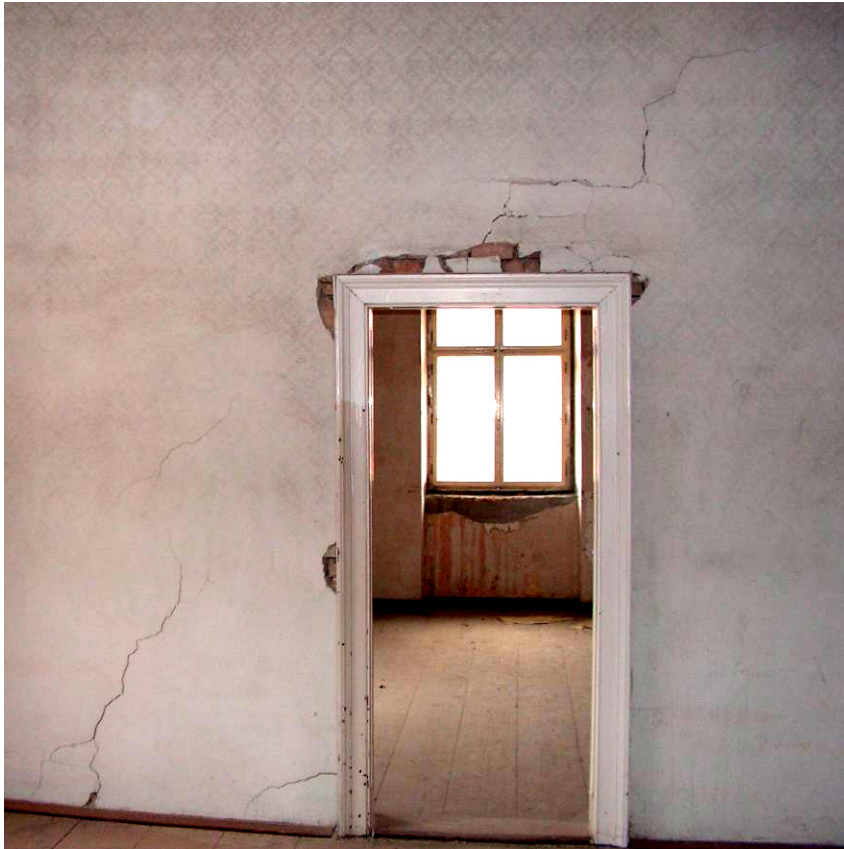
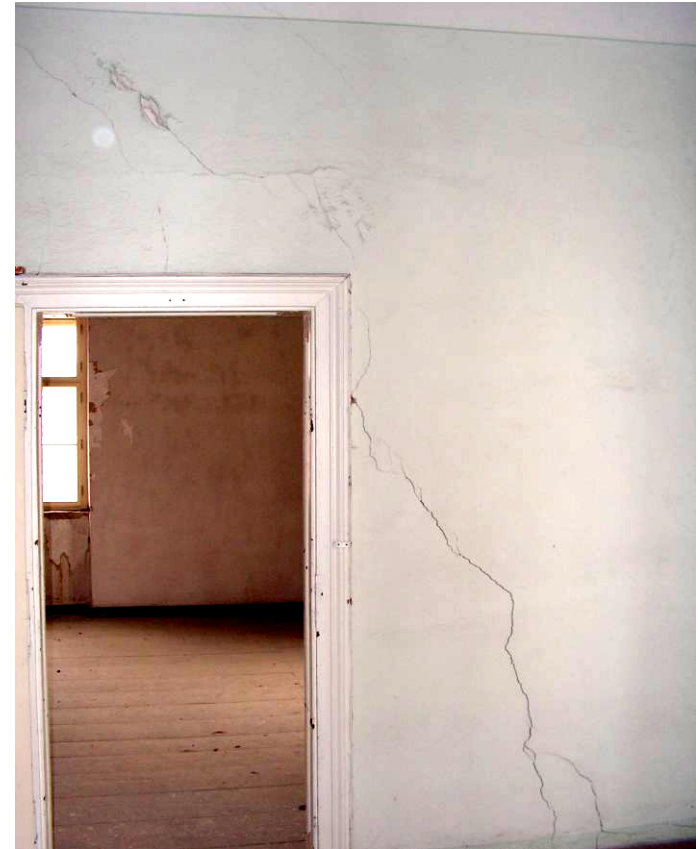
- ▶ Defects of vertical structures in 3rd floor
