CTU in Prague Faculty of Civil Engineering Department of Building Structures

Restoration of masonry

Church of St. Giles in Milevsko

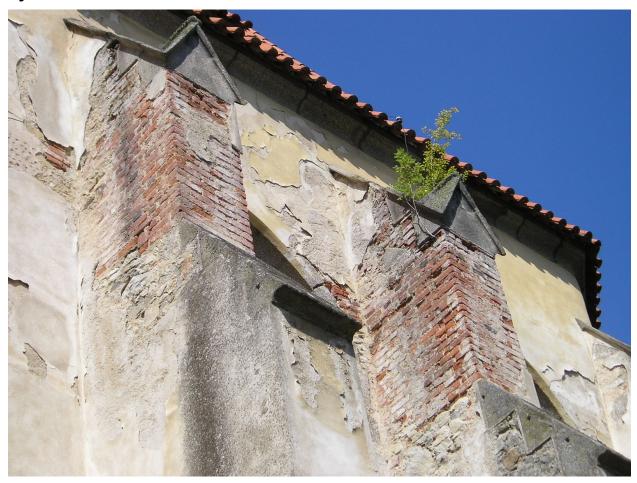
Masonry defects

- high groundwater level
- the object is so called "drowned" in not compressed earthworks.
- paving of polished granite into the cement mortar
- roof structure has no effective system of rainwater drain
- inappropriate moisture regime of internal space, especially the impossibility of systematic and regular ventilation

- Design of restoration of humid masonry
 - restore the original drainage system and modification of the terrain around the church
 - restoration using ventilated air channels in the outer and inner peripheral face of the masonry
 - making downpipes and effective rainwater drainage
 - restoration of surface treatments interior flooring, stone masonry and plasters
