CTU in Prague  
Faculty of Civil Engineering  
Department of Building Structures

# Restoration of foundations

## Leaning Tower of Pisa

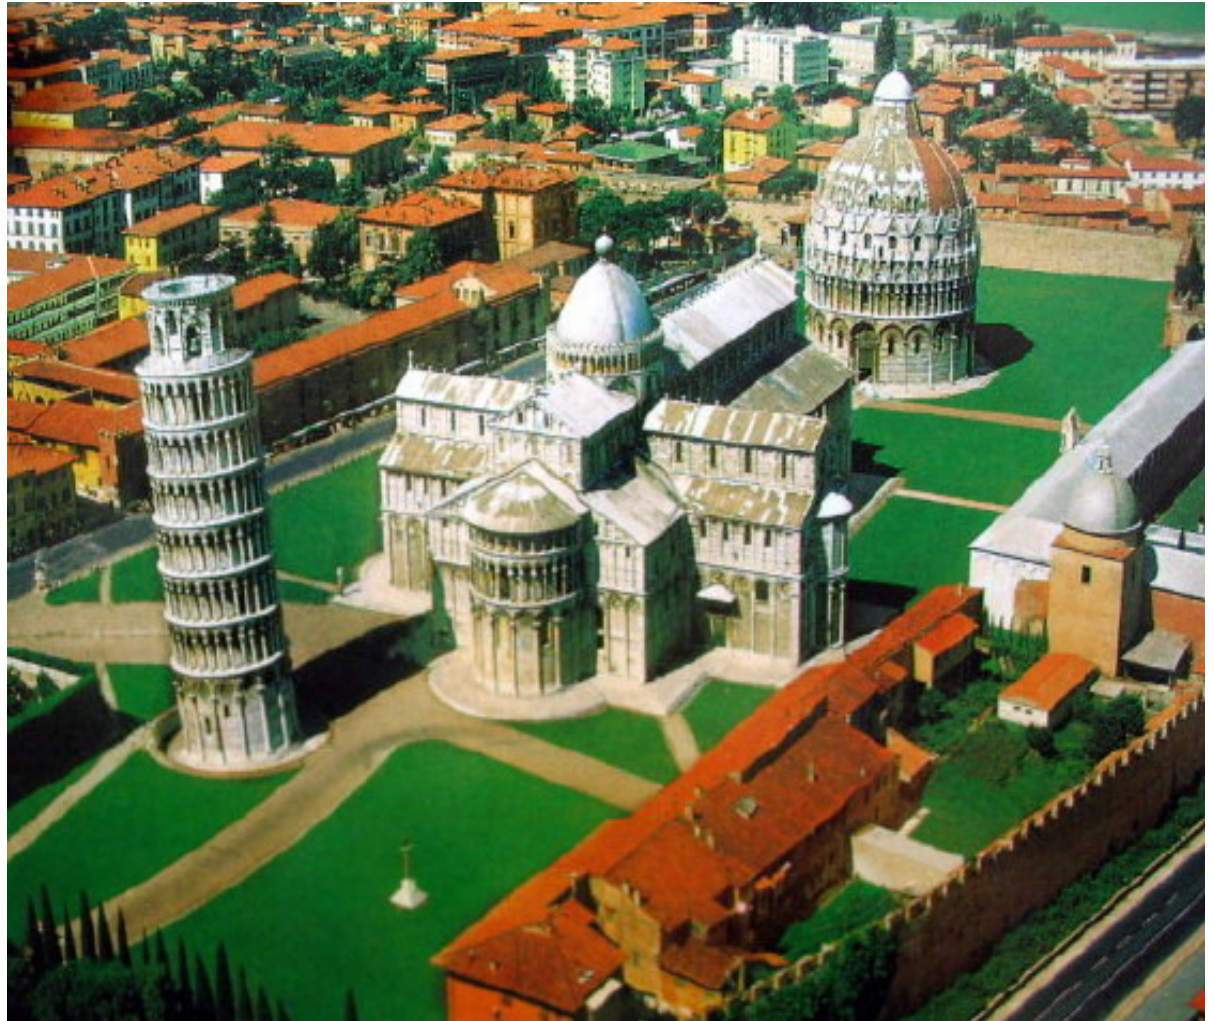
- ▶ in 20 century tower top deflection increased to more than 5 meters
- ▶ 1990 Tower closed to the public, conservation work

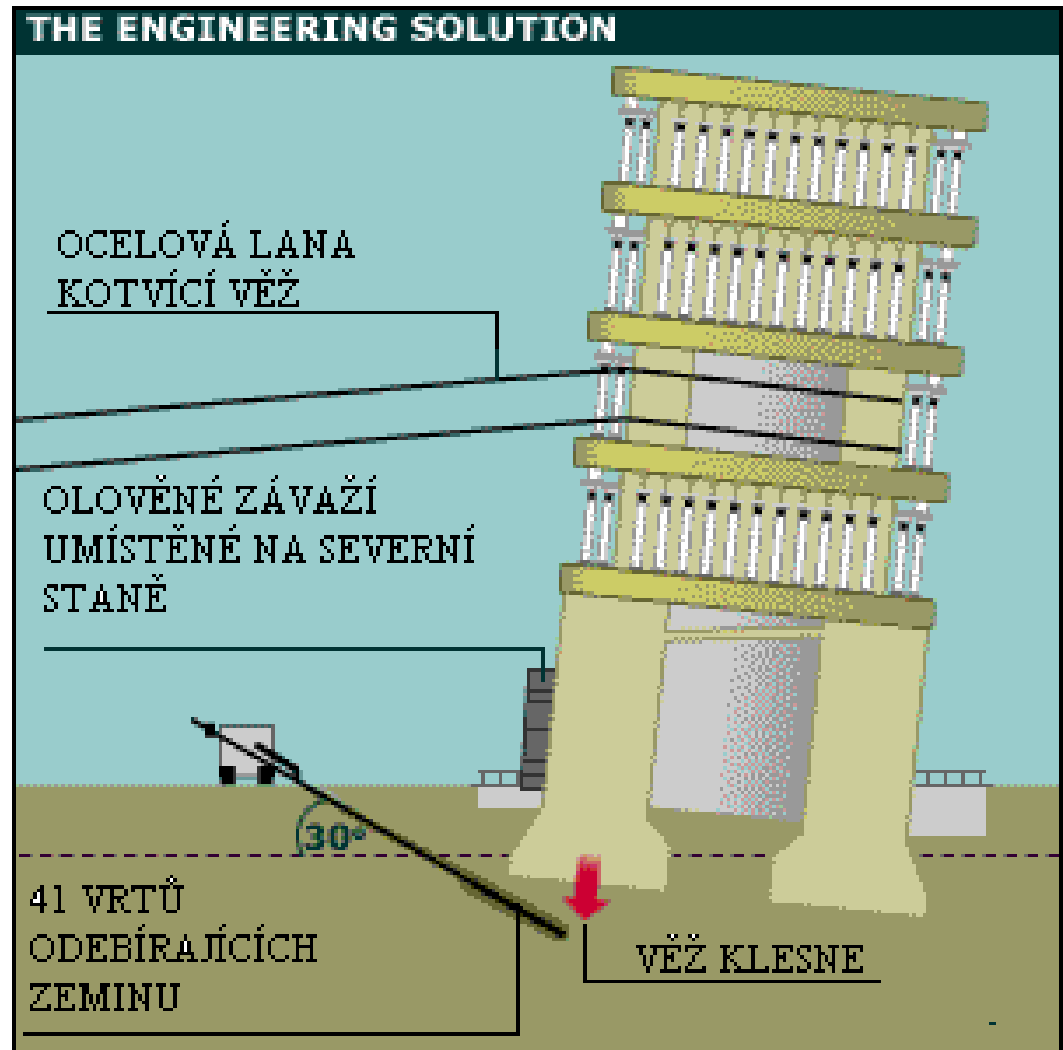
- ▶ designed restoration
  - ▶ 4 cables around the 3rd floor transmit power from the load and the hydraulic piston stabilizes the tower during the drilling

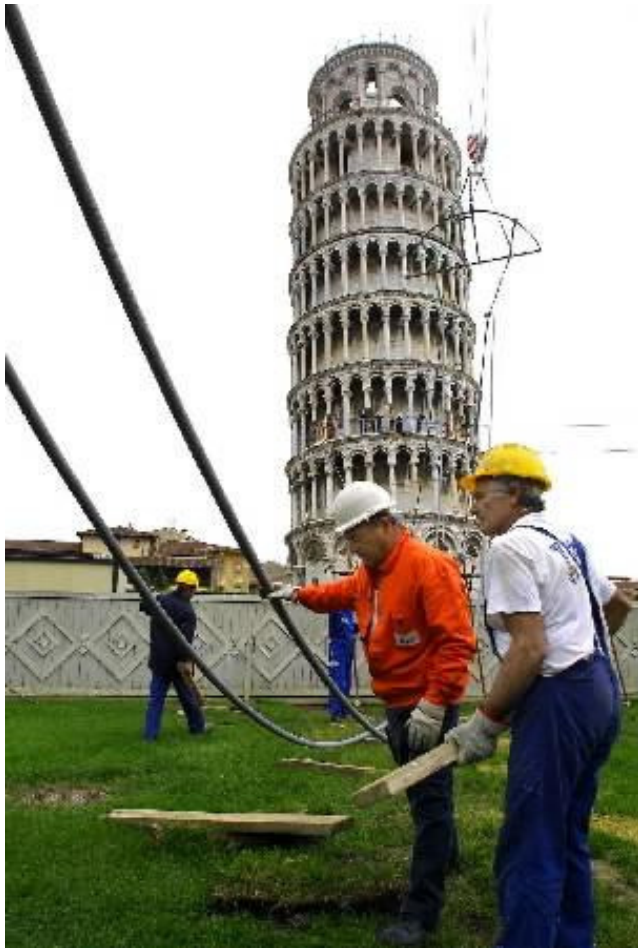
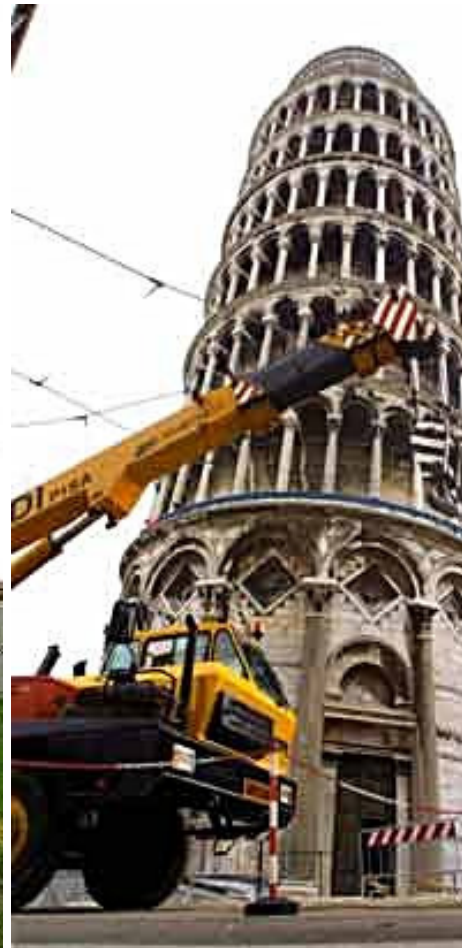
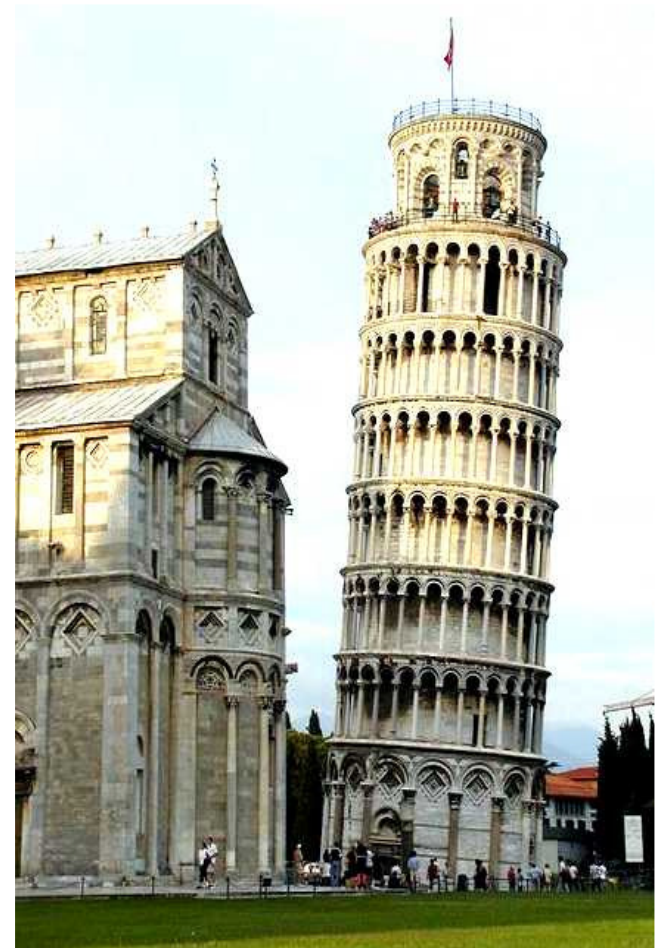
- ▶ restoration process
  - ▶ an iron ropes was let into the ground to consolidate the foundations
  - ▶ part of the unstable subsoil under the foundations of the tower was take out
  - ▶ inclination of the tower began to gradually decrease, now is the deviation of the tower only about 3 meters
