CTU in Prague
Faculty of Civil Engineering
Department of Building Structures

Restoration of vaults

Parish Church of St. Henry and St. Kunhuta in Prague

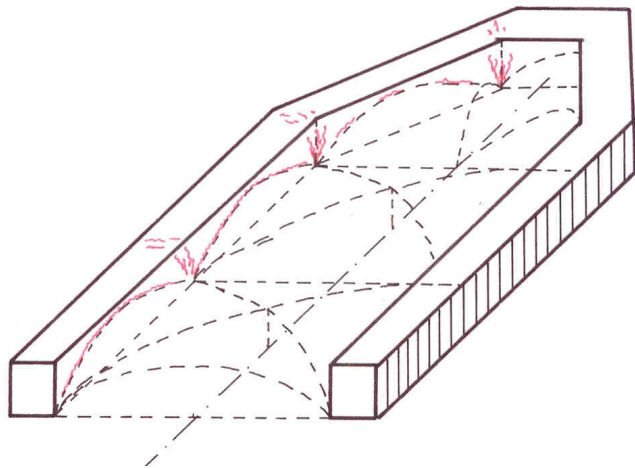
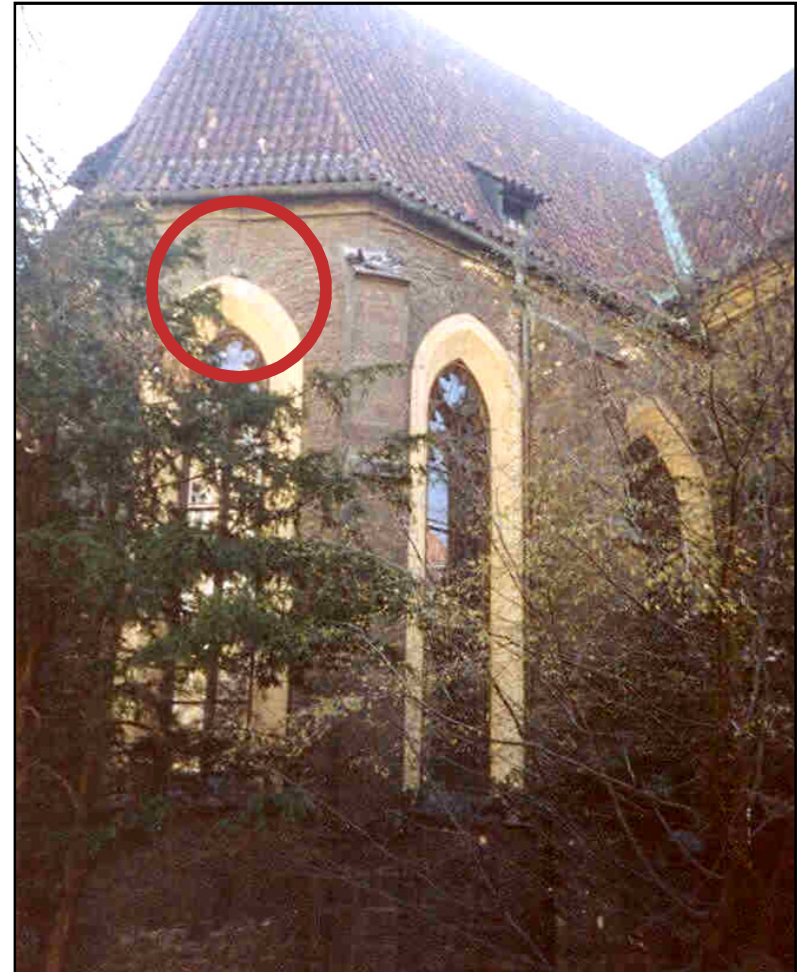
- ▶ Above the left window of the presbytery apparent crack
- ▶ Drawing of the cracks in the attic area

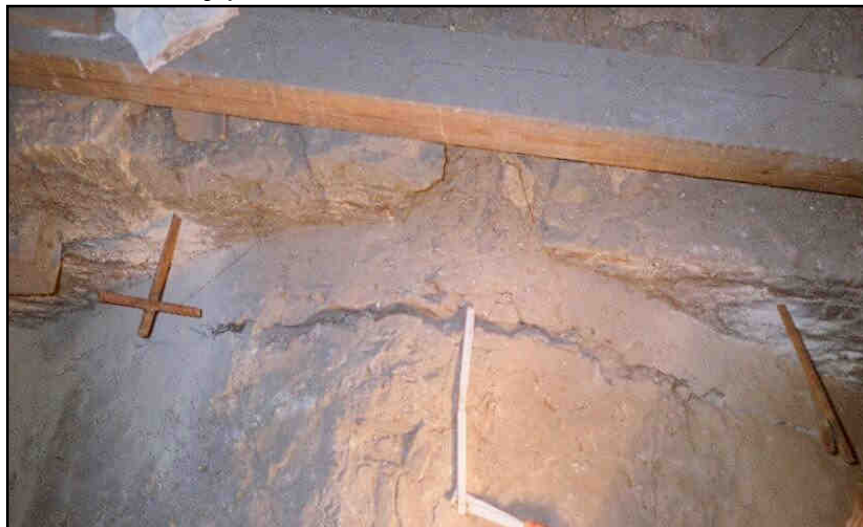
- ▶ Transverse crack of the vault - the vault separation from the presbytery perimeter walls (Fig.: the anchors are ready to attach the masonry)

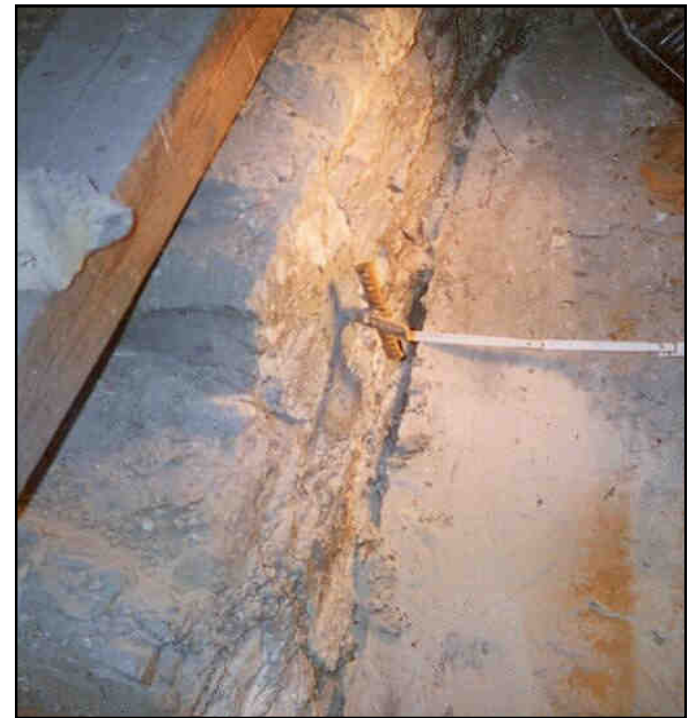
- ▶ Detail of the vault separation from the perimeter wall in presbytery

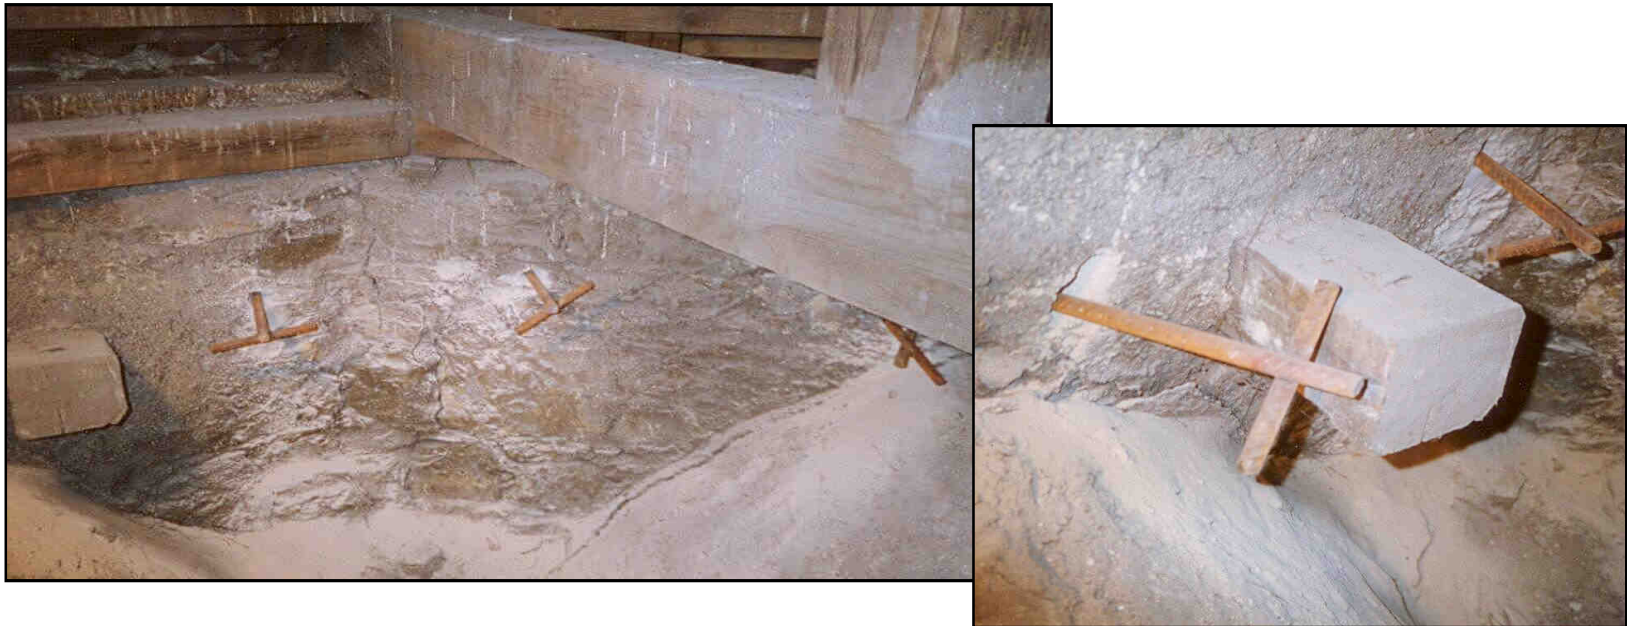
- ▶ Truss tie beam (rotten beam gridiron) and vertical cracks in the perimeter wall of presbytery

- ▶ Detail of anchor and canceled interlock of presbytery perimeter walls by oak beam

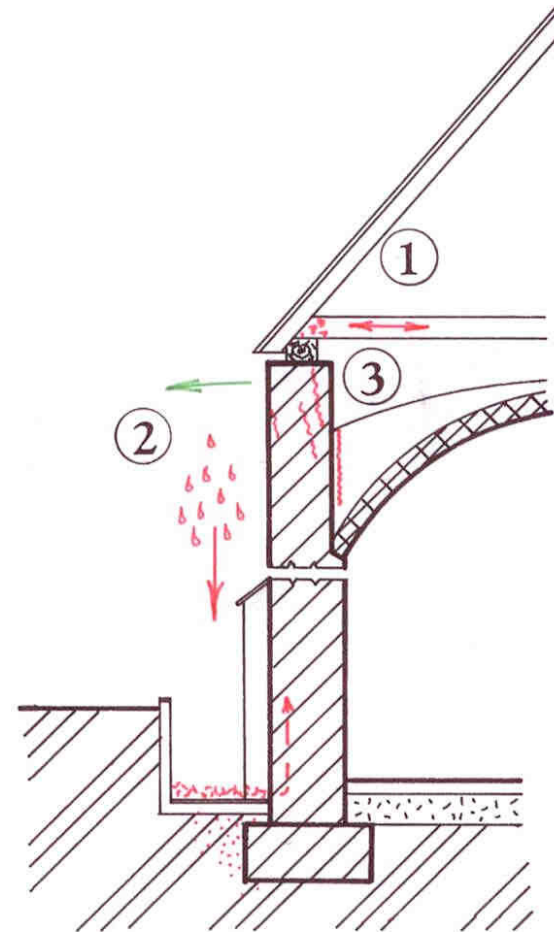
- ▶ Stability of the wall - effects that affect the stability of the wall
 - ▶ 1) dysfunctional interlock (rot)
 - ▶ 2) rising damp (maps)
 - ▶ 3) static faults

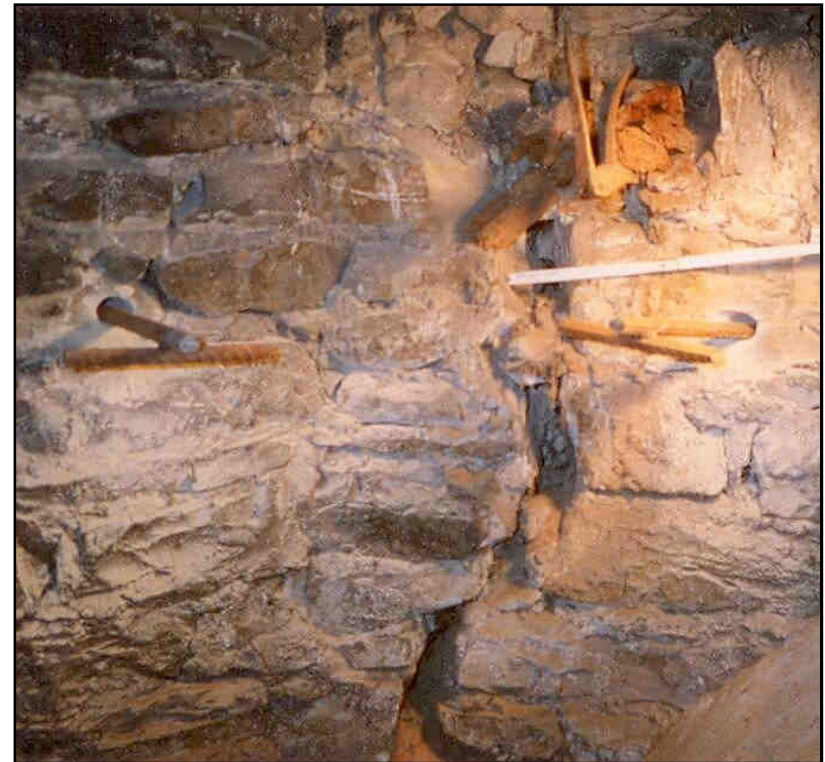
- ▶ vertical crack in the circumferential wall of the presbytery attic area (Fig.: prepared steel anchors for making the rim)
