CTU in Prague
Faculty of Civil Engineering
Department of Building Structures

Restoration of foundings

Santa Maria Dei Frari in Venice

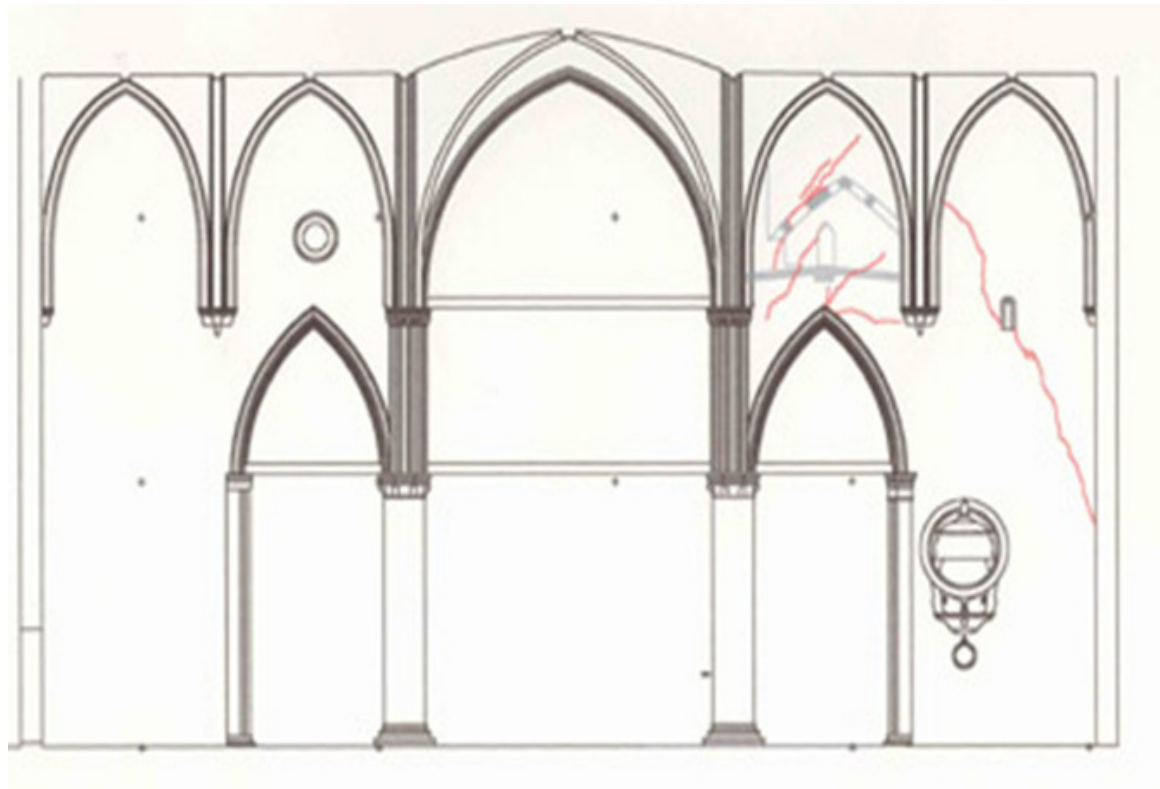
- ▶ Comparison between historical and present map of cracks – red cracks in 2000

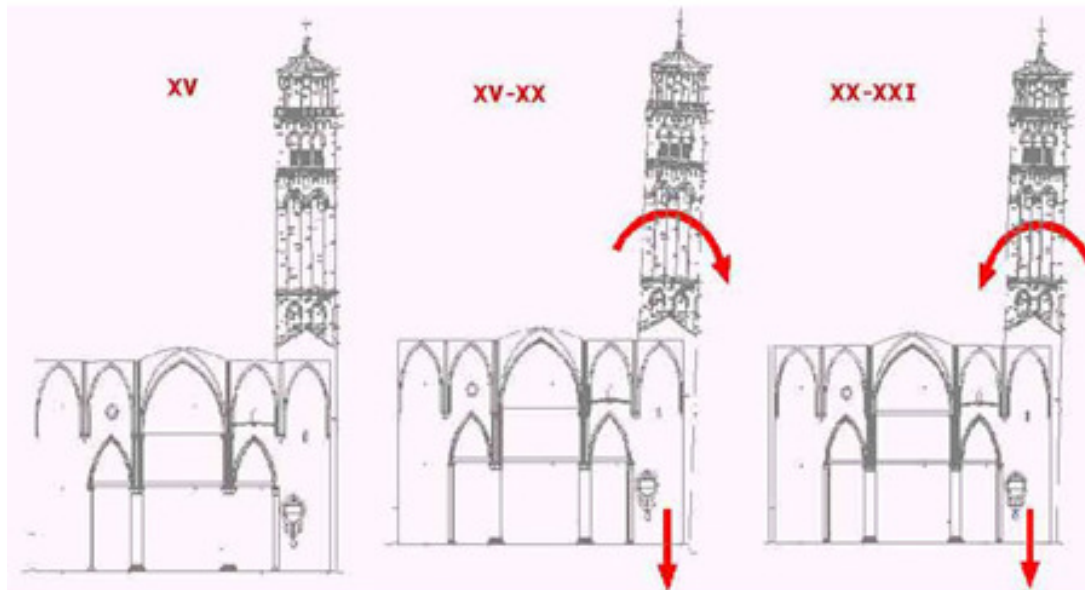
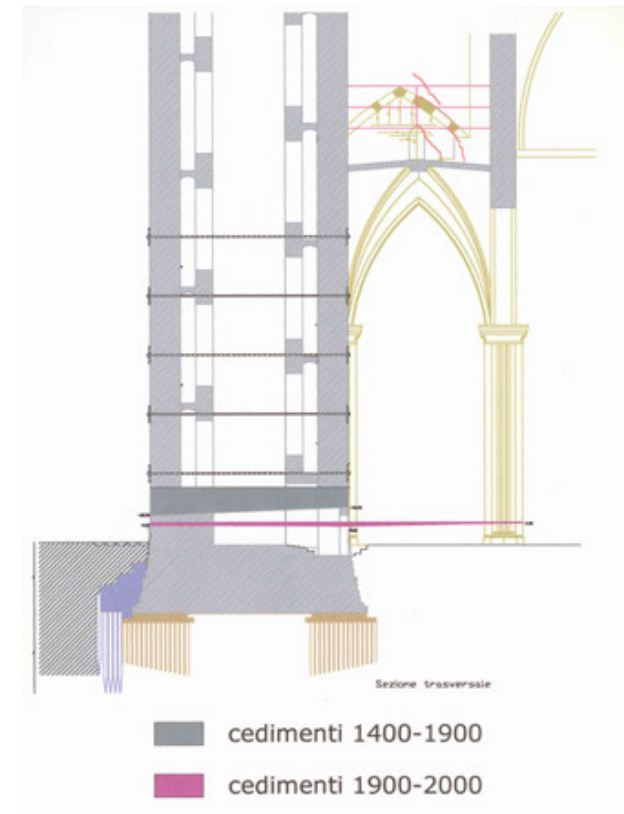
- ▶ change of movement due to settlement of tower

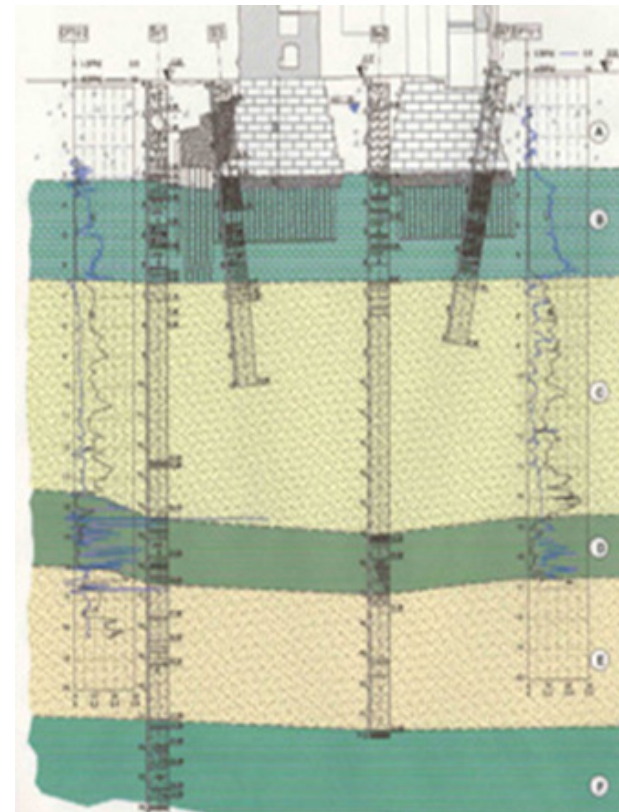
- ▶ A) 0-3 m backfilling material
- ▶ B) 3 - 6.8 m clay (low cohesion)
- ▶ C) 6.8 - 14.5 m of medium-grained sand (low plasticity)
- ▶ D) 14.5 - 16.8 m clay
