CTU in Prague
Faculty of Civil Engineering
Department of Building Structures

Restoration of vaults

Šlechta restaurant in Prague - Bubeneč (Main Hall)

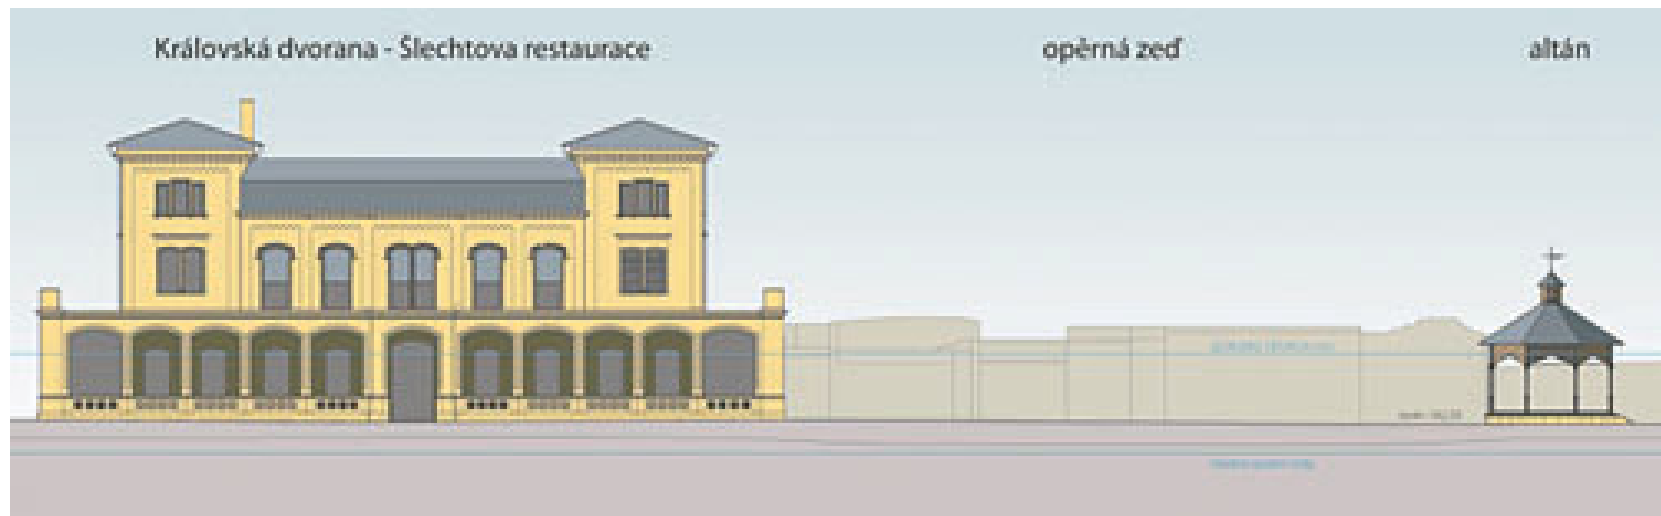
- ▶ Current state of Šlechta restaurant
 - ▶ waiting for the start reconstruction of Šlechta restaurant
 - ▶ there are static securing needed in the context of the construction of the tunnel Blanka

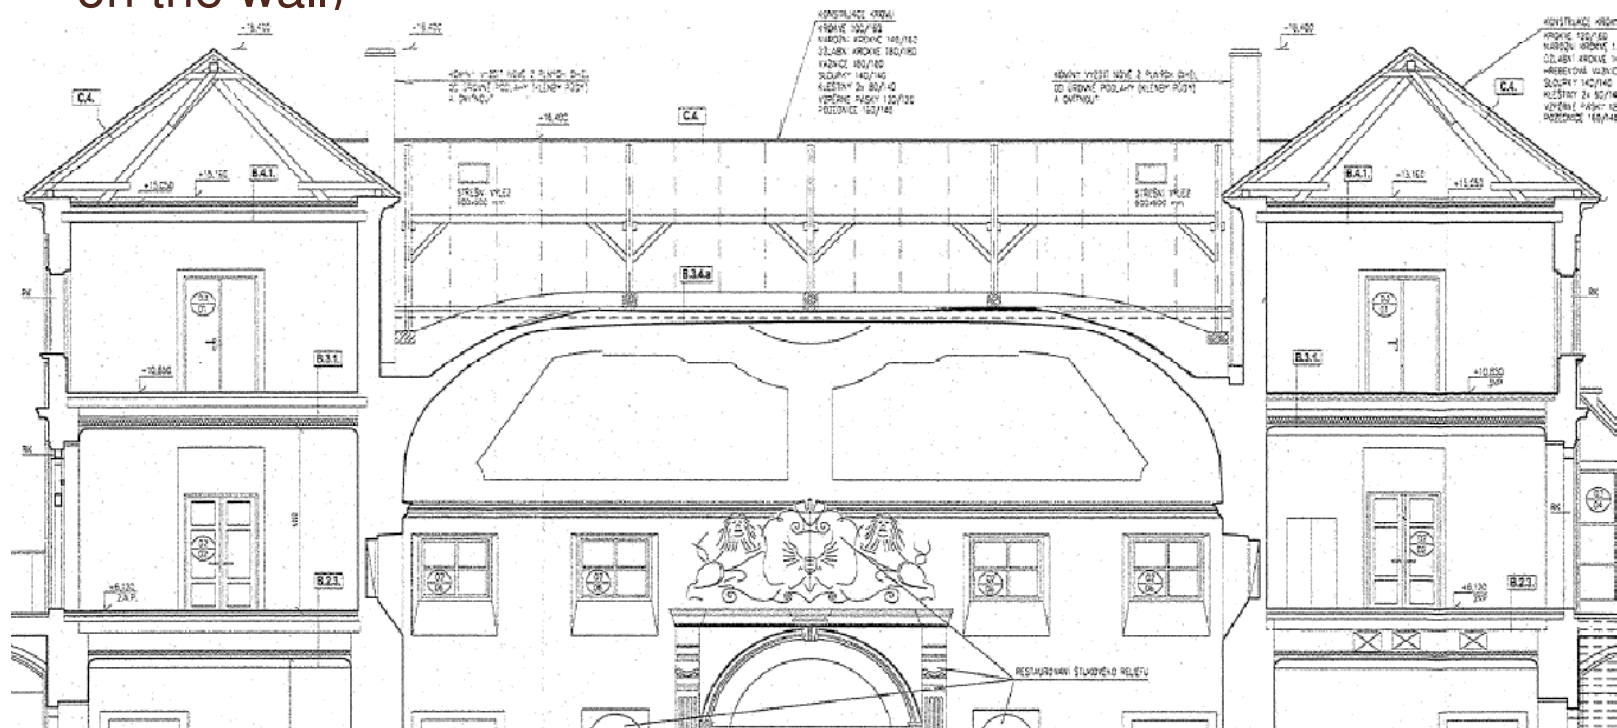
- ▶ Brick vault above the main hall
 - ▶ in the arch abutment at the northern perimeter wall crack exists (large horizontal reactions and insufficient rigidity in the imposition on the wall)

- ▶ Brick vault above the main hall
 - ▶ large horizontal reaction and insufficient rigidity in the imposition on the masonry caused cracks in the arch abutment at the northern perimeter wall

- ▶ The vault is sufficiently bearable to buckling
 - ▶ => steel rods will be made visibly under a listed fresco and after finalization of the tunnel will be removed)
 - ▶ => Reinforced concrete grid above the vault will be made
 - ▶ peripheral ring of reinforced concrete closed together with arch ribs(1 longitudinal, 3 transverse ribs)

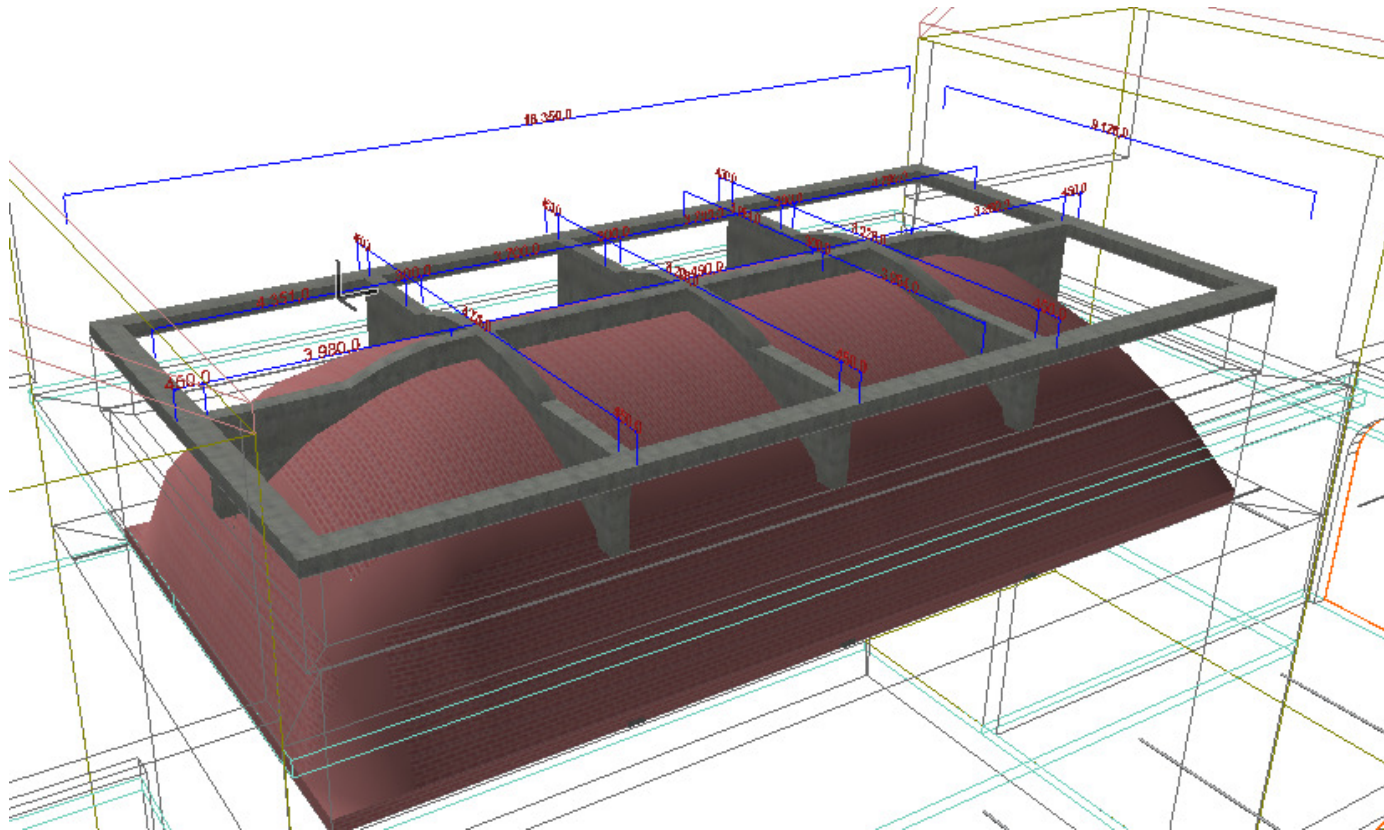
- Brick vault above the main hall – grid construction of reinforced concrete

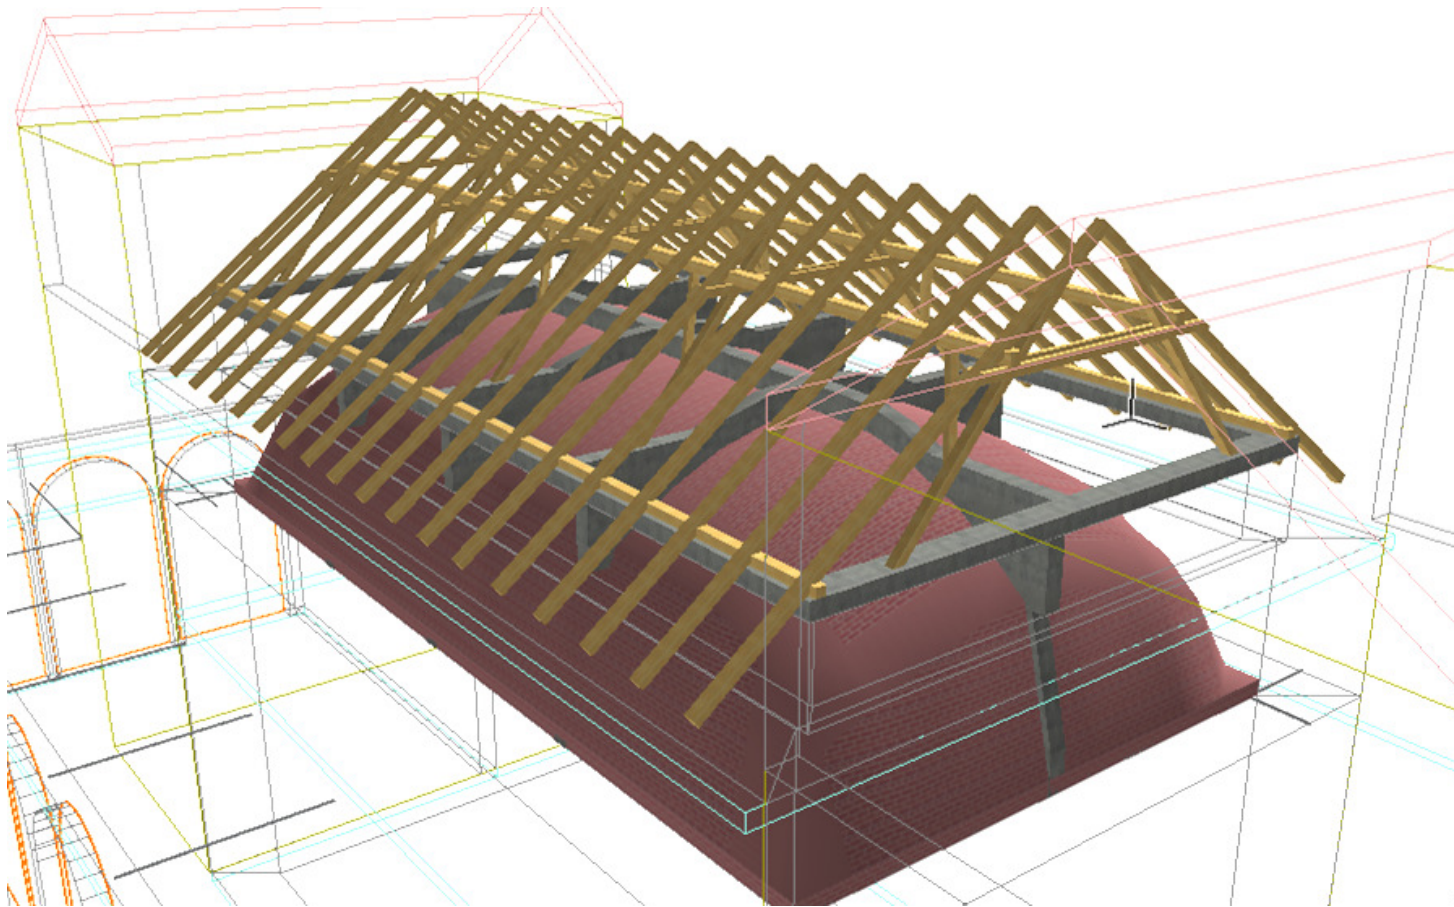
- ▶ Brick vault above the main hall - truss
