CTU in Prague
Faculty of Civil Engineering
Department of Building Structures

Restoration of masonry

U Fleku Brewery in Prague 1

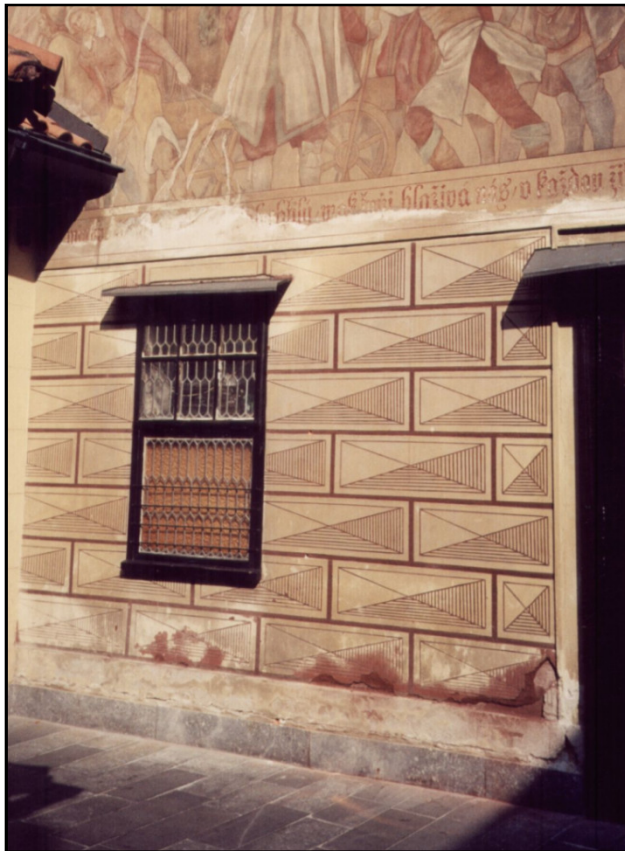
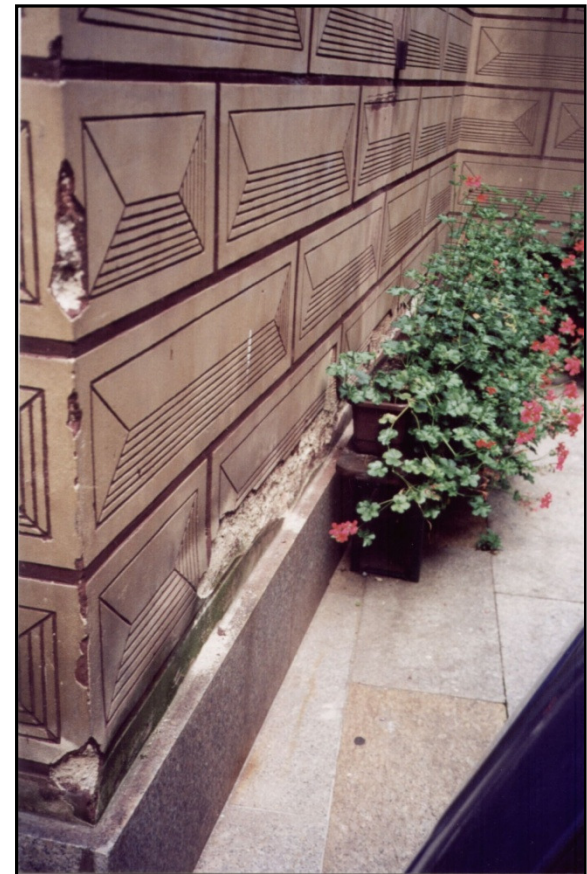
Description of defects

- ▶ The values of moisture in the walls just above the socle: at the exterior were in the range of 2 to 4%, in the interior from 6 to 9%

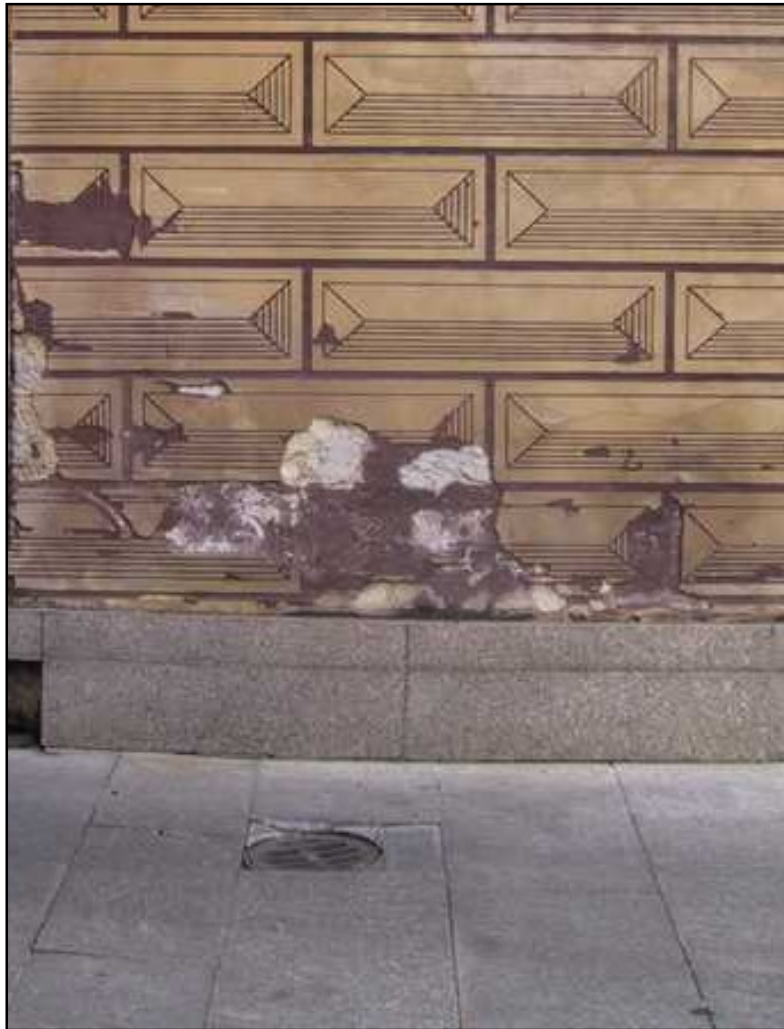
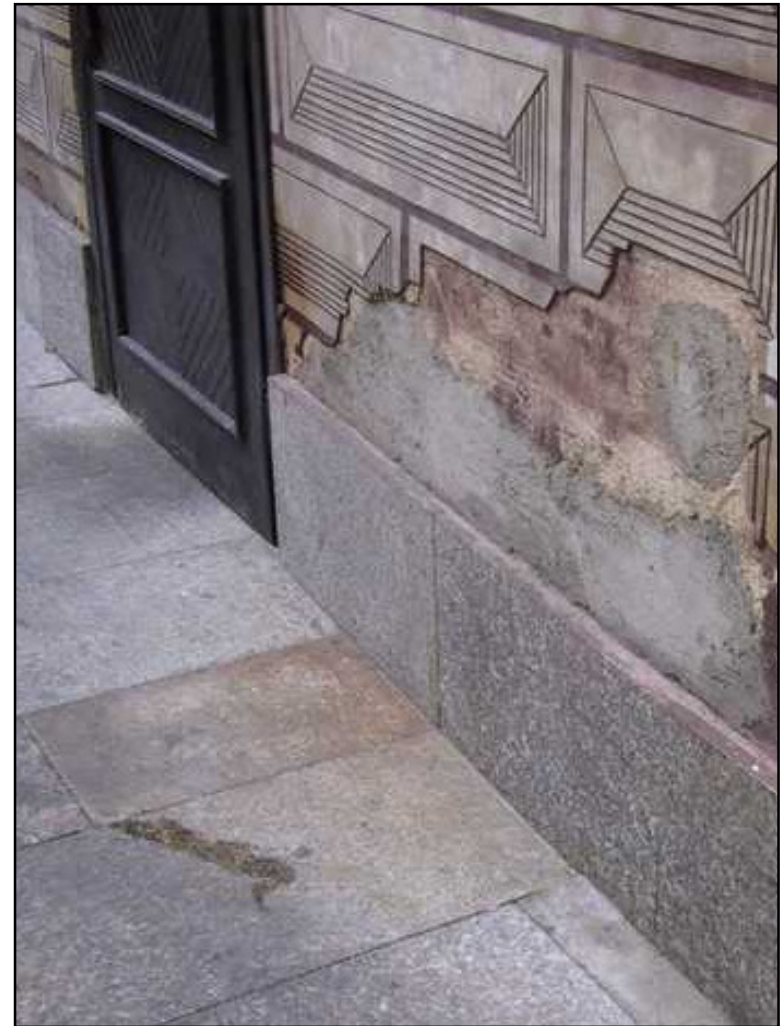
Description of defects

- ▶ unsuitable design of the socle
- ▶ replacement of traditional paving by large-scale paving in a concrete bed
- ▶ inappropriate temperature and humidity regime of some rooms
- ▶ not suitable cleaning system of the courts

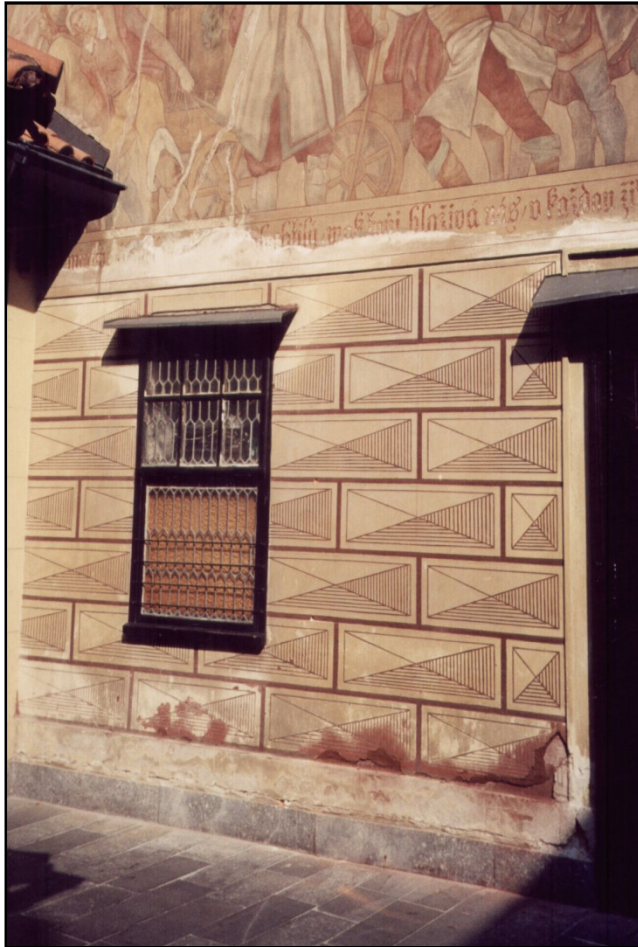
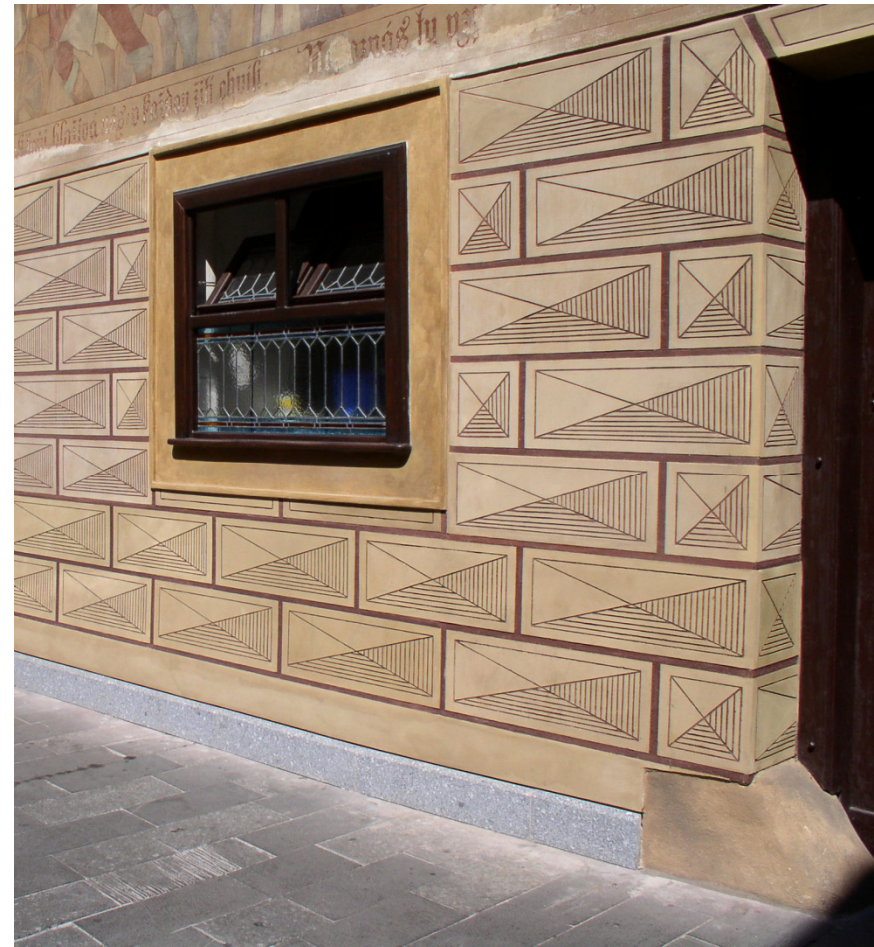
- ▶ Comparing the state of the masonry in 2002 and 2011

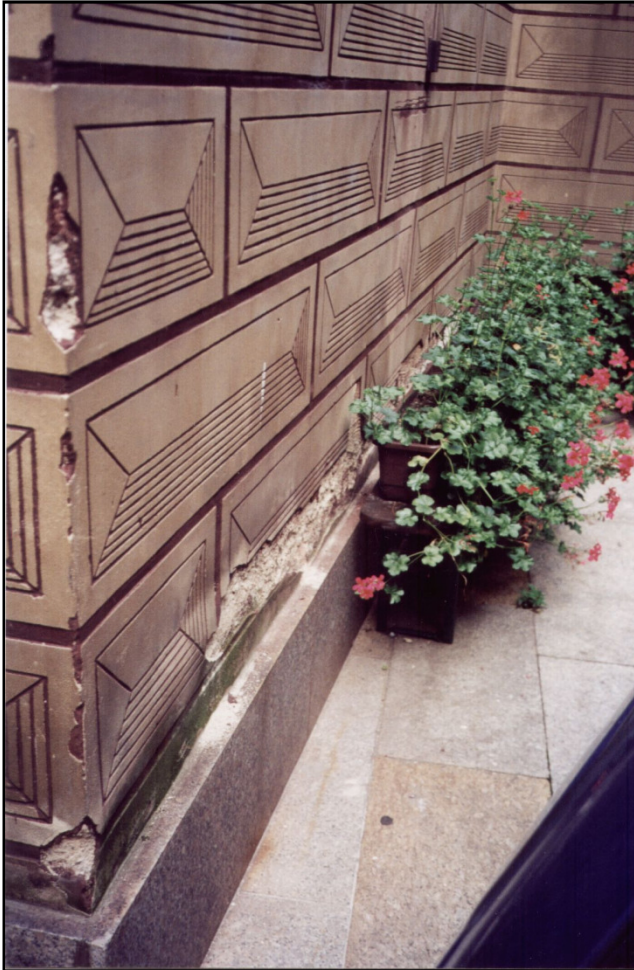
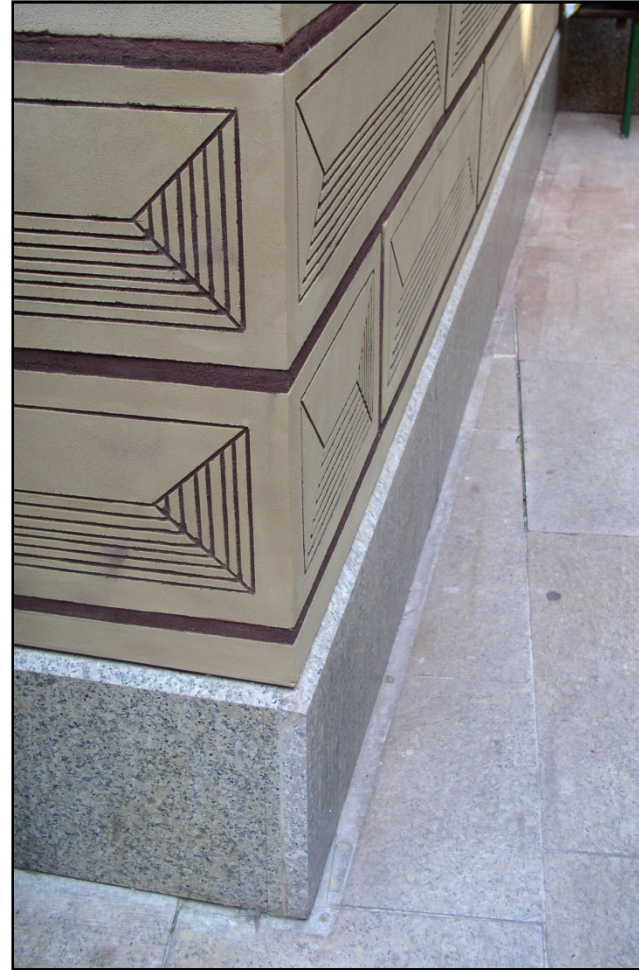
- ▶ Comparing the state of the masonry in 2002 and 2011

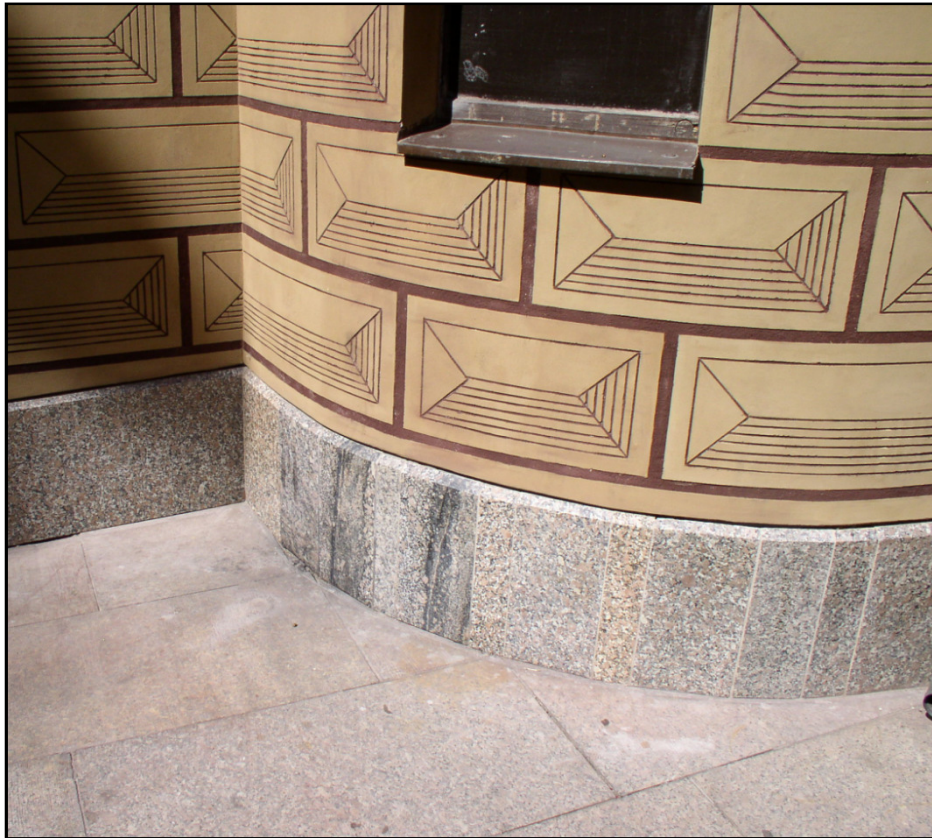
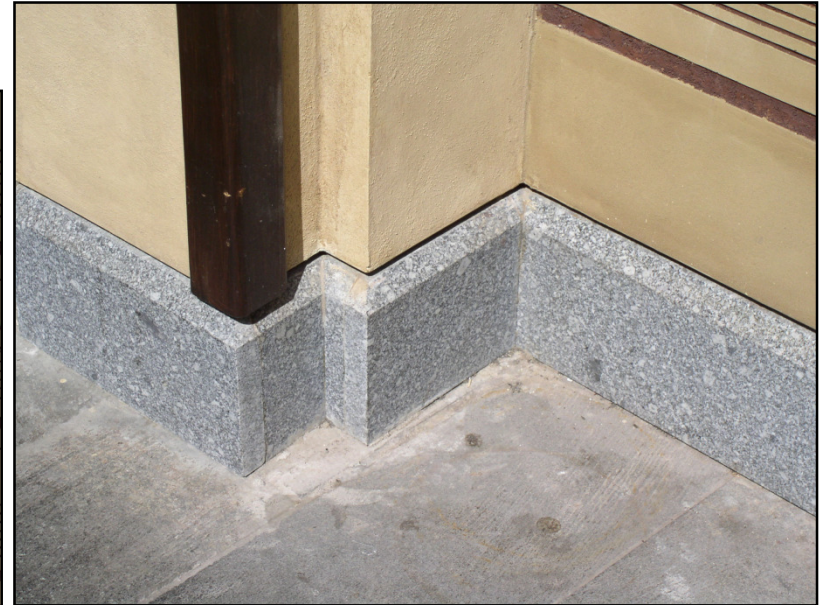
► Detail of socle

- designed solution is fully functional

- respects the natural evaporation of moisture from the structure
- is consistent with the requirements of monument preservation
