CTU in Prague
Faculty of Civil Engineering
Department of Building Structures

Restoration of truss

Church of St. Vaclav in Mikulovice

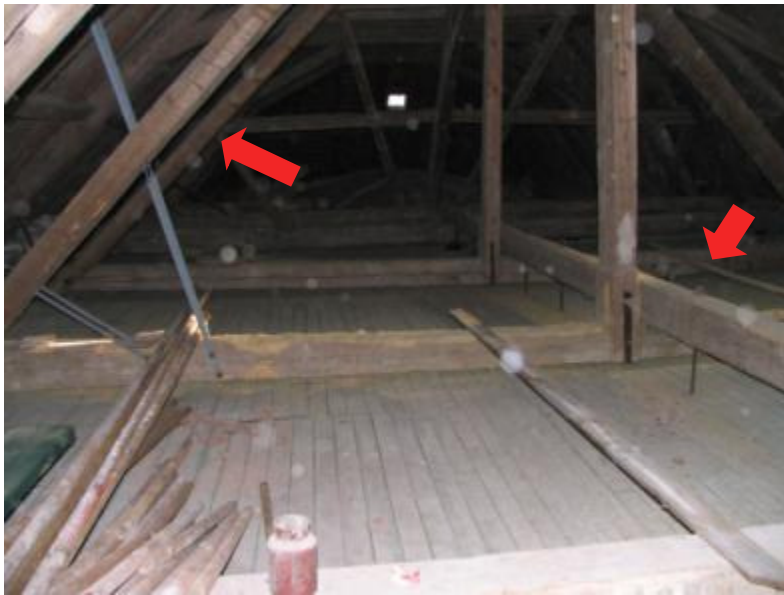
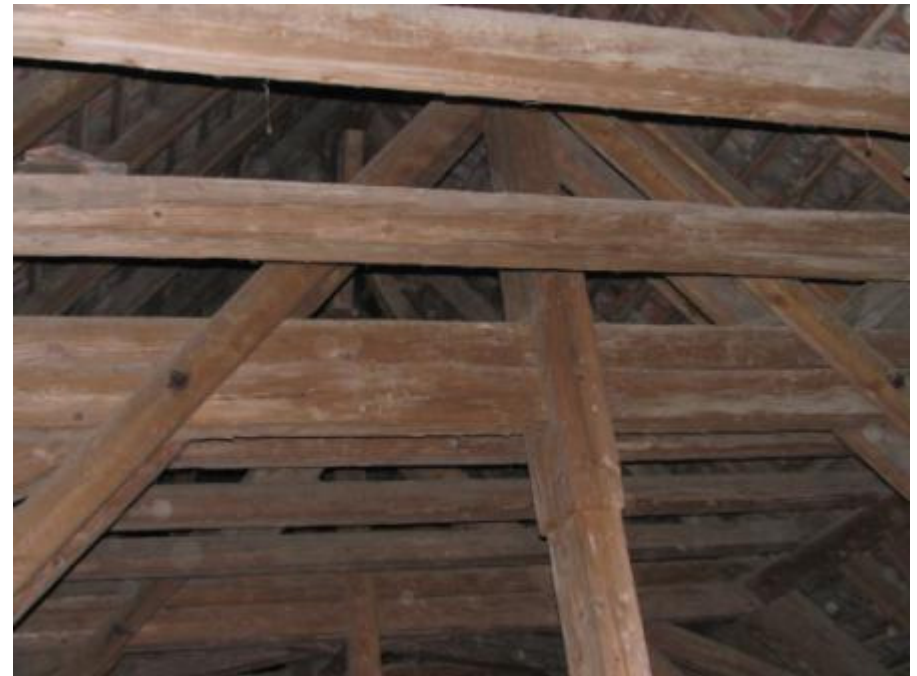
- ▶ 1885 solved static failure of the truss and floor
 - ▶ hanging tie beams by medium threshold purlin
 - ▶ added braces in full frames, which deal with tie beam deflection in their centers

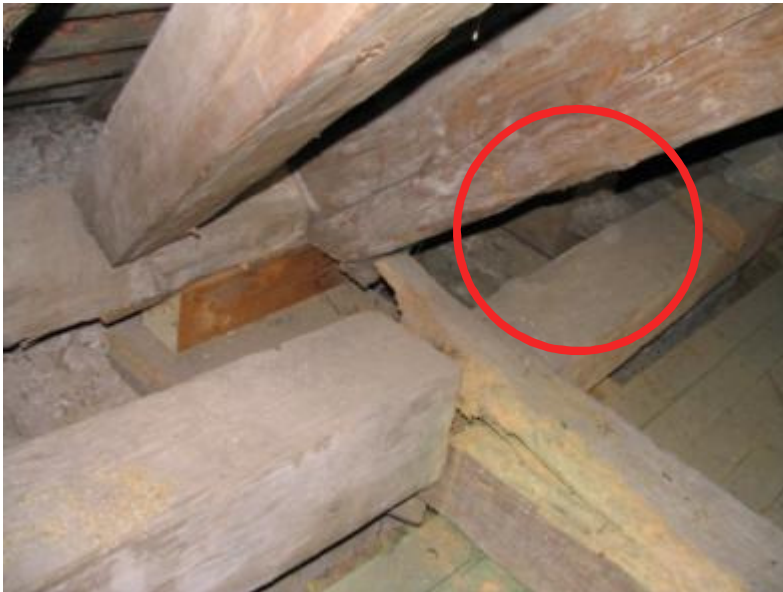
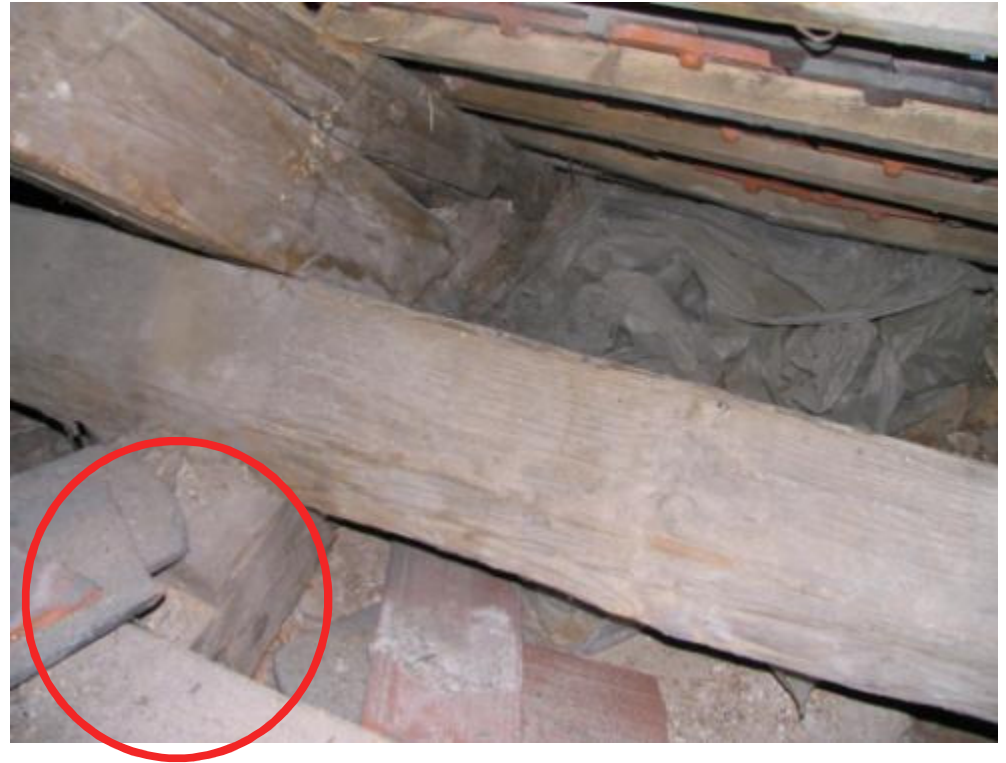
- ▶ Tie beams gridiron is severely damaged or completely missing. Yeast frames were unable to carry the load and there was a rapture of short exchanges

- ▶ Rapture of exchanges

- ▶ Securing construction by steel draw rods
 - ▶ secure the stability the truss
 - ▶ replacement of wooden truss elements
 - ▶ fungicidal treatment of the truss
 - ▶ the roof deck replacement

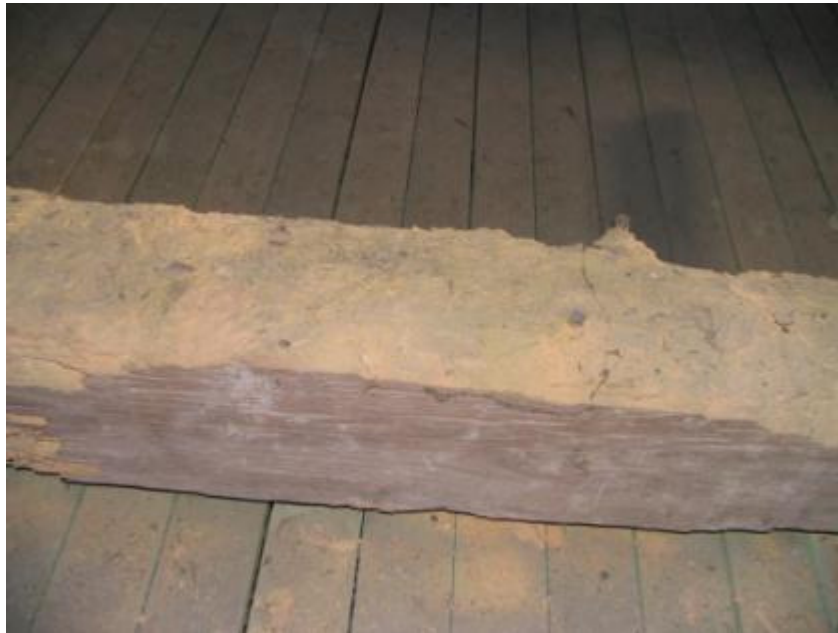
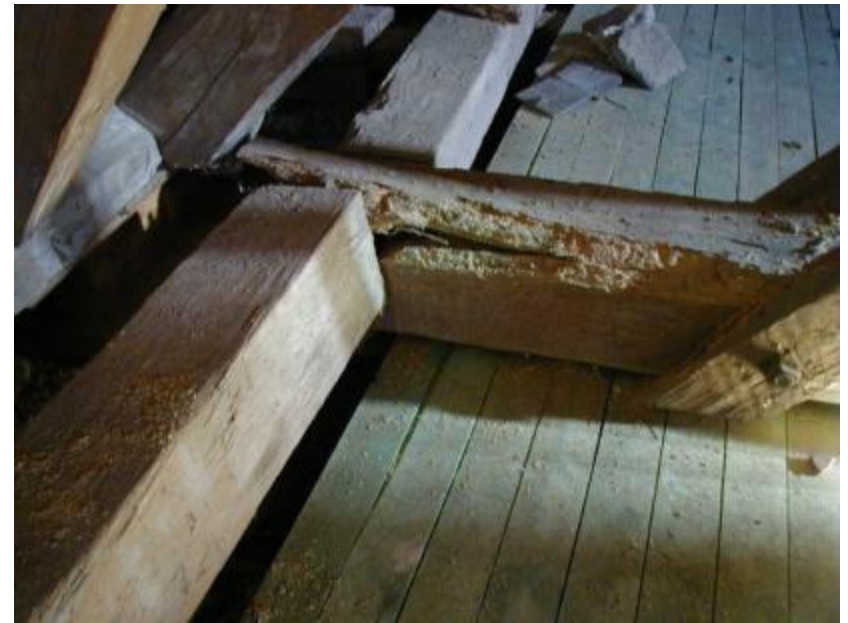
- ▶ Some tie beams are in very poor condition and will require their total replacement

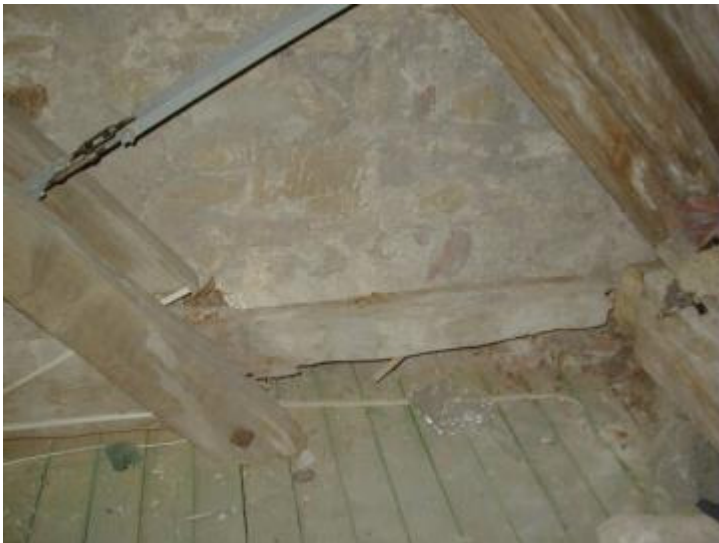
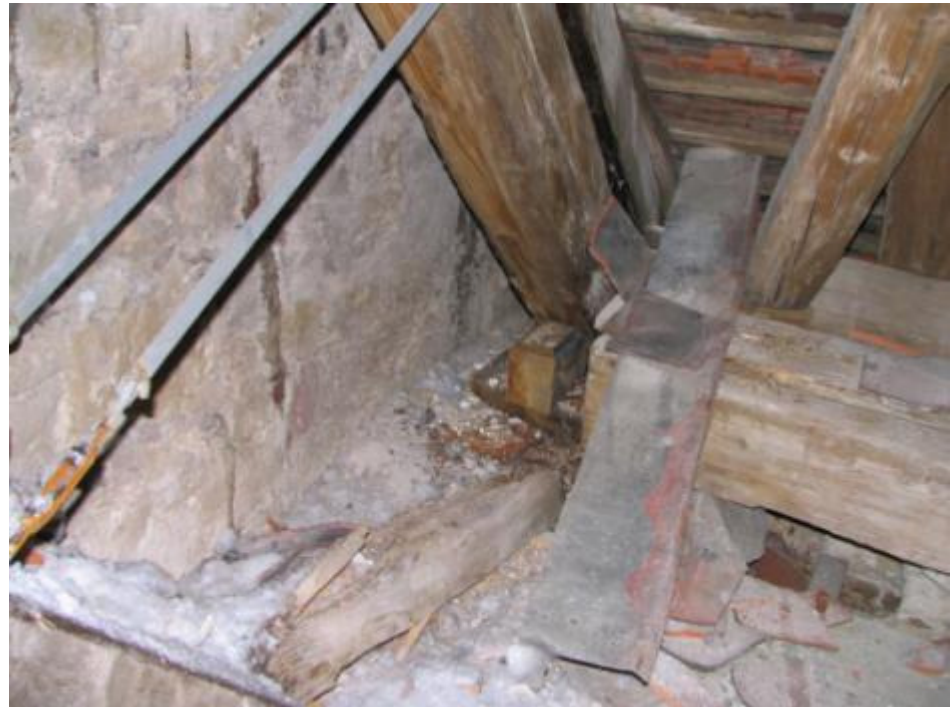
- ▶ Missing tie beams gridirons

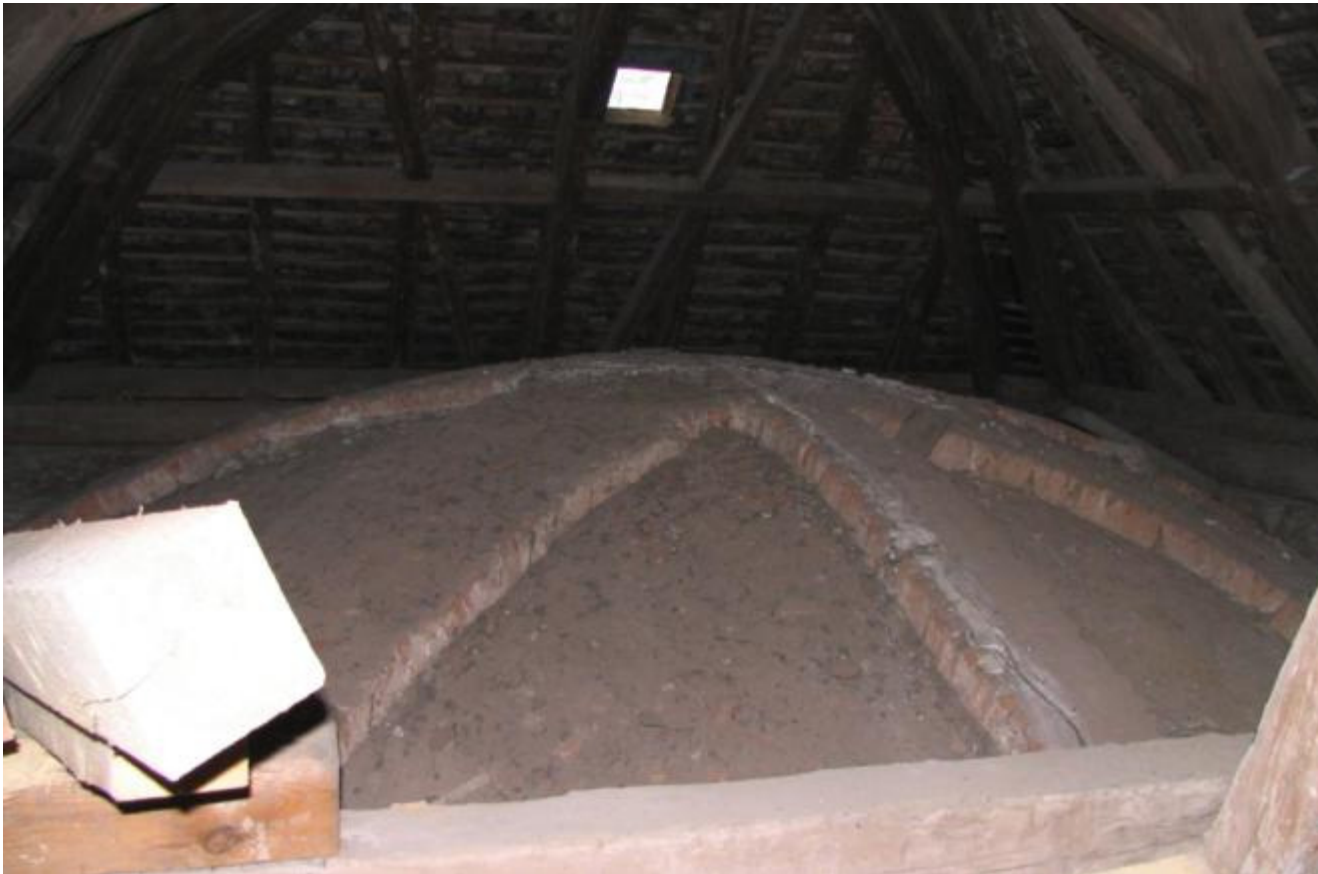
- ▶ Because of vault, truss over the chancel is solved without tie beams - vault has no signs of damage

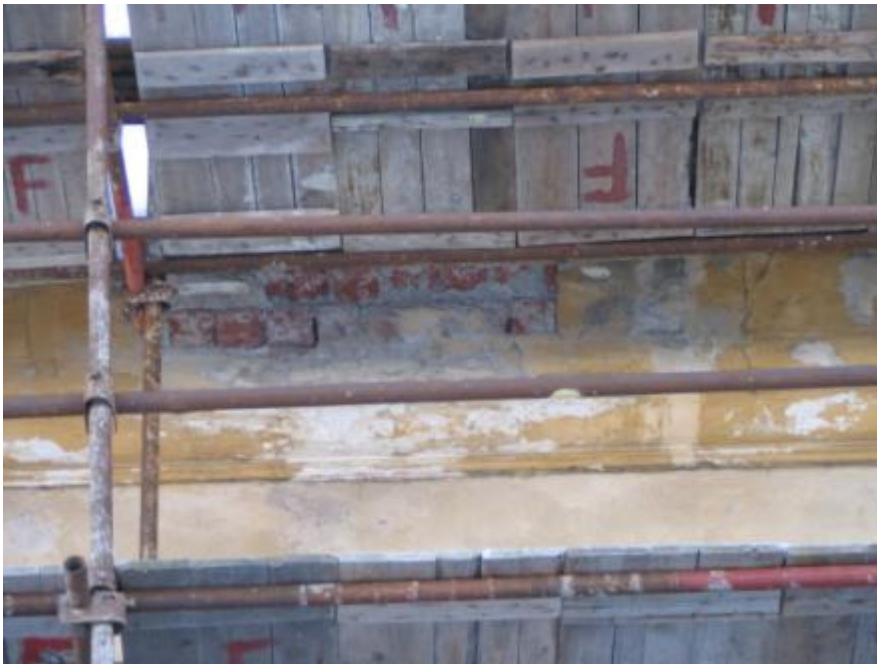
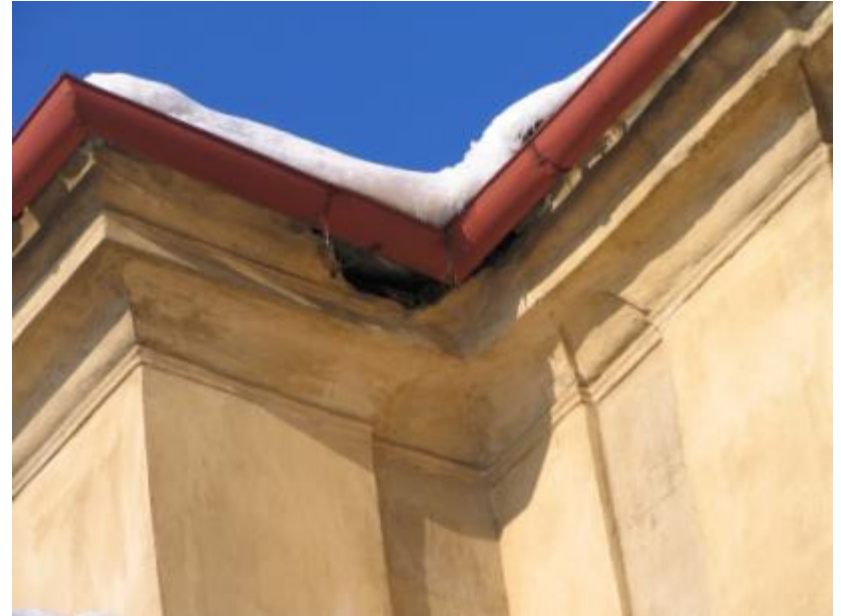
- ▶ Faults of other parts of the church
 - ▶ rapture of short exchanges led to cracks in the perimeter wall moldings, sometimes missing bricks

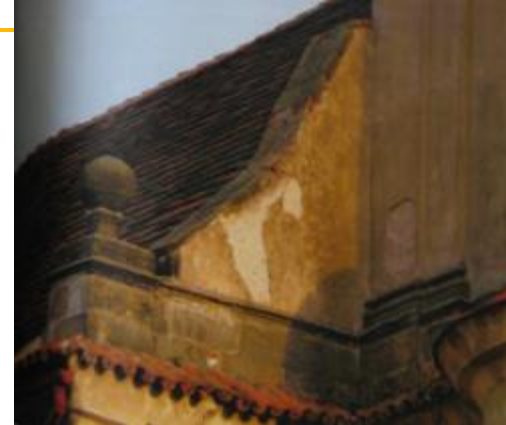
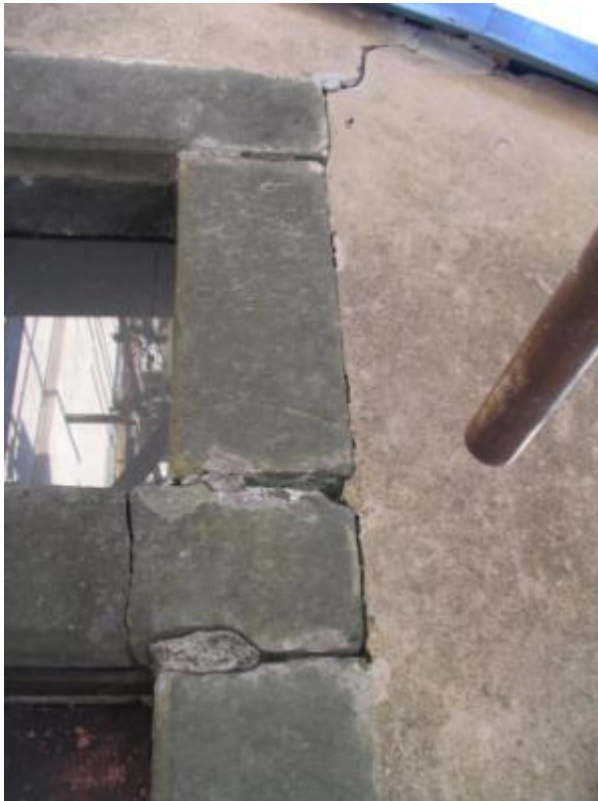
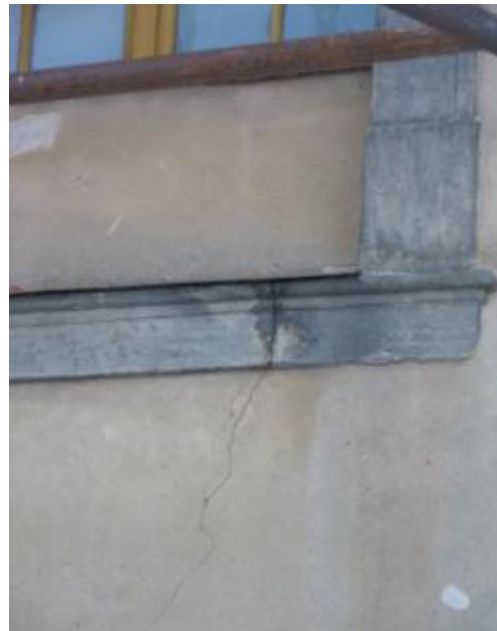
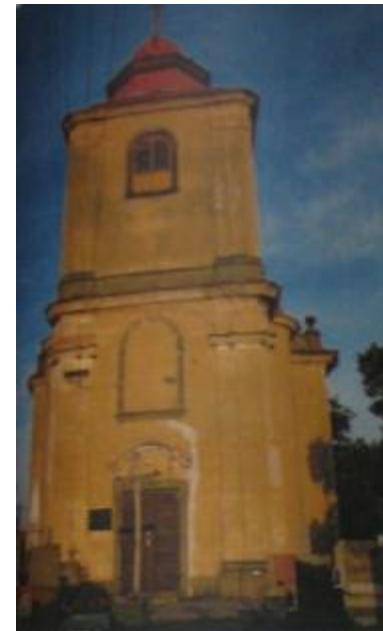
- ▶ Faults of other parts of the church
 - ▶ blown and weathered facade
 - ▶ cracked stone elements

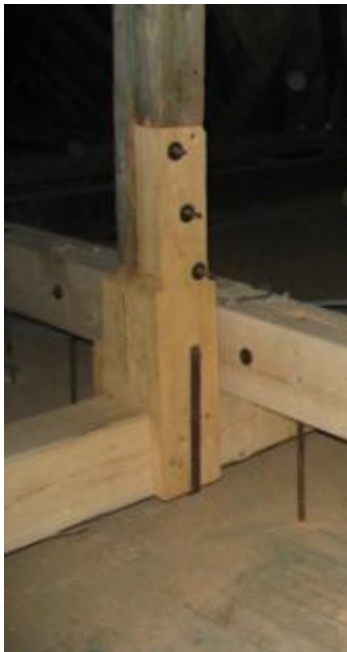
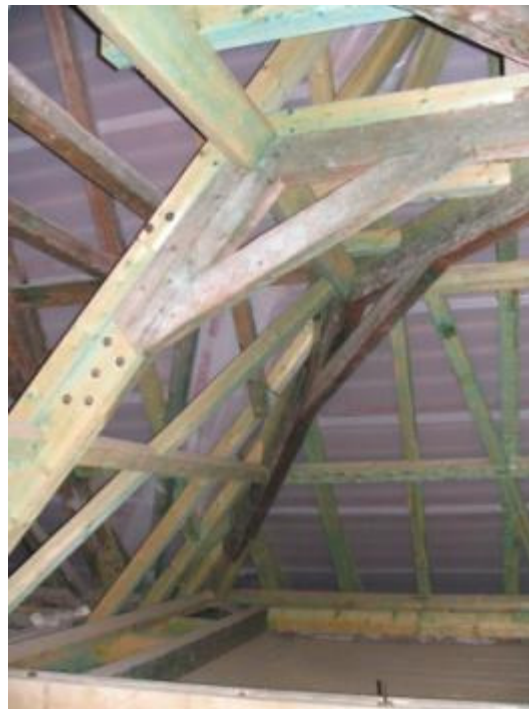
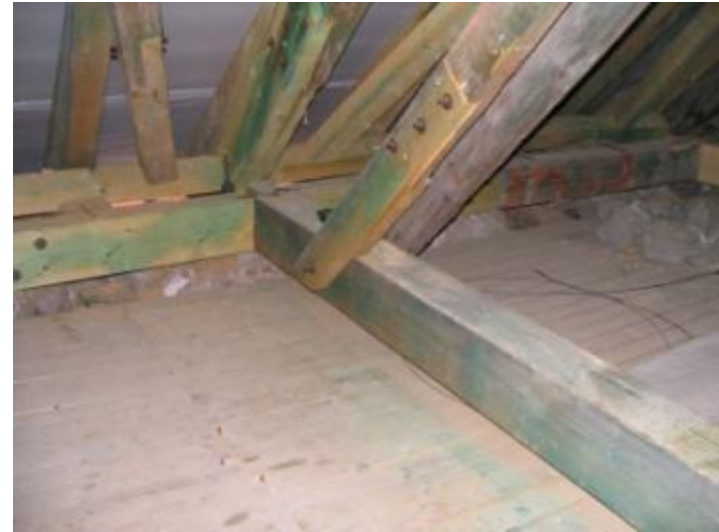
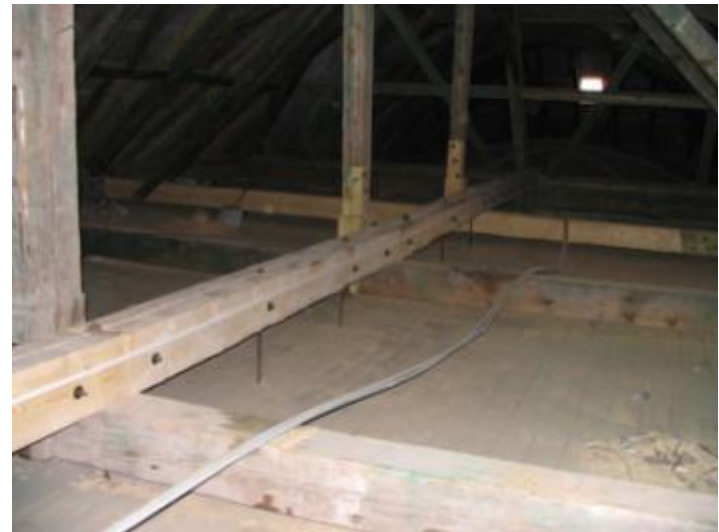
- ▶ condition after reconstruction

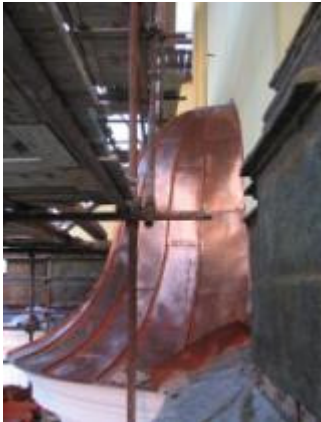
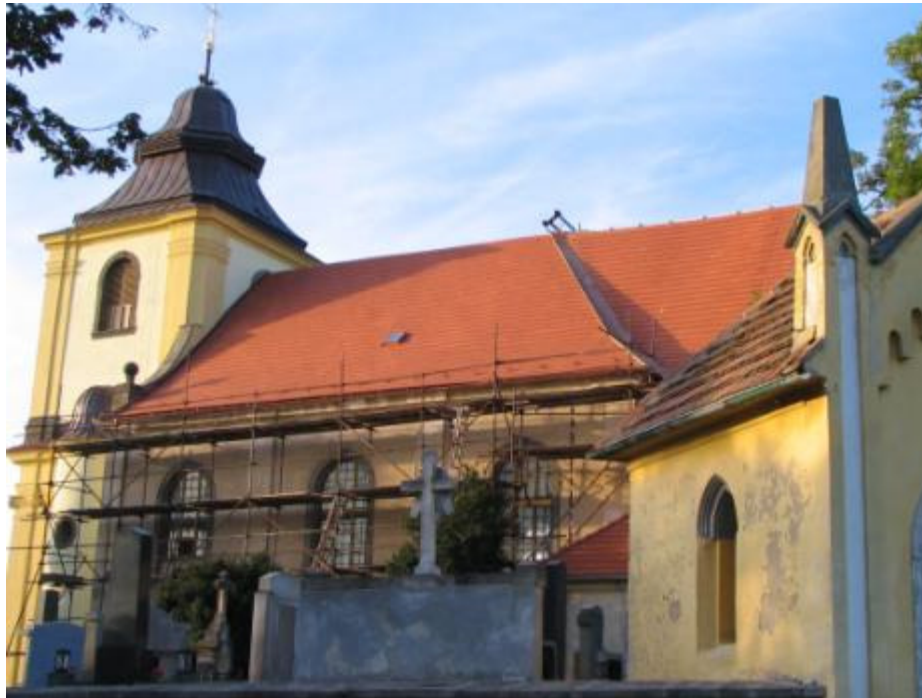
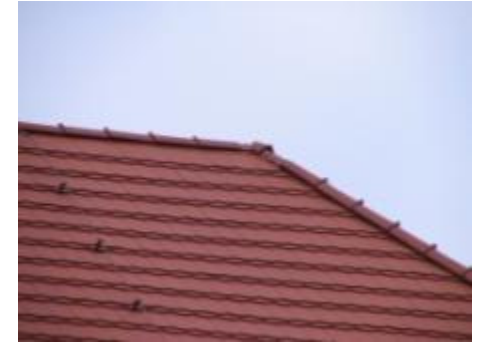
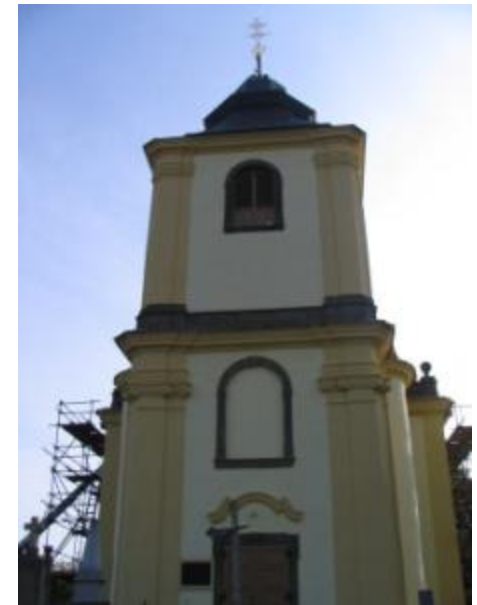
- ▶ condition after reconstruction
