CTU in Prague  
Faculty of Civil Engineering  
Department of Building Structures

# Restoration of load-bearing structures

Buštěhrad

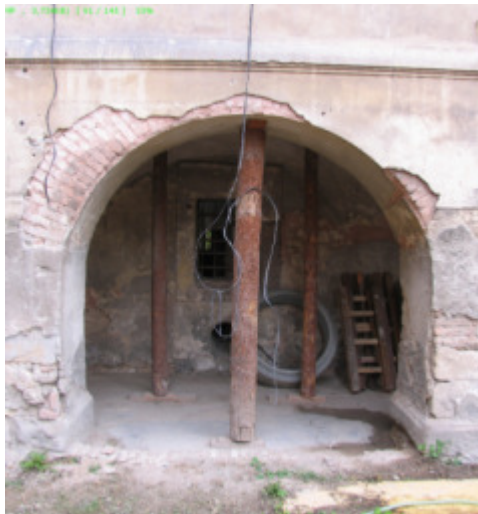
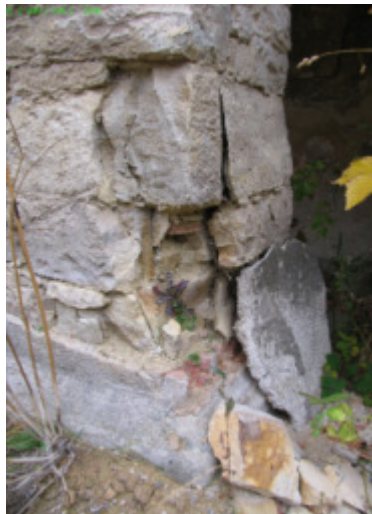
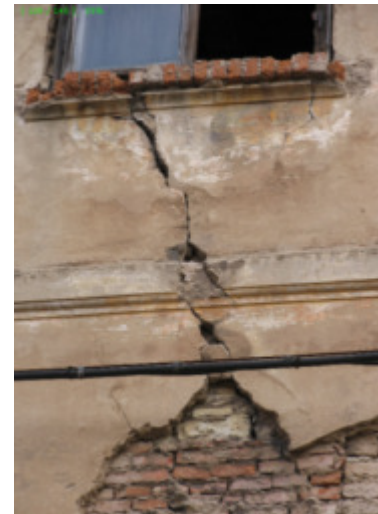
- ▶ structural damages
  - ▶ arch failure mechanism
  - ▶ scaling and spalling
  - ▶ diagonal cracks
  - ▶ efflorescence

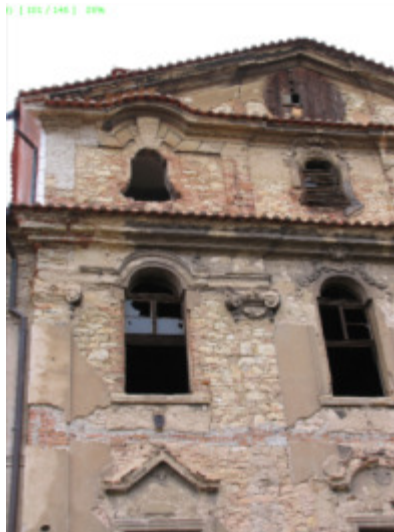
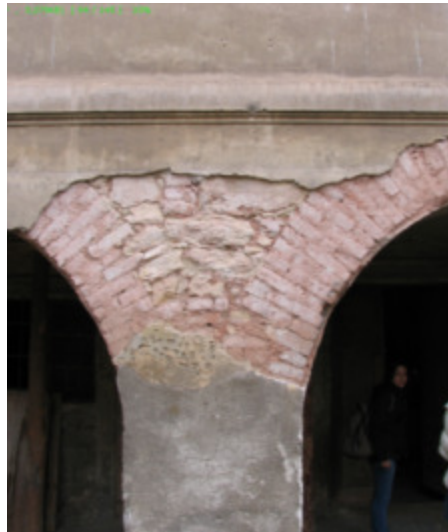
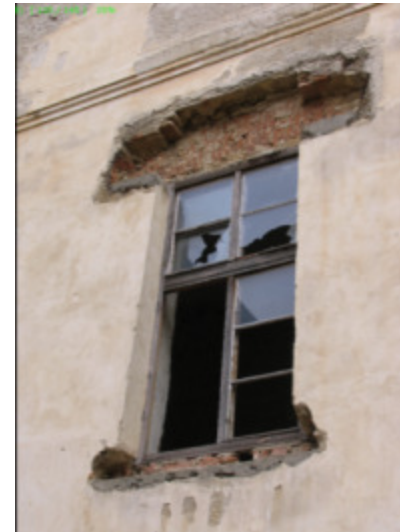
- ▶ architectural damages
  - ▶ brick – blistering, exfoliation
  - ▶ erosion
  - ▶ missing elements

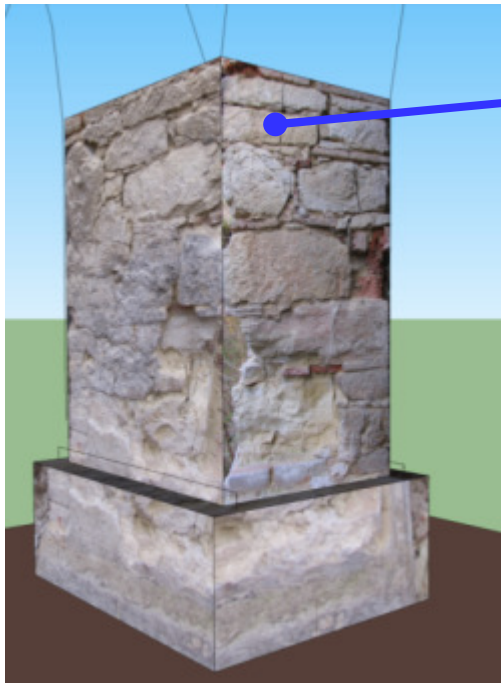
front view

- ▶ column 1x0,6 m, height 1,5 m (ground to springing)

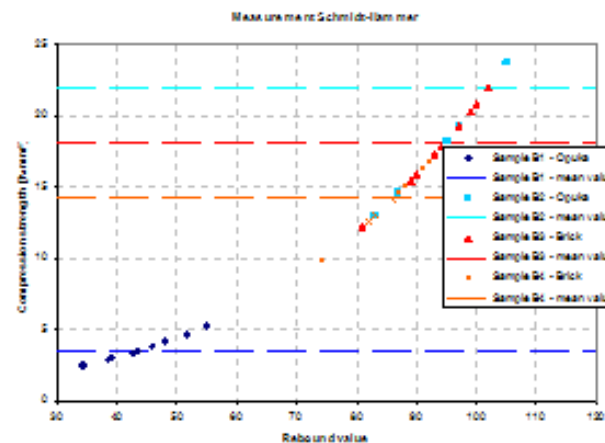
- ▶ Schmidt-hammer type PT

- ▶  $B1 = 3.6 \text{ N/mm}^2$
- ▶  $B2 = 22.0 \text{ N/mm}^2$
- ▶  $\text{Lab} = 30.24 \text{ N/mm}^2$
- ▶ Big difference between measured values

- ▶  $B3 = 18.2 \text{ N/mm}^2$
- ▶  $B4 = 14.3 \text{ N/mm}^2$
- ▶  $\text{Lab} = 14.34 \text{ N/mm}^2$
- ▶ compressive strength matches relatively well to the laboratory tests

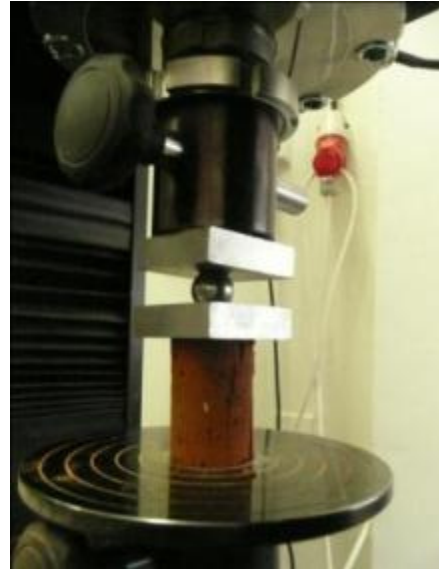
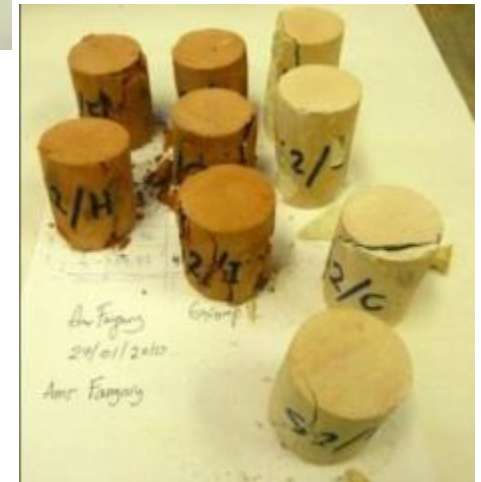
- ▶ laboratory tests – compression tests
  - ▶ determine the compressive strength of the masonry (brick, opuka)
  - ▶ selecting of 4-5 samples for each stone type
  - ▶ cutting out cylindrical specimen ( $d=35\text{mm}$ ,  $h=40\text{mm}$ )
  - ▶ perform the compression test until the failure of the material (cracking)
  - ▶ results for the compressive strength and the Young's modulus

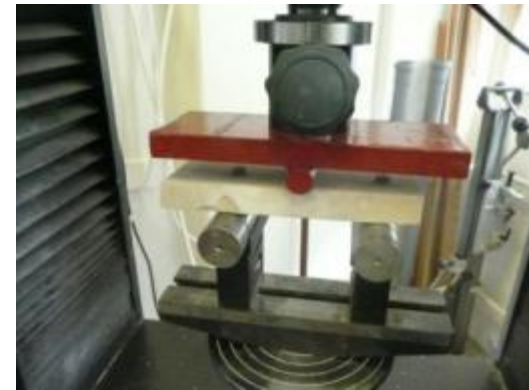
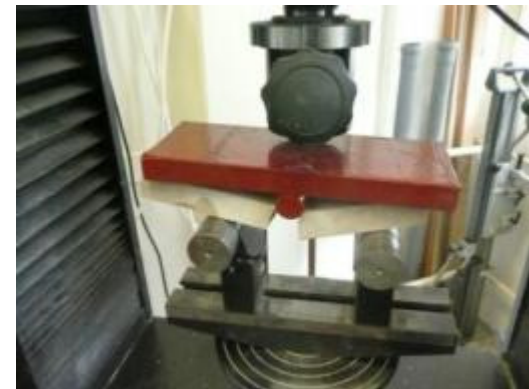
- ▶ laboratory tests – bending test for opuka
  - ▶ determine the tensile strength
  - ▶ cutting out a rectangular specimen (distance between supports 100mm)
  - ▶ perform the bending test until the failure of the material (cracking)
  - ▶ storing the results and evaluate the tensile strength and the Young's modulus
  - ▶ result: tensile strength
    - ▶  $0.38 \text{ N/mm}^2 - 0.73 \text{ N/mm}^2 \rightarrow$  negligible for the calculation

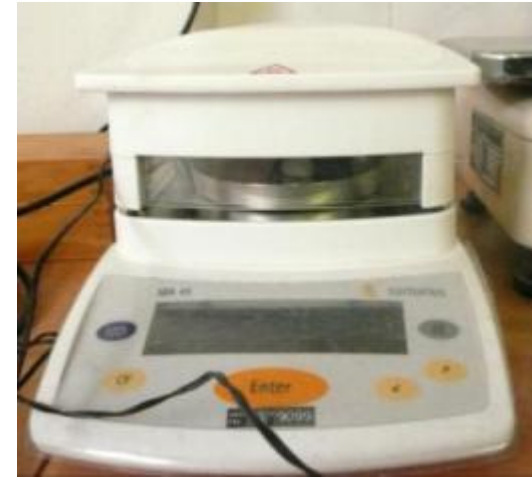
- ▶ Laboratory tests – moisture content
  - ▶ determine of the moisture content in the opuka and the brick
  - ▶ removing the sample for each stone type and put them into airtight bags
  - ▶ weigh the samples in the original state
  - ▶ drying the specimen in an oven (24h)
  - ▶ weigh the samples after drying
  - ▶ result: moisture content
    - ▶ opuka 2.7%
    - ▶ brick 4.1% → can be assumed as 'dry'

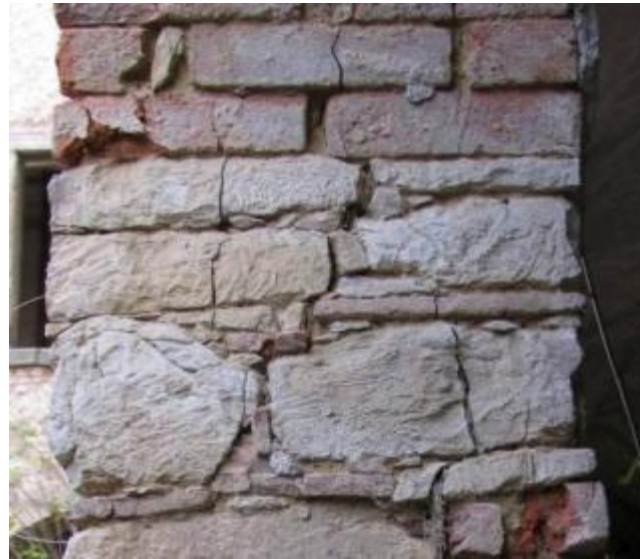
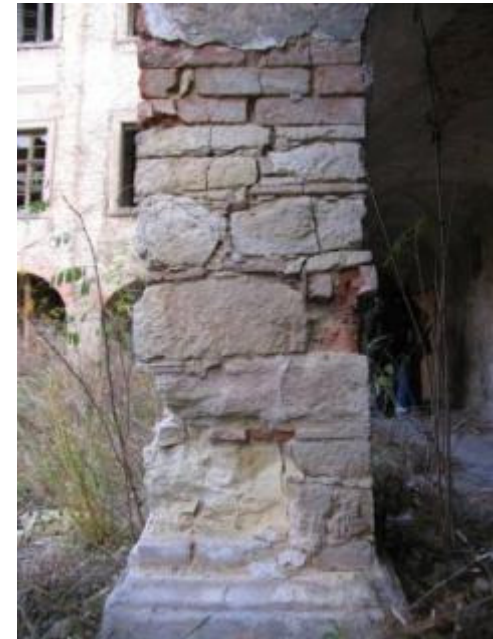
- ▶ failures of the pillar are caused by the decrease of the column strength and modulus of elasticity of masonry elements for long-term exposure effects of humidity and climate change
