CTU in Prague
Faculty of Civil Engineering
Department of Building Structures

Restoration of truss

Nostitz Palace in Prague

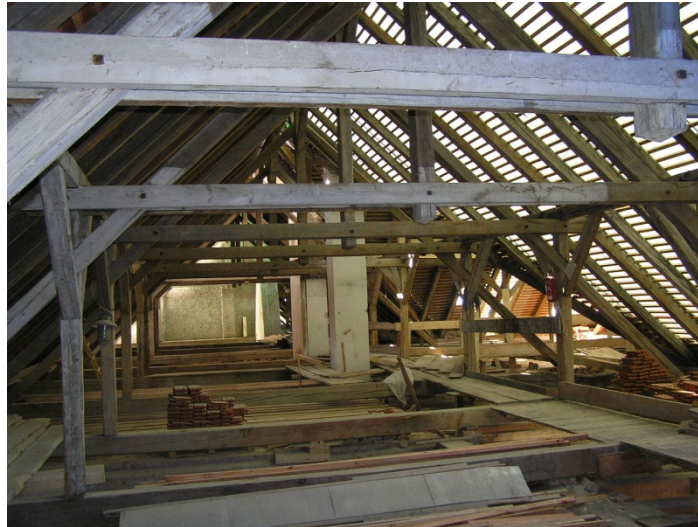
Truss

- ▶ rotten beams gridiron
- ▶ wall plate infected by wood decaying fungi (Coriolus)

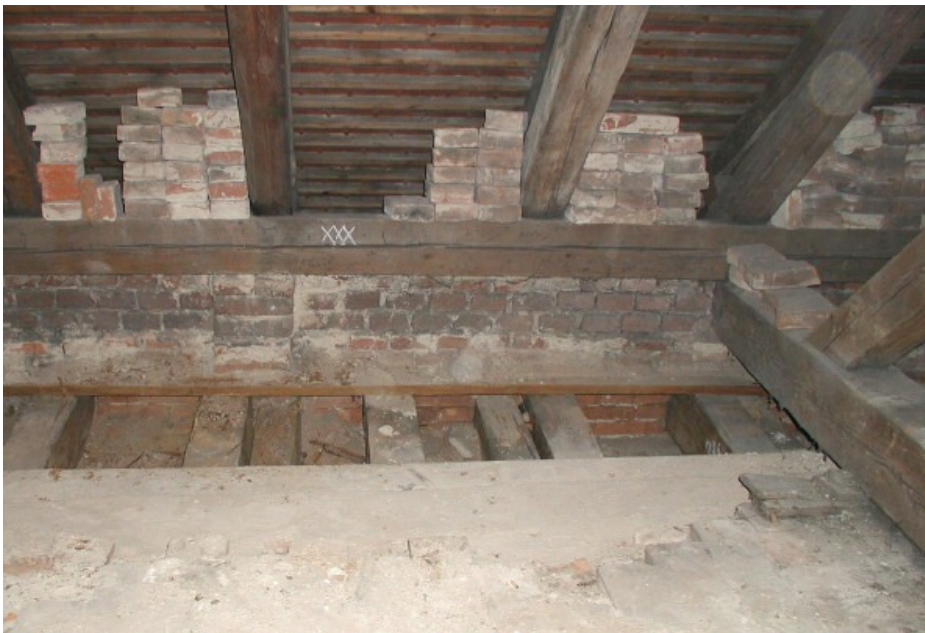
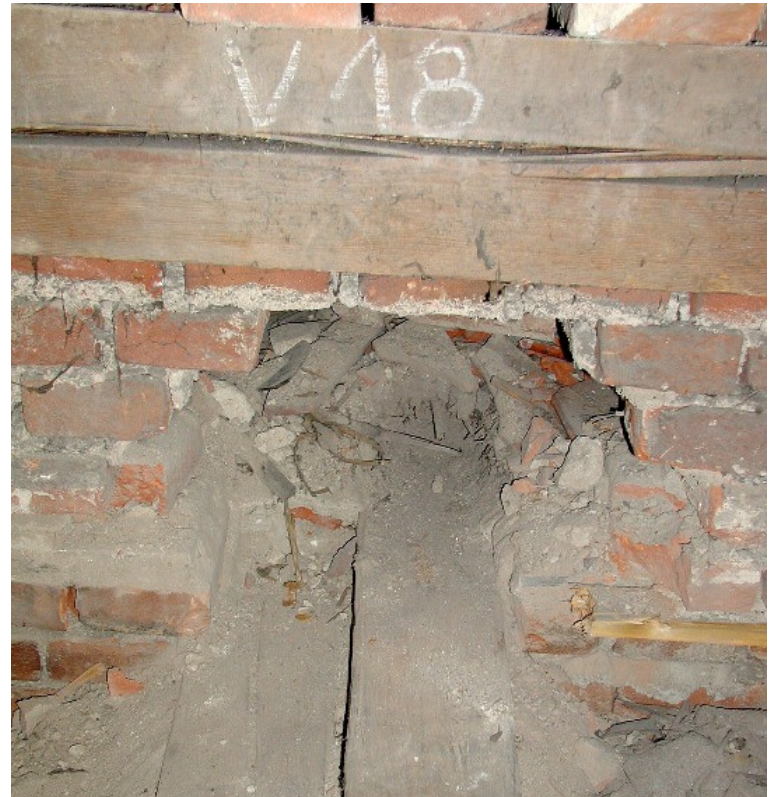
Mycological survey

- ▶ Determination of the extent and seriousness of infestation
 - ▶ destructive methods

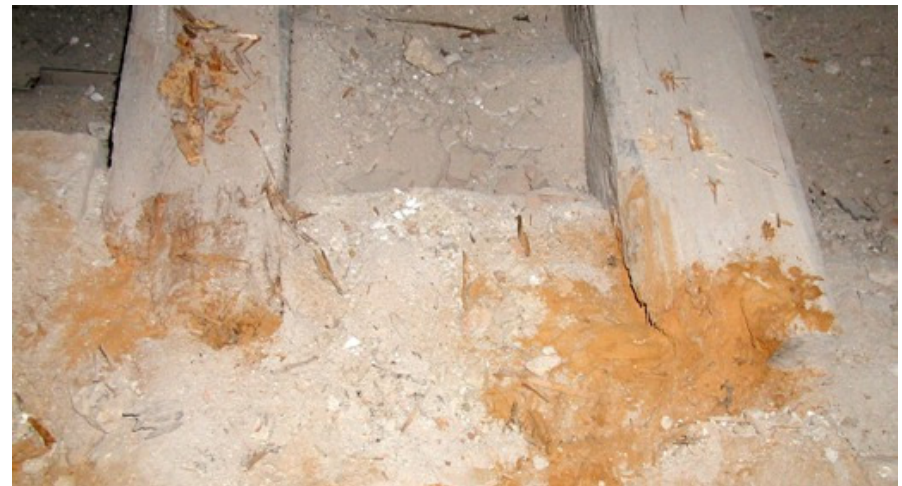
Mycological survey

- ▶ The degree of damage to elements
 - ▶ **A** – completely without damaging the wood
 - ▶ **B** – surface or shallow damaged timber
 - ▶ **C** – deeply damaged wood
 - ▶ **C!** – focus on in-depth damage element
 - ▶ **D** – more than 1 / 3 of cross-sectional area of wood damaged

- ▶ **B-C, C-D** – reflect condition between the degree (state variations in the length of the element under consideration)

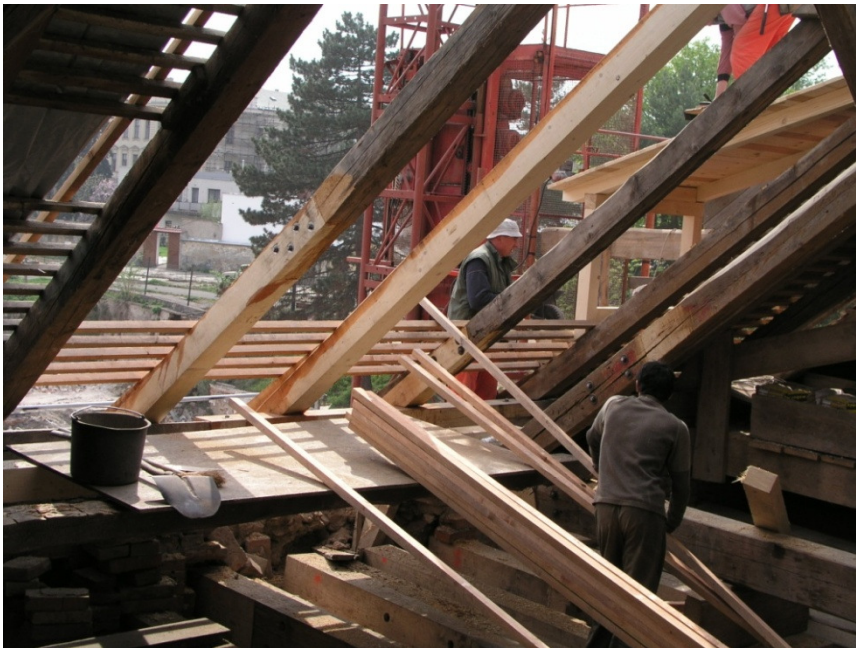
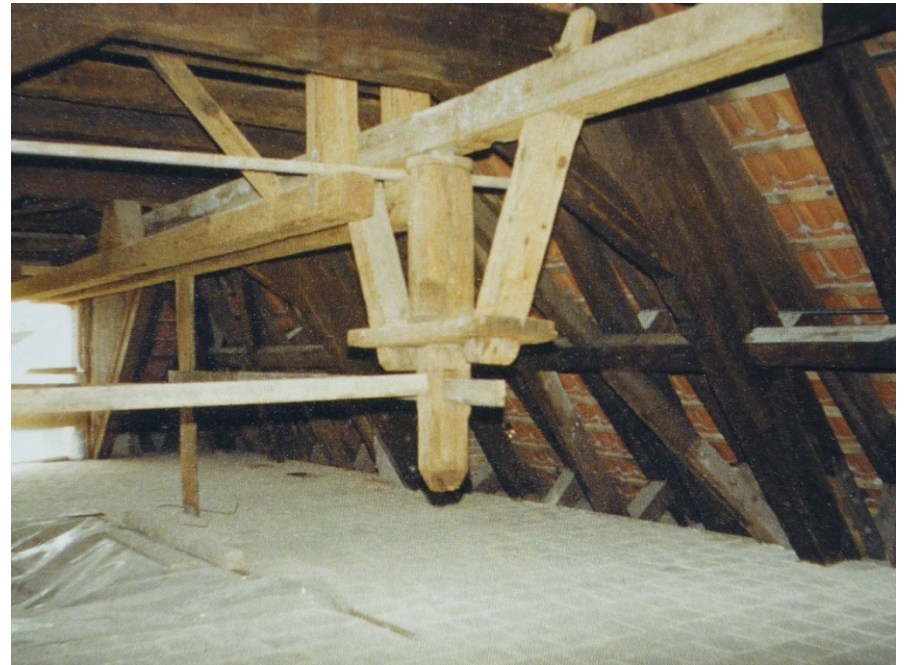
- ▶ Requirements of preservation of monuments
 - ▶ maintaining the authenticity of repaired structure

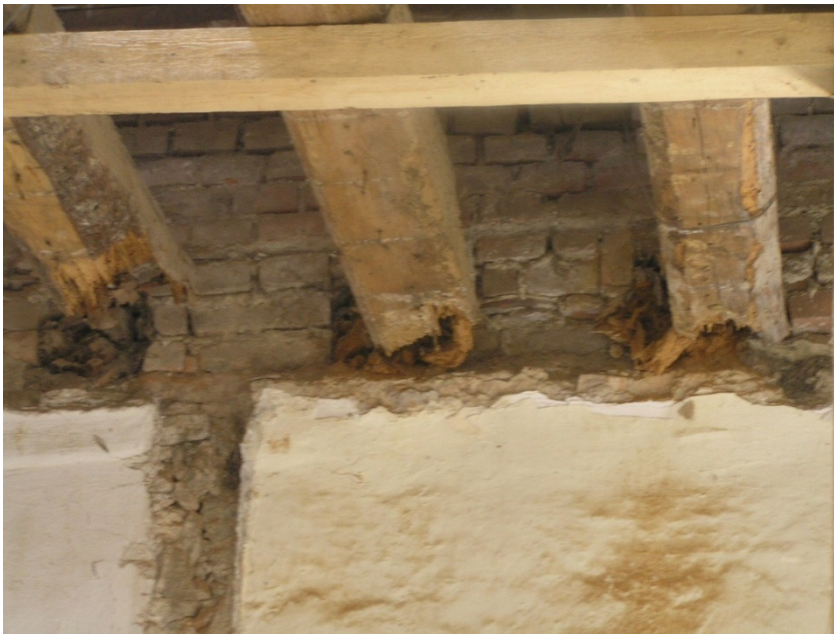
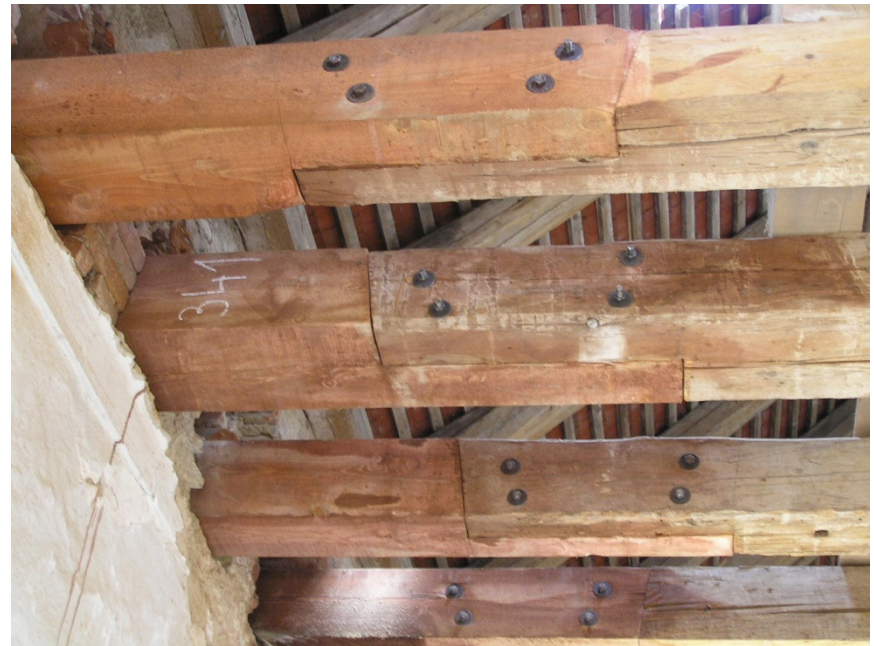
- ▶ Requirements of preservation of monuments
 - ▶ maintaining the authenticity of repaired structure

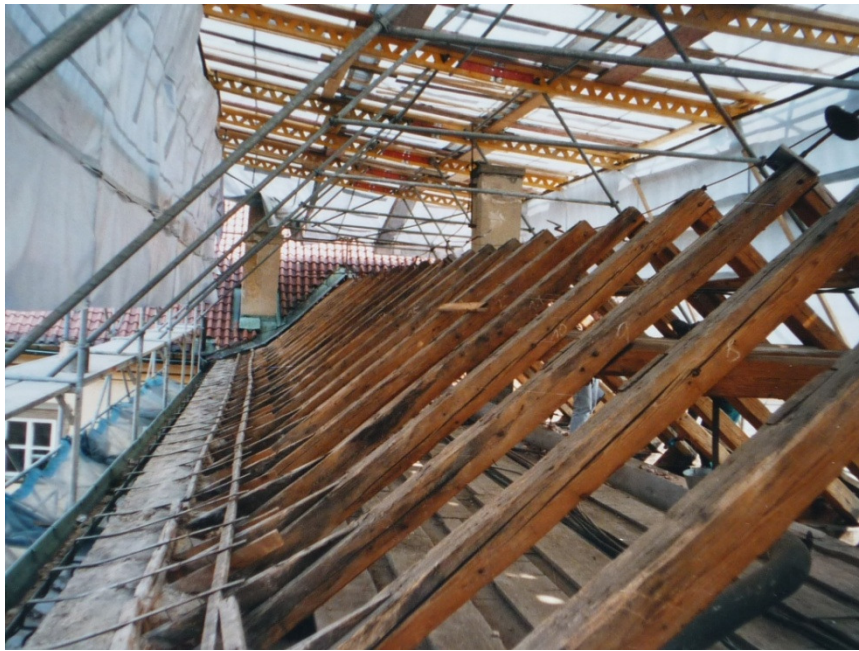
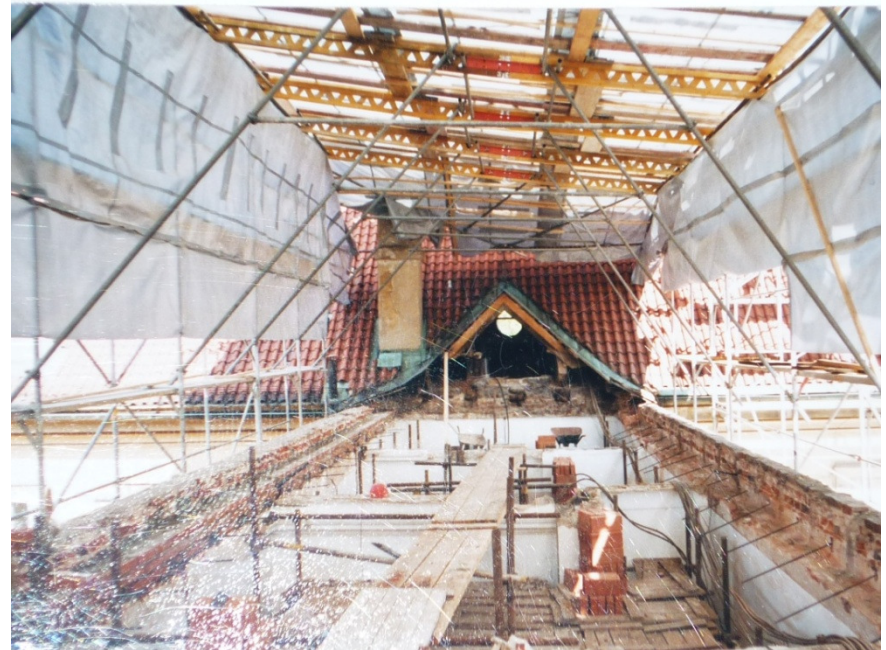
- ▶ Protection from severe weather during restoration - Nostitz Palace (Prague)
 - ▶ roofing for objects up to 10 m span

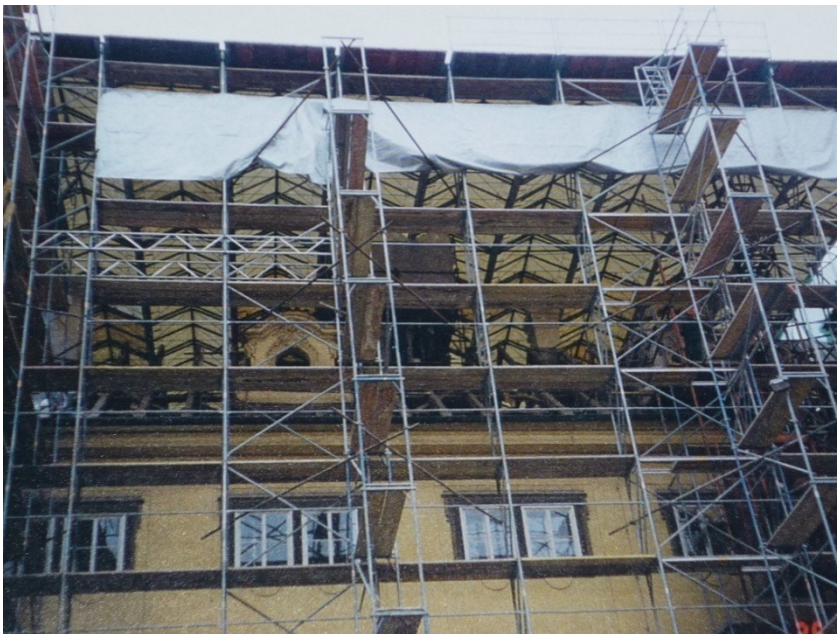
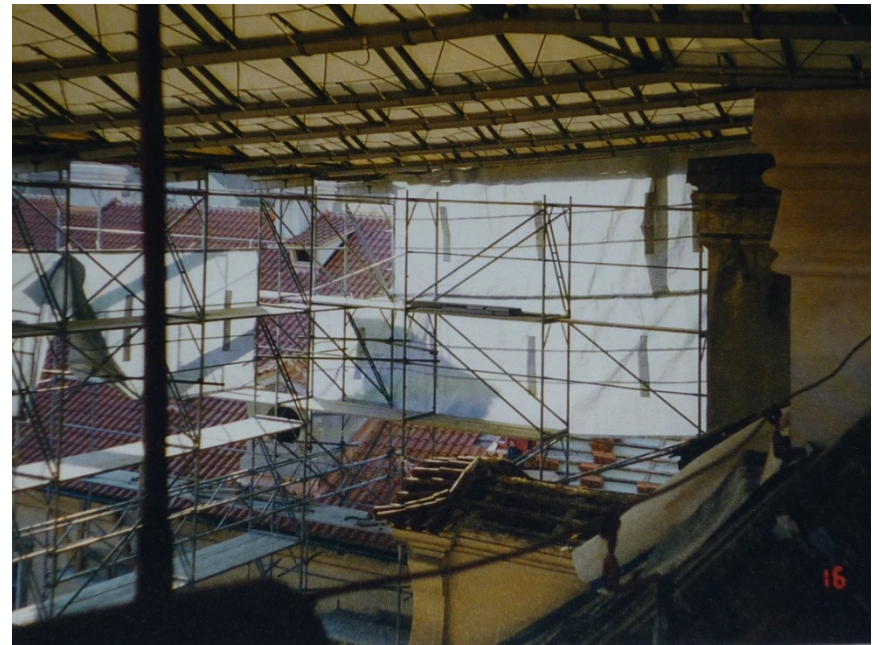
- ▶ Protection from severe weather during restoration - Nostitz Palace (Prague)
 - ▶ system roof panels mounted on scaffolding support (up to 24m)

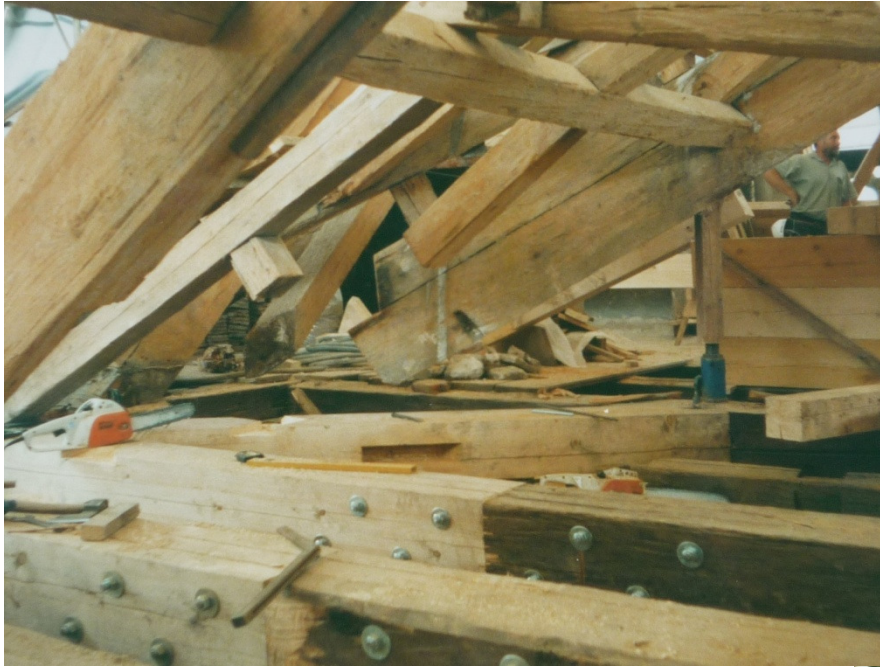
- ▶ Elevation of the truss for repairs

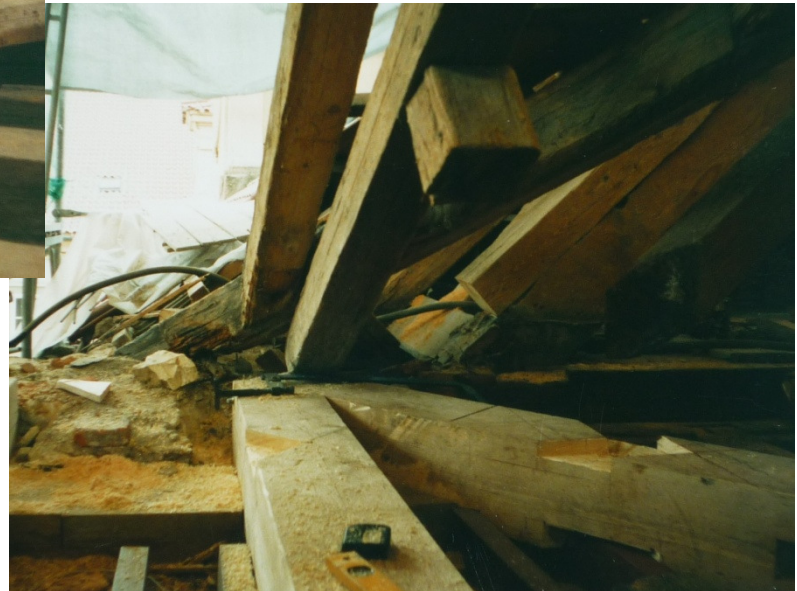
- ▶ repair of corner of the truss

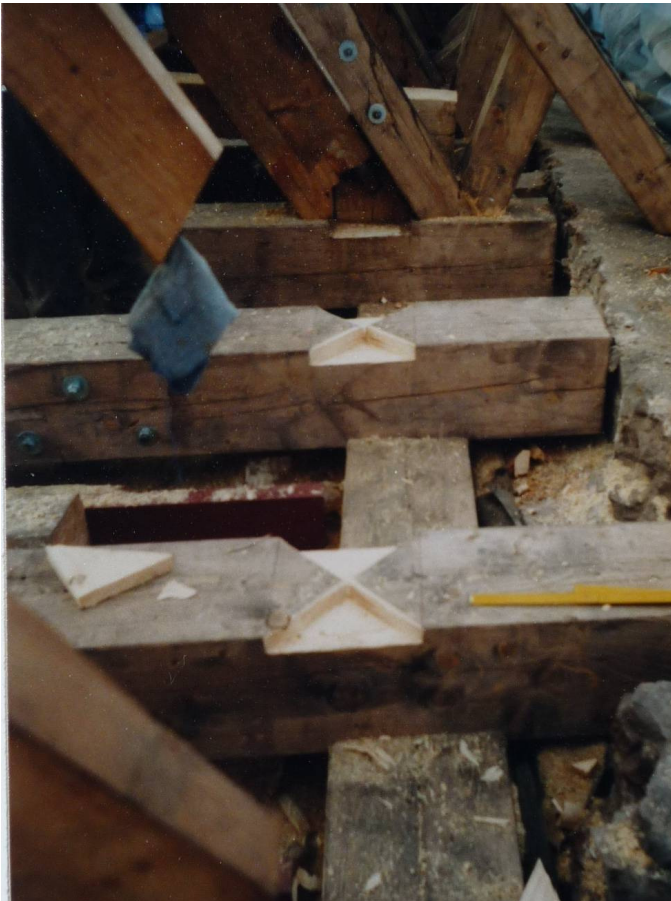
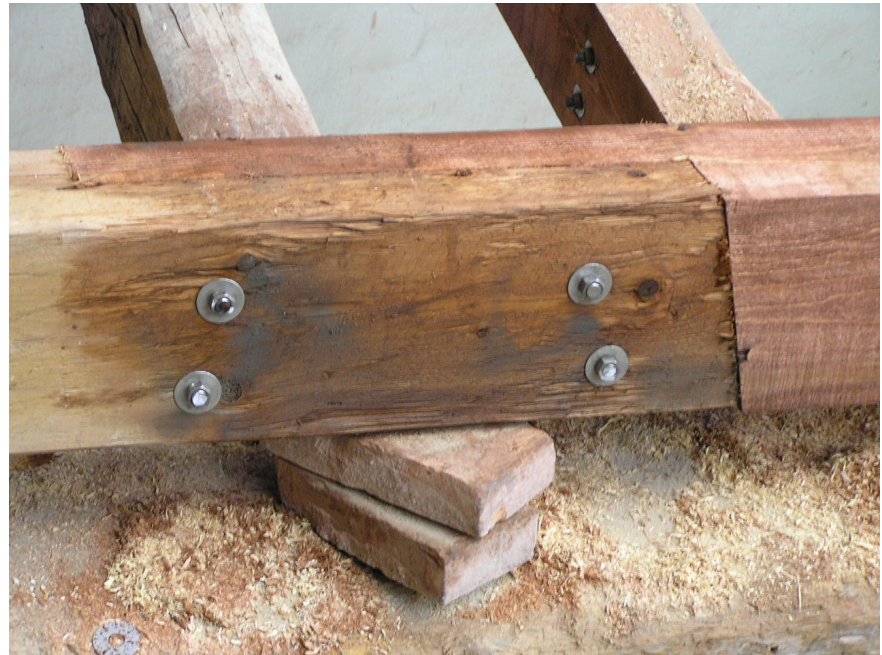
- ▶ Cross joists for five-sided purlins

- ▶ Edge-halved scarf

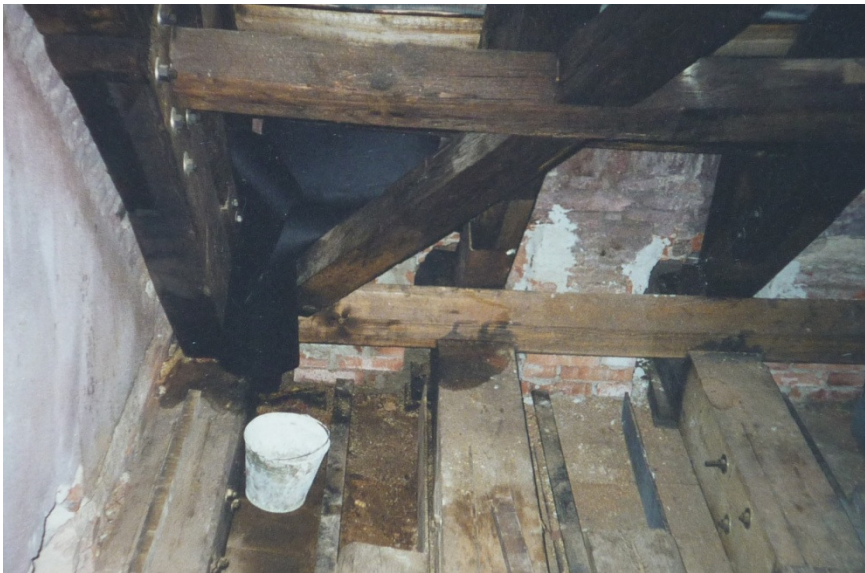
- ▶ use of quality wood
- ▶ prevent moisture

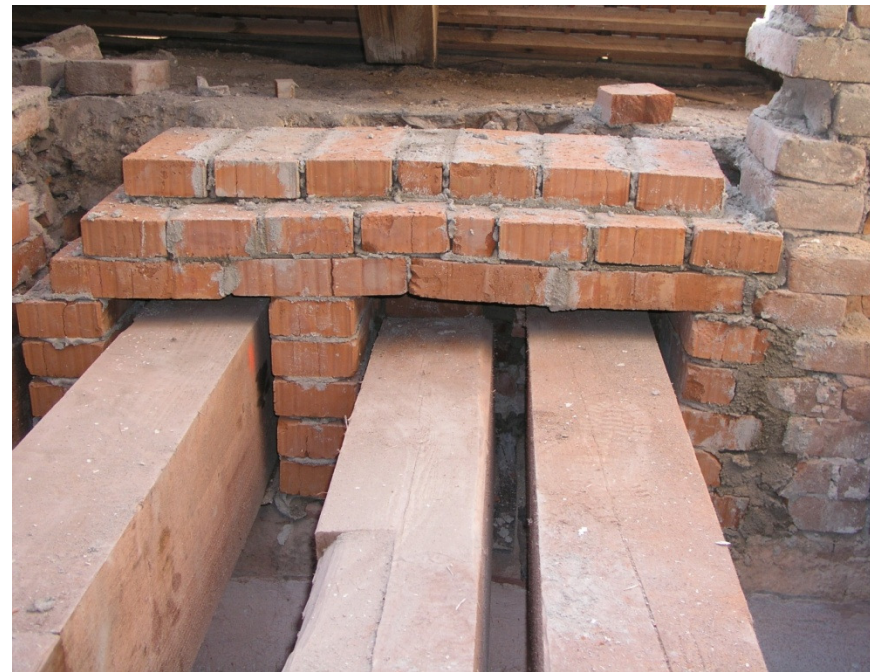
- ▶ wood treatment by biocidal chemical means
- ▶ separation of wooden elements from the wall
