CTU in Prague
Faculty of Civil Engineering
Department of Building Structures

Restoration of load-bearing structures

Residential house - Havlíčkova 7, Pilsen

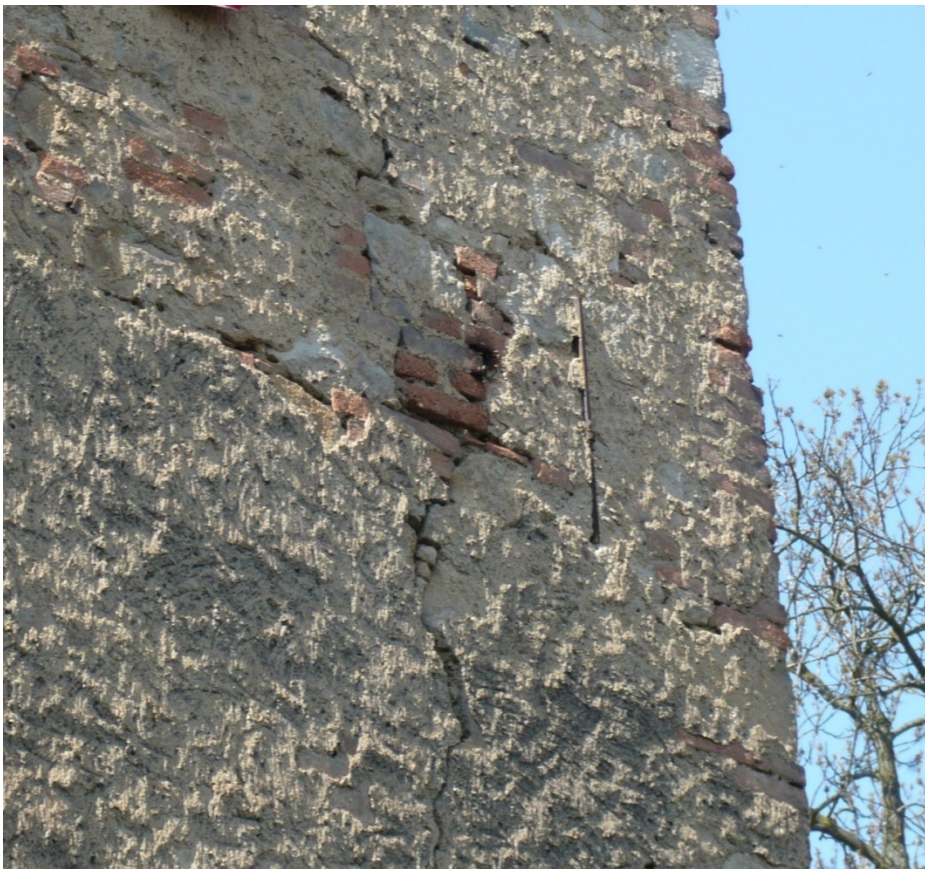
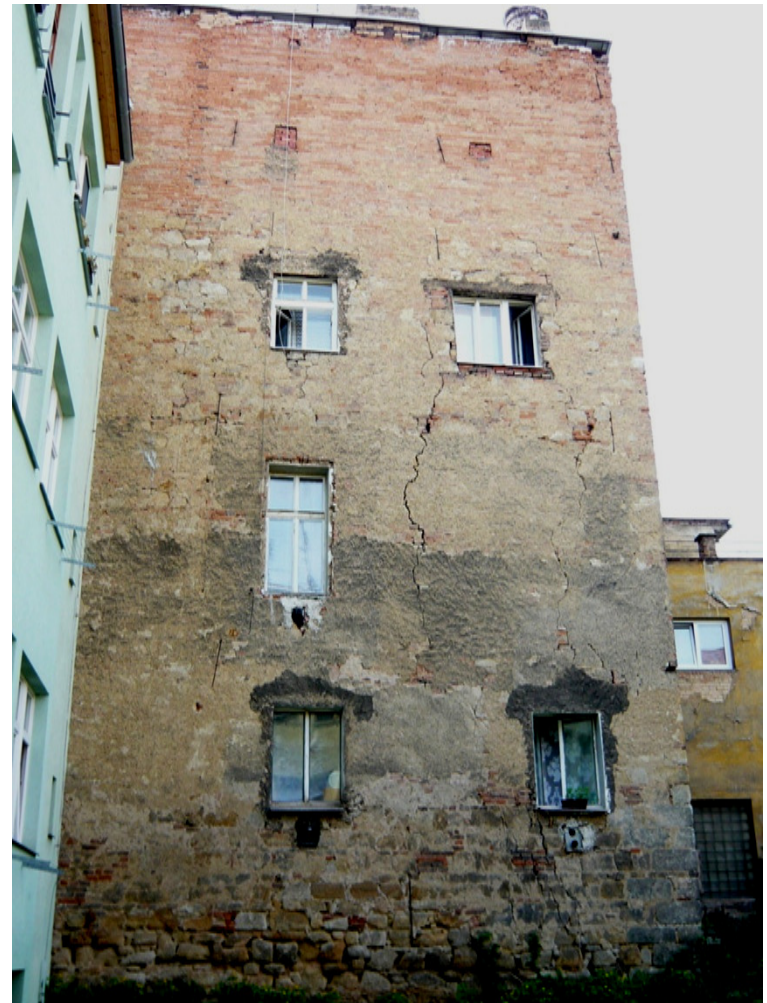
- ▶ significant vertical cracks in the facade

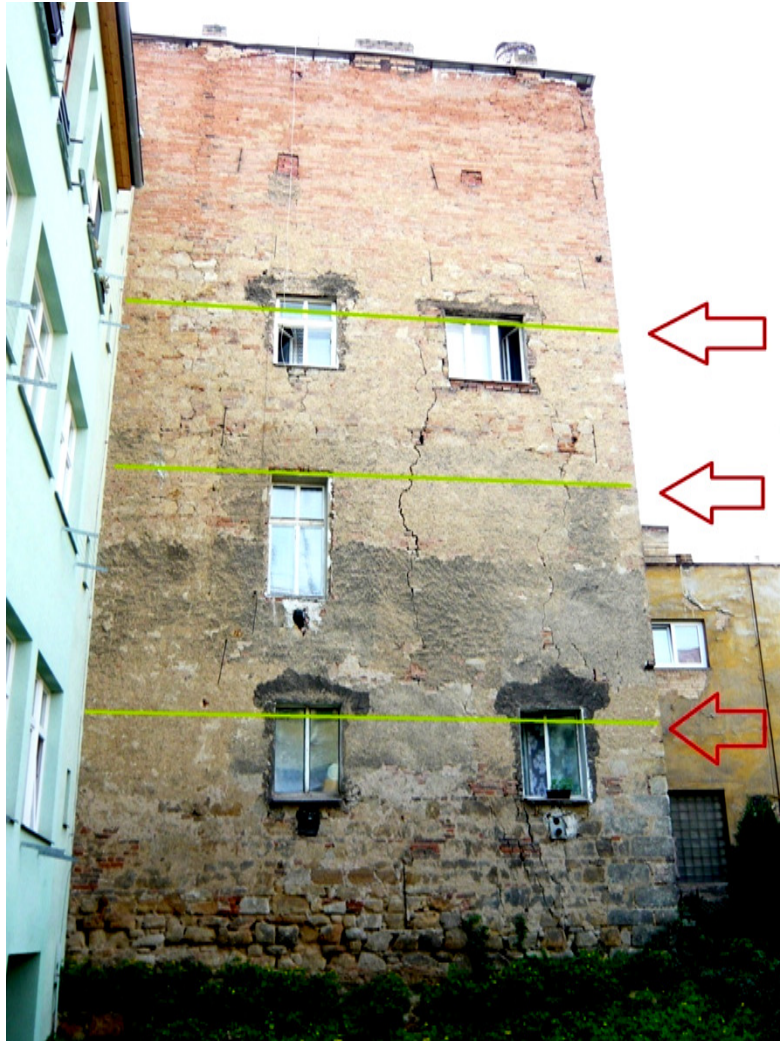
- ▶ Interrupted ironcramp anchors in combination with a reduction of cross-section by window openings

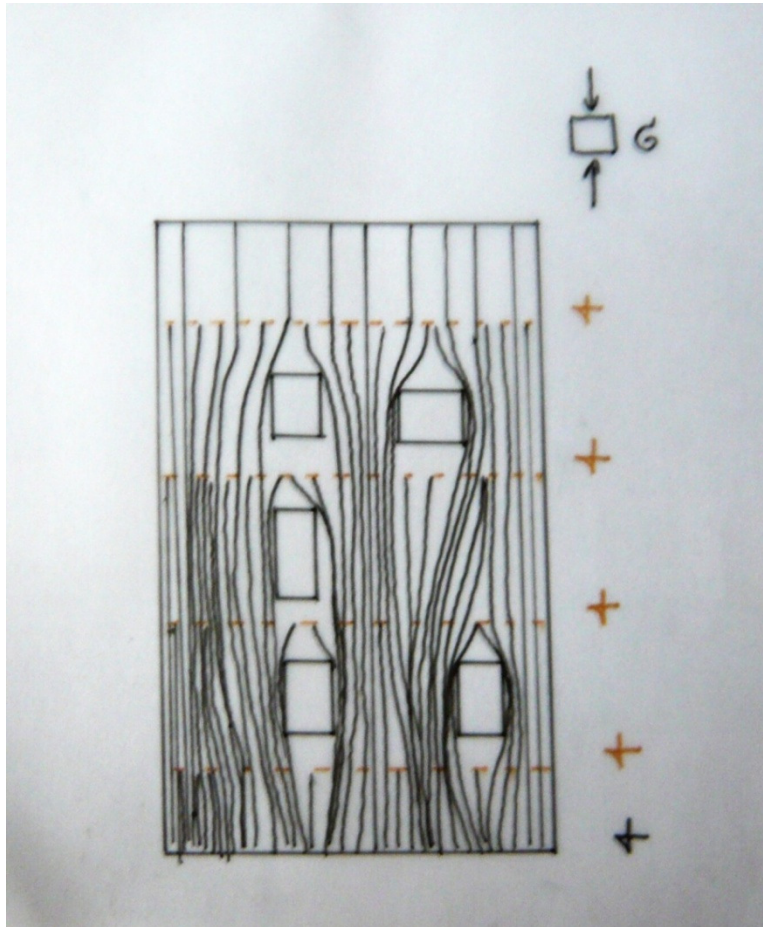
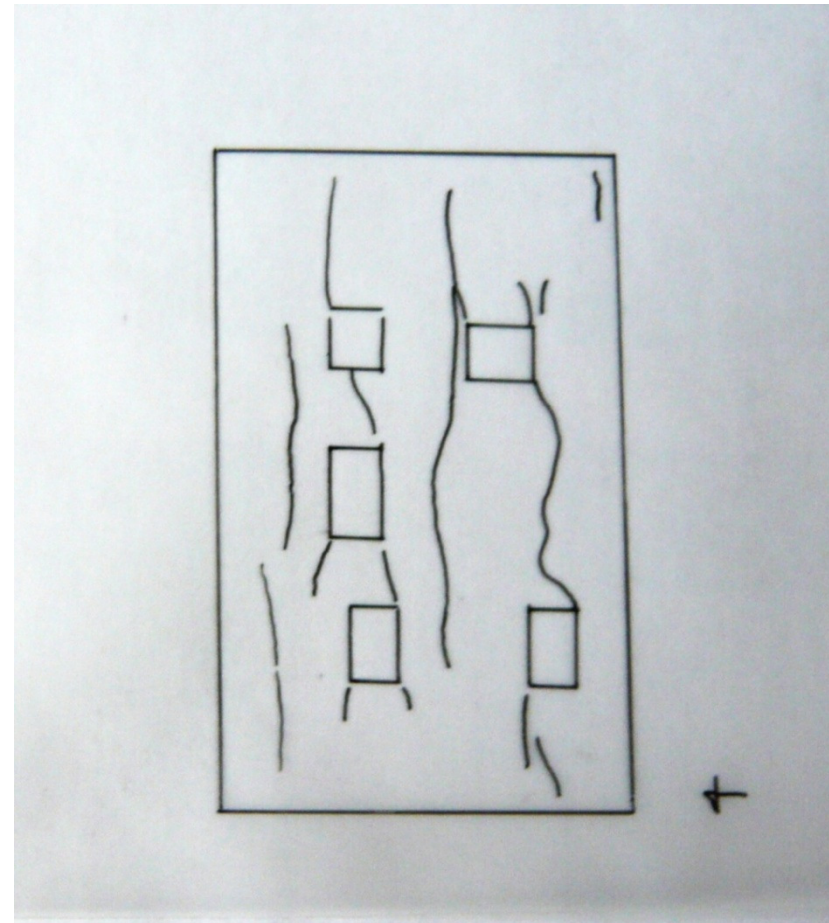
- Compression stress and cracks scheme
