CTU in Prague
Faculty of Civil Engineering
Department of Building Structures

Restoration of vaults

Nerudova 15, Prague

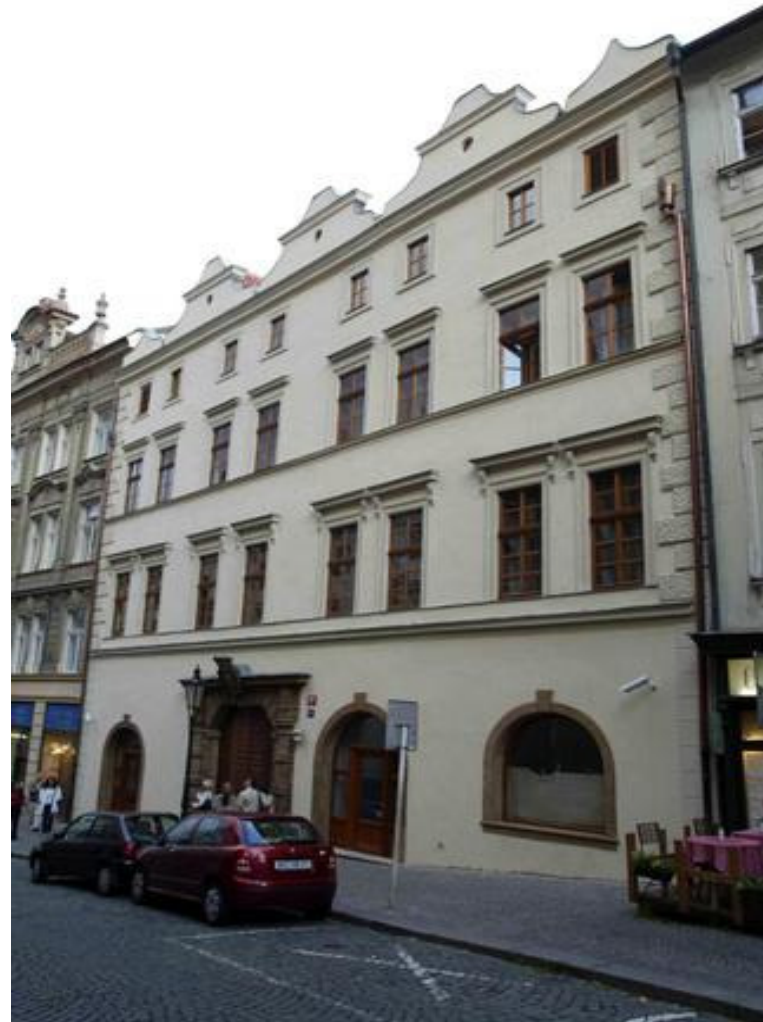
- ▶ view from the street
- ▶ traditional building technologies :
 - ▶ basement and ground floor of the vaults (brick)
 - ▶ other floors are wooden girder floors

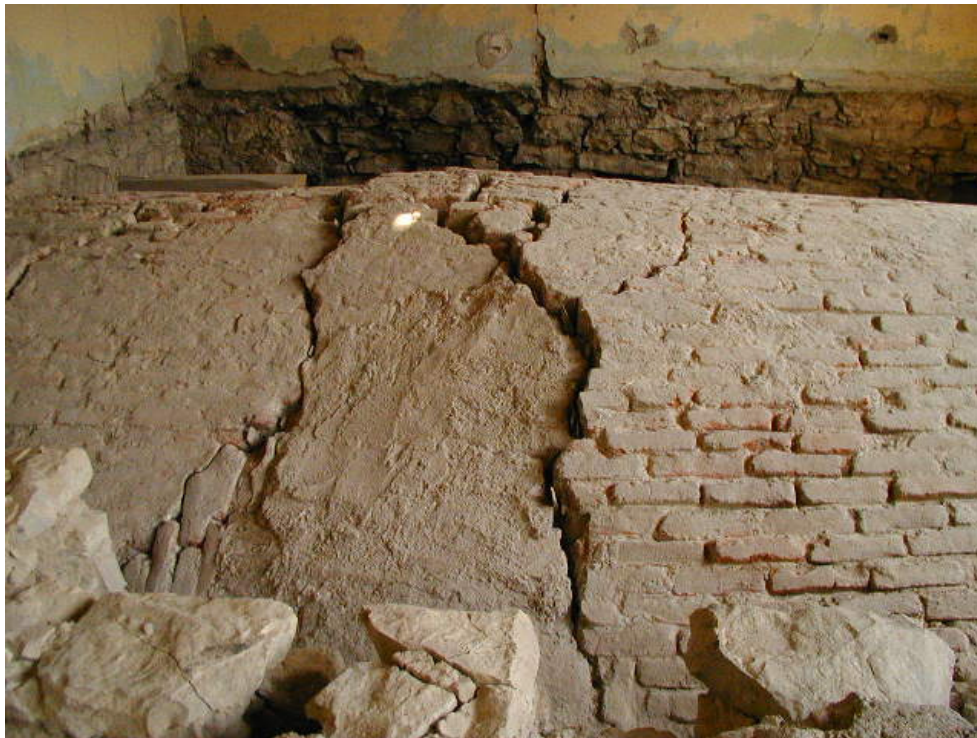
- ▶ unstable foundation subsoil (site Jánský vršek)
- ▶ insufficient structure reinforcement in the past
