CTU in Prague
Faculty of Civil Engineering
Department of Building Structures

Restoration of load-bearing structures

Chateau in Bystřice pod Hostýnem

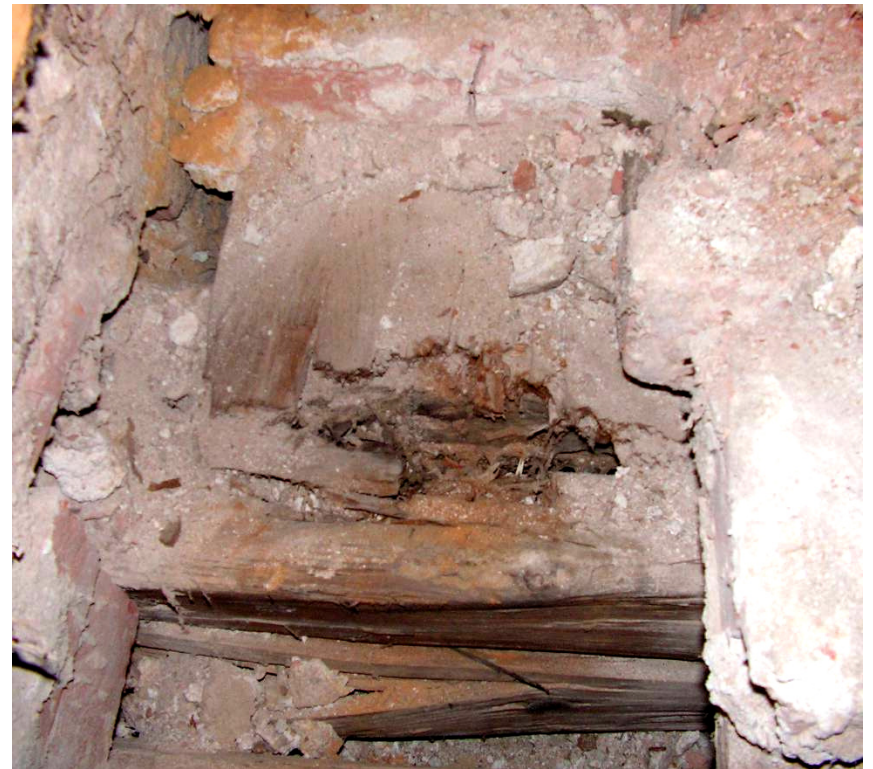
- ▶ Probing between 2nd – 3rd floor
 - ▶ board flooring 20 mm
 - ▶ wooden crate 50 x 100 mm
 - ▶ filling – rubble 150 mm
 - ▶ bricks placed horizontally 70 mm
 - ▶ mortar 30 mm
 - ▶ board deck 20 mm
 - ▶ beams 250/200 250 mm
 - ▶ board deck 20 mm
 - ▶ reed plaster 20 mm

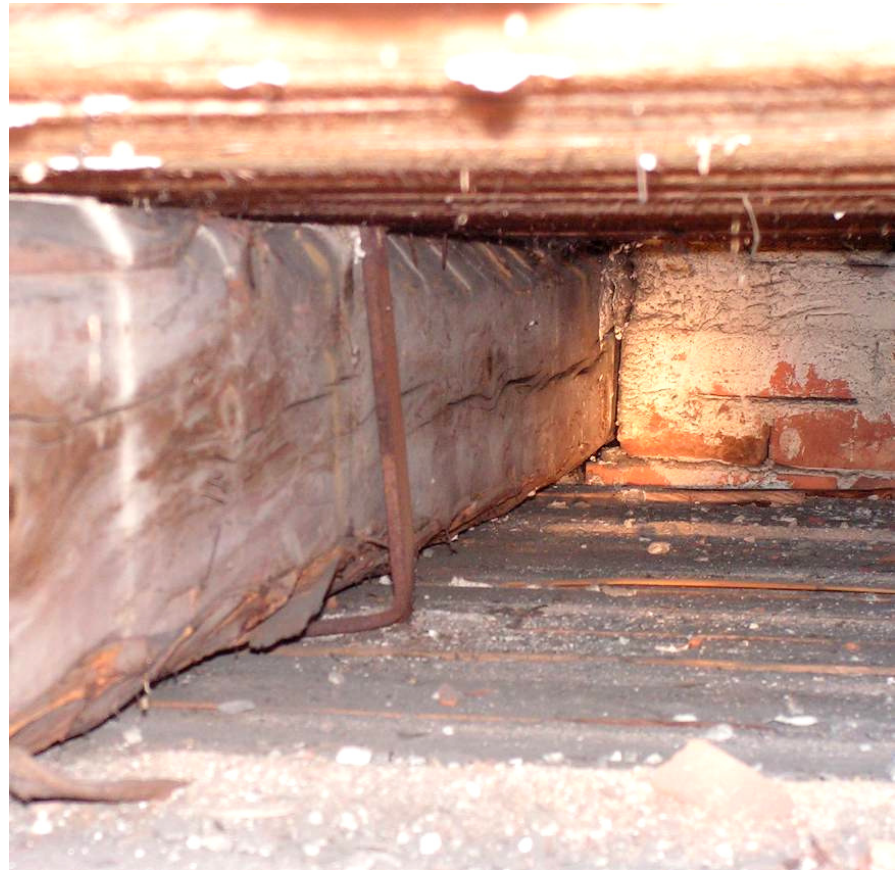
- ▶ Probing roof floor
 - ▶ bricks 50 mm
 - ▶ sawdust filling 30 mm
 - ▶ board deck 20 mm
 - ▶ beams 300/200 300 mm
 - ▶ board deck 20 mm
 - ▶ reed plaster 20 mm

- ▶ place of roof floor collapse

- ▶ increase in loading during chateau conversions caused drop of roof floor structure and the formation of cracks in the load-bearing walls
