CTU in Prague Faculty of Civil Engineering Department of Building Structures

Restoration of masonry

Church of St. Giles in Milevsko

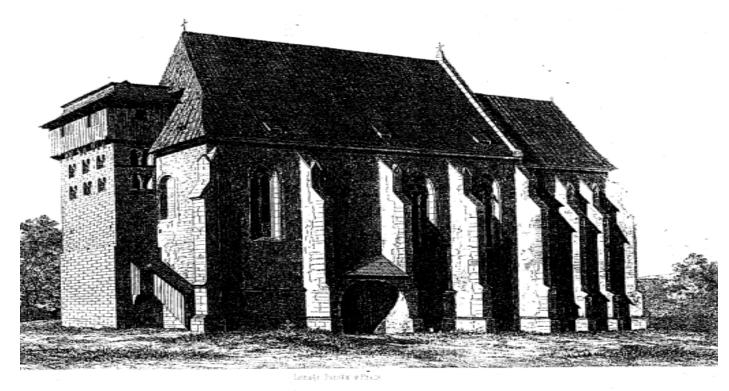
1407 – rebuilding lead by master Staněk,
Gothic building was originally built into the smaller Romanesque church

Chrám sv. Jilji v Milevsku.

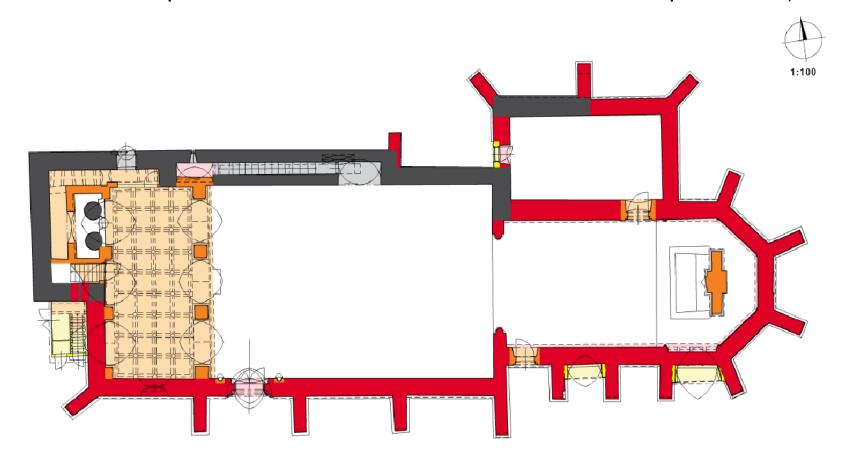
unique structure composed of two styles blended together (from Romanesque time the northwest wall and "westverk" preserved)

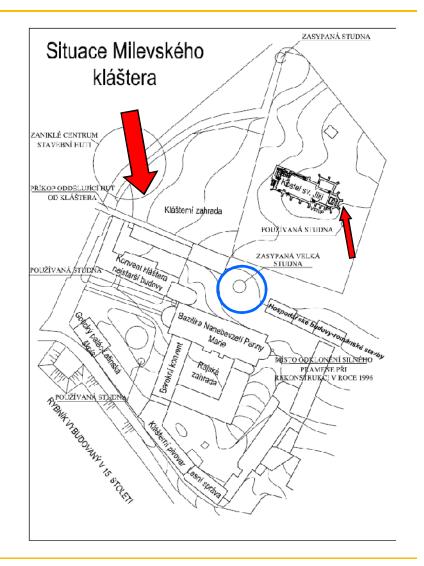
- 11 to 12 century.
 - system of deep foundation wells of different sizes and depths
 - position refers to the purposeful, coherent deployment
