CTU in Prague  
Faculty of Civil Engineering  
Department of Building Structures

# Restoration of foundations

## Leaning Tower of Pisa

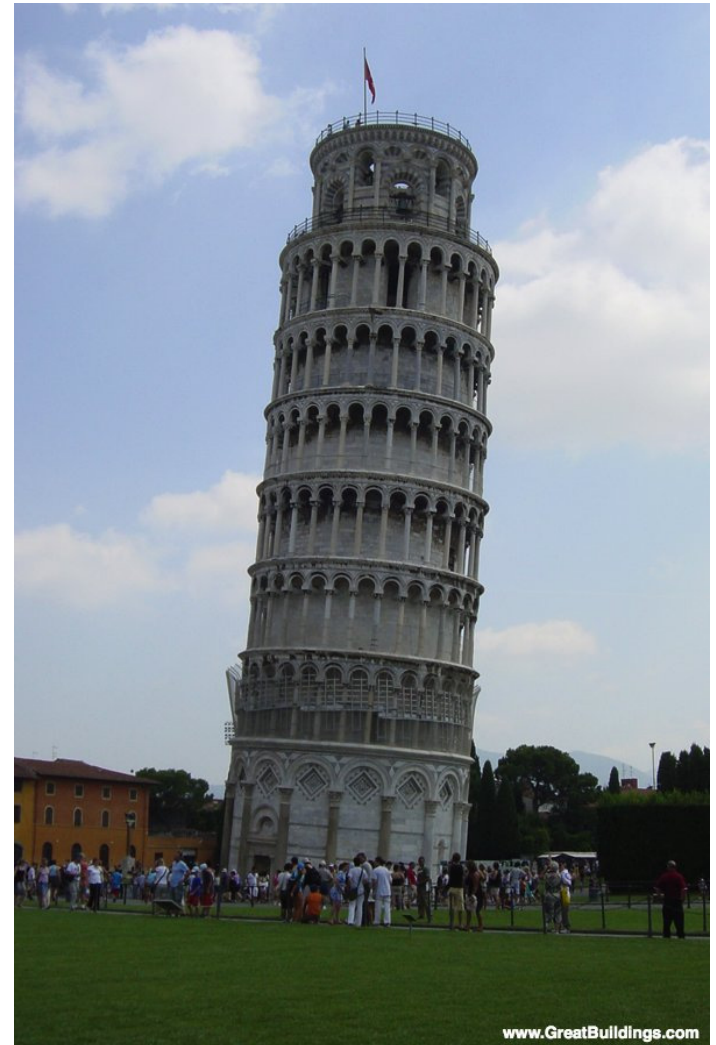
- ▶ tower based on clay with seashells and with layers of sand
- ▶ tower height of 56.4 m, weight of 14,453 tons
- ▶ diameter of 14.54 m, 48.6 m circumference
- ▶ 296 steps
- ▶ wall thickness
  - ▶ at the foot 4.09 m, in the top 2.48 m
  - ▶ deviation: in 1272 to 90 cm,  
in 1992 to 447 cm
- ▶ originally inclination to one side after the additional load tower flips to the other side
- ▶ settlement of tower - almost 2 m

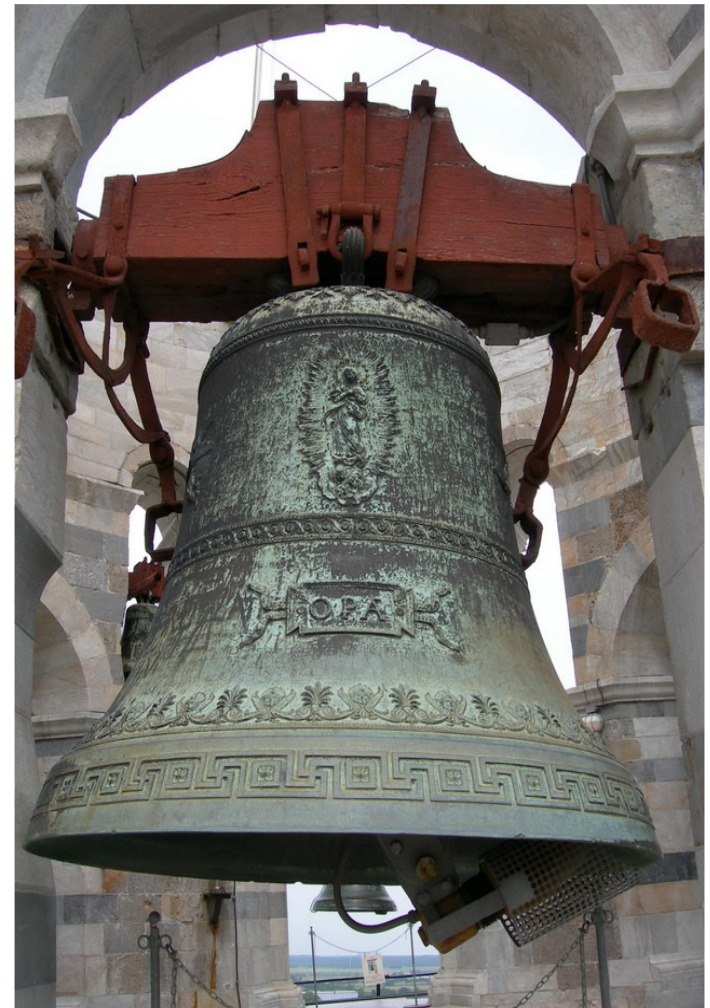
- ▶ construction works started in 1173, shortly after the beginning began to tilt. (setting from 30 to 40 cm, tilt 5cm)
  - ▶ based shallow foundations in soft ground (1 kg / m)
- ▶ attempt to compensate tilt - into the foundations thrown stones and branches
- ▶ the tower, formed up and later began leaning to the other side
- ▶ 1185 three-story height - apparent tilt - construction stopped
- ▶ 1275 built another floor slightly tilted to the other side = change in center of gravity, an attempt to stop further tilt
- ▶ compared to the original plan to build the highest bell tower of its time in 1350 ended the sixth floor of belfry for hanging bells
