CTU in Prague
Faculty of Civil Engineering
Department of Building Structures

Restoration of foundings

Santa Maria Dei Frari in Venice

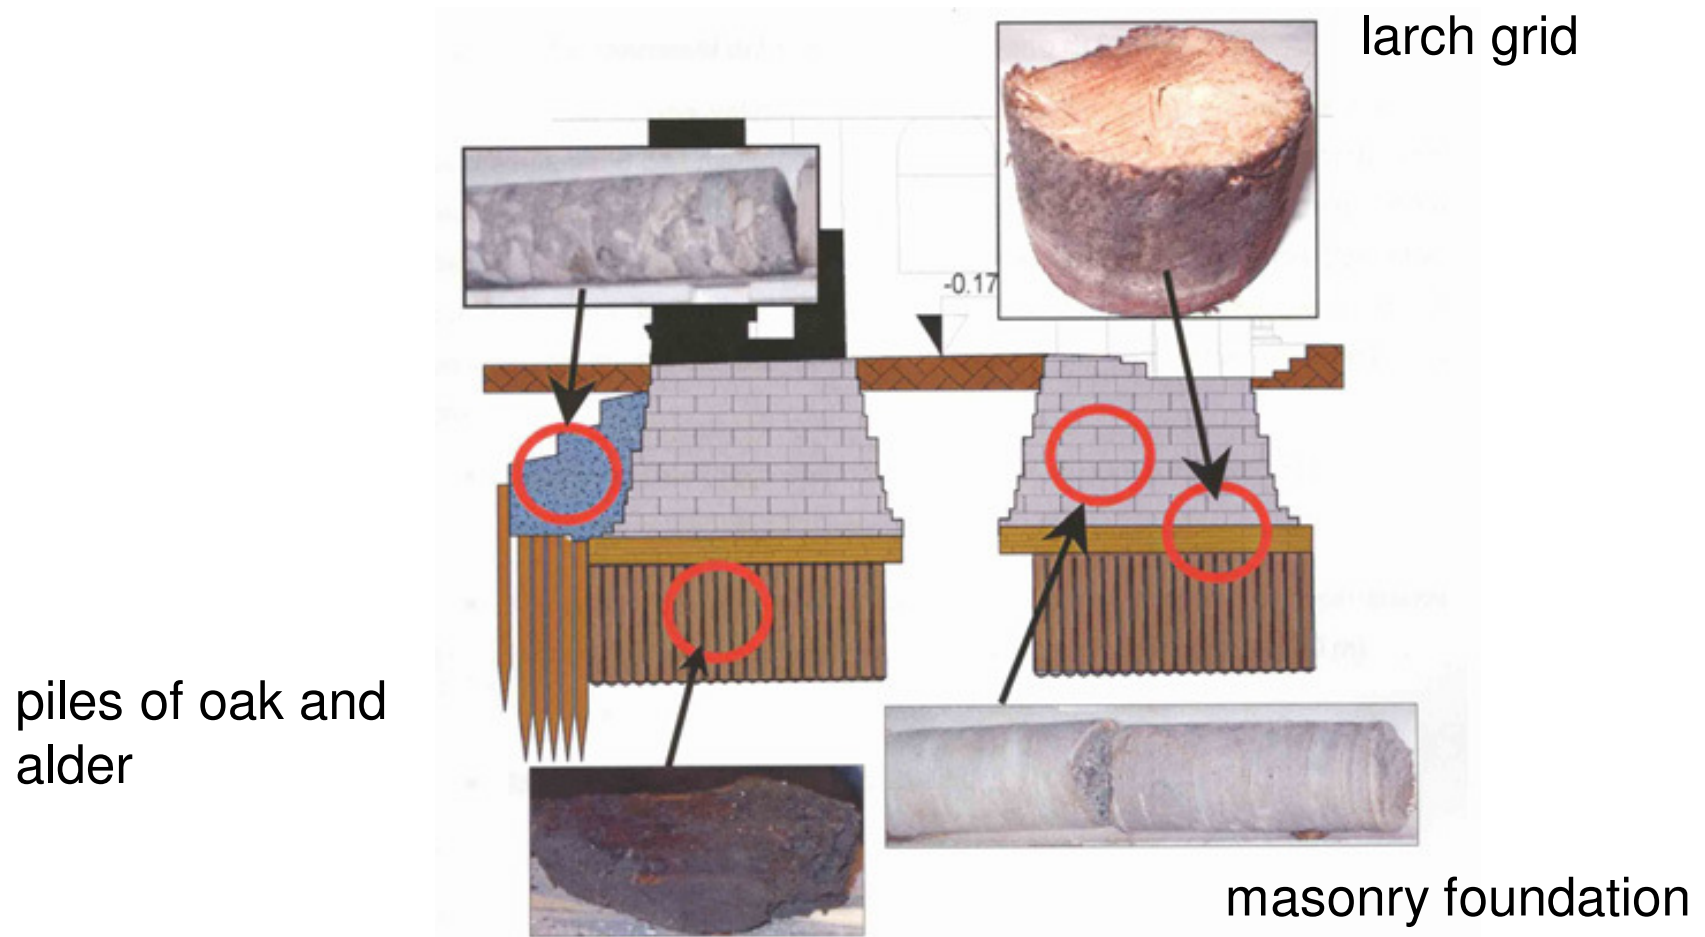
Foundations conditions

- ▶ A) 0-3 m backfilling material
- ▶ B) 3 - 6.8 m clay (low cohesion)
- ▶ C) 6.8 - 14.5 m of medium-grained sand (low plasticity)
- ▶ D) 14.5 - 16.8 m clay
