CTU in Prague
Faculty of Civil Engineering
Department of Building Structures

Restoration of vaults

Šlechta restaurant in Prague - Bubeneč (Main Hall)

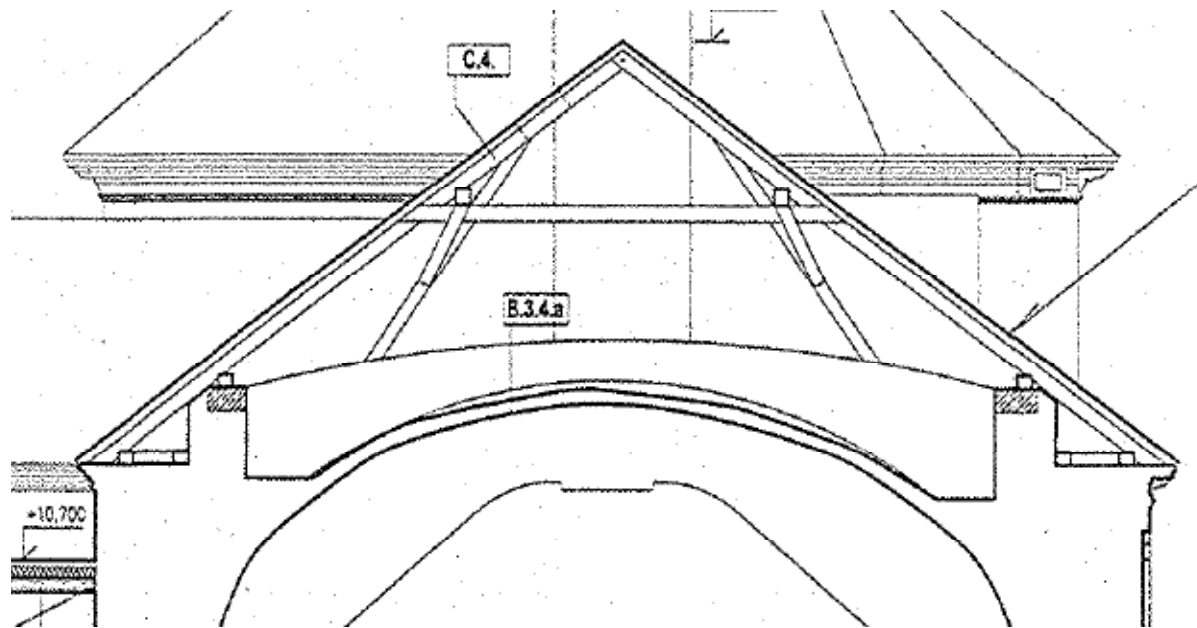
- ▶ truss above the main hall
 - ▶ New-made King Post Truss above the main hall
 - ▶ supported by circuit reinforced concrete rims and arch reinforced concrete ribs
 - ▶ full frames – King Post Truss with 2 purlins

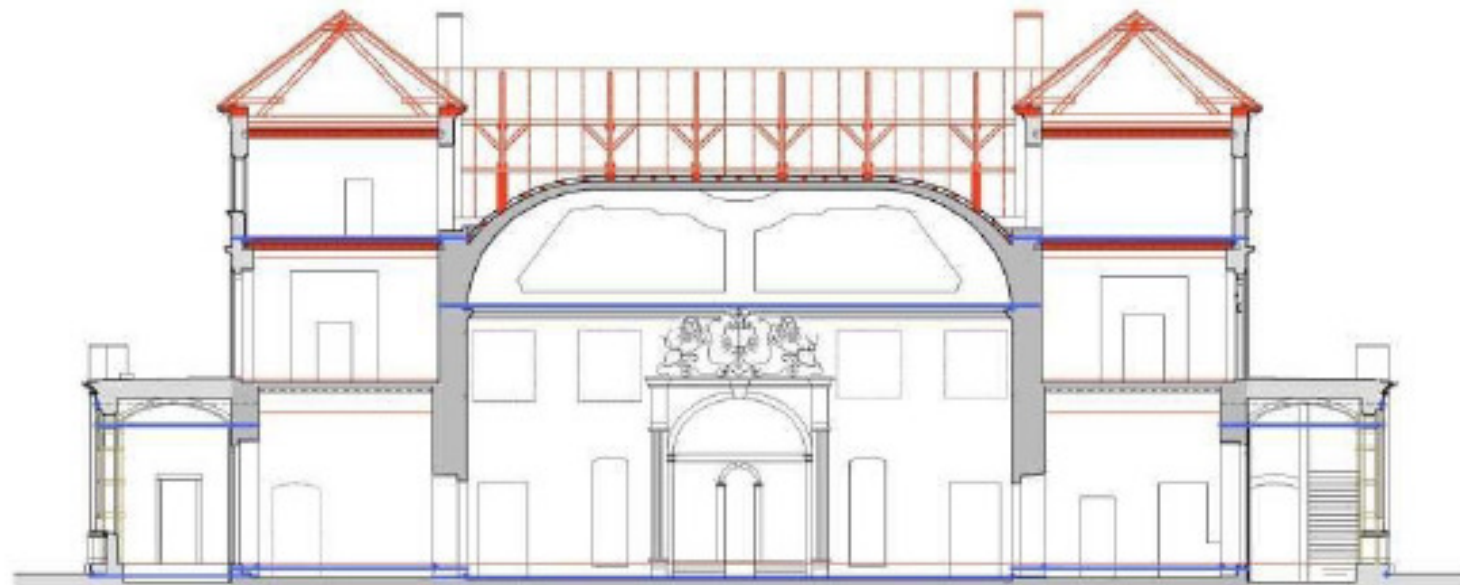
- ▶ Current state of Šlechta restaurant
